NUMBER: 08-109-20

GROUP: 08 - Electrical

UGQ Radio Enhancements

2021	(JL)	Jeep Wrangler
2021	(JT)	Jeep Gladiator

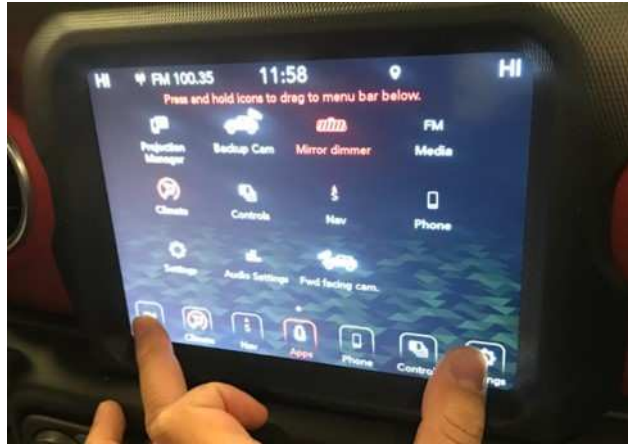
Fig. 1
Checking Software Level

1. Verify the radio software version. Radio must be in Dealer Mode to verify by following these steps:
 - a. Push and hold the lower corners of the radio screen down buttons simultaneously until the 'Dealer Mode' screen appears (approximately seven seconds). Release buttons (Fig. 1) .

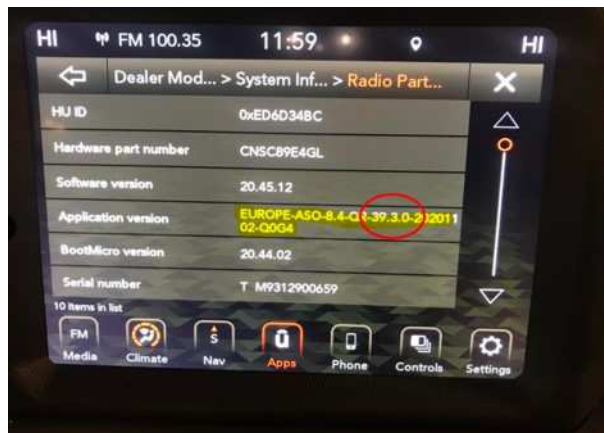
Fig. 2
Radio Software Level Screen

- b. Select "Radio Part Information". The software version will be listed next to "Application Version" (Fig. 2) .

2. Is the radio software level (Application Version) at or higher than 39.3?
 - YES>>> The radio software is already up to date, use inspect LOP (18-60-02-CC) to close the active RRT.
 - NO>>> Proceed to [Step 1](#) of the Repair Procedure.

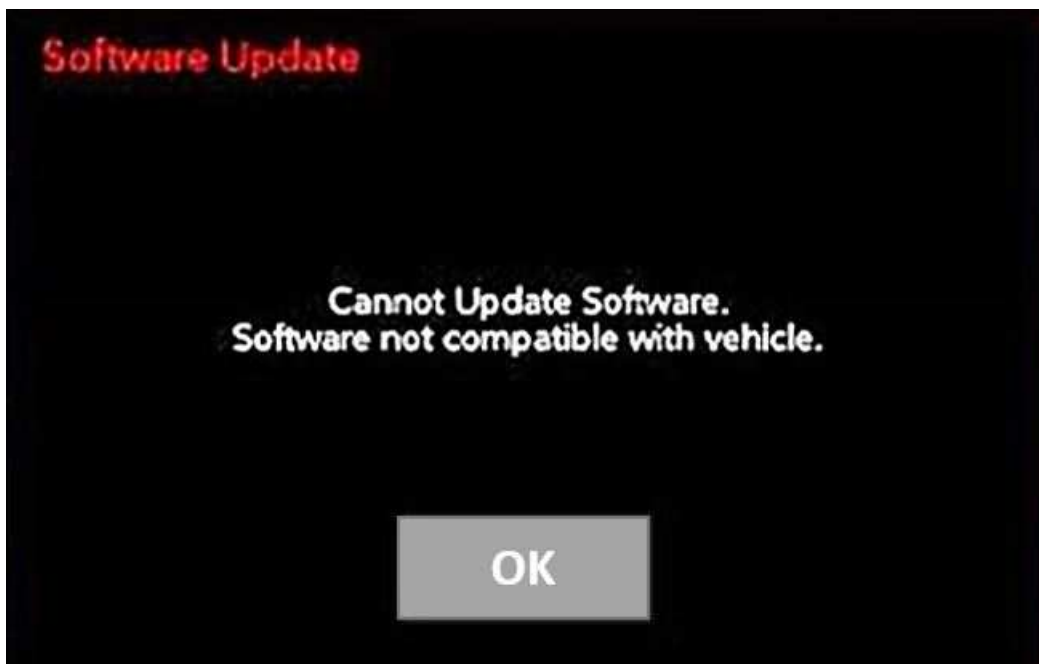
Fig. 6
Software Not Compatible

10. If the screen in (Fig. 6) is displayed, the USB flash drive was not set up correctly. Use a top name brand USB flash drive and create a new USB flash drive. Start the update again.

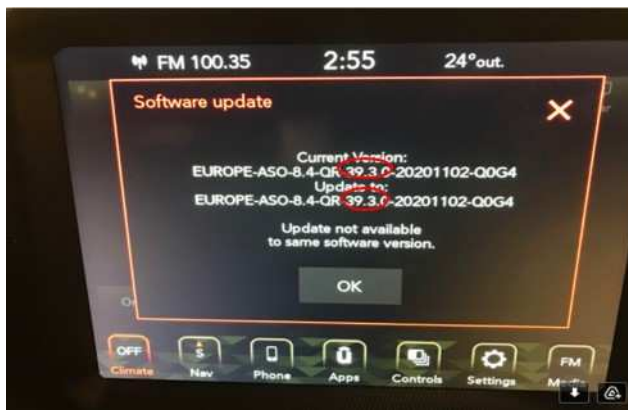
Fig. 7
Screen Displayed When Radio Software Level Is Up To Date

11. If the radio software is up to date, the screen in (Fig. 7) will be displayed. Press "OK" and remove the USB flash drive.
