**Bulletin Number: 20-006 Models: FE/FG Issue Date: July 30, 2020 Page 1 of 2**

Diagnostic Trouble Code (DTC) 1623-19 after EEC programming during C10084 Recall

EPA10 FEC52, FEC72, FEC92, FGB72 produced prior to August 1, 2013

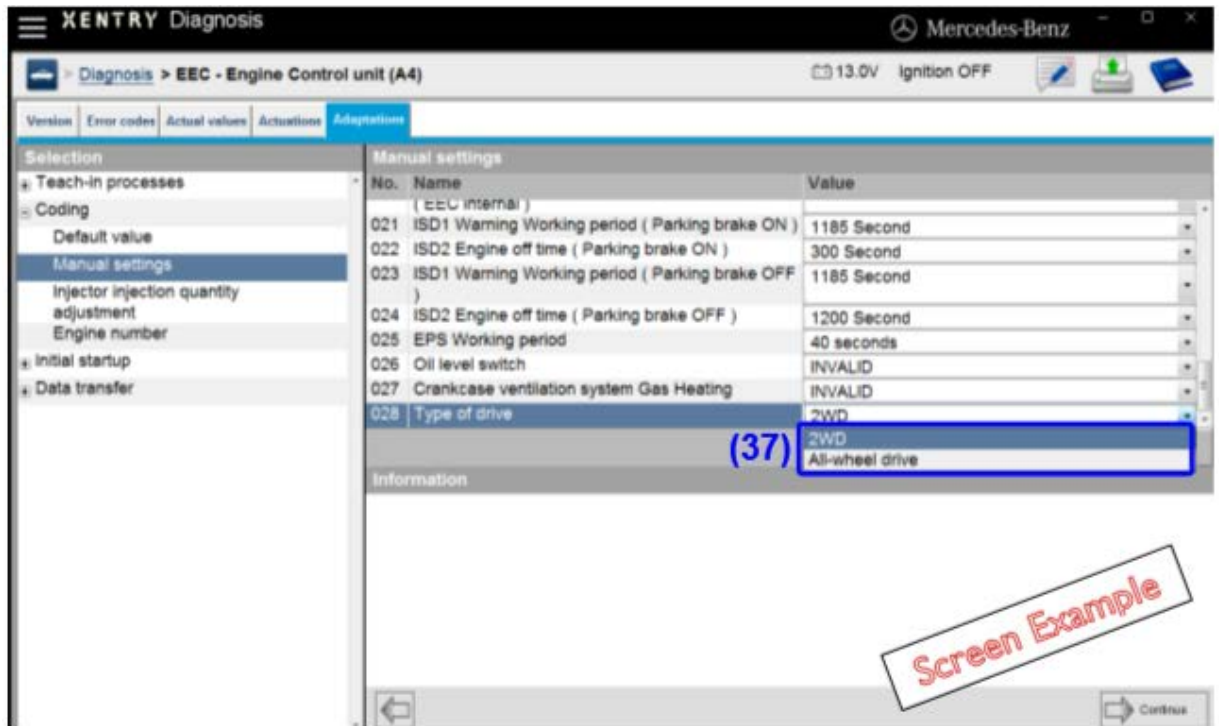
Using the Fuso Diagnostic Tool (FD) scan for active/stored codes, the DTC1623-19 "The CAN message from component instrument panel is faulty" indicates re-flashing instructions were not followed. Please note that MFTA Warranty will not reimburse dealers to correct this condition resulting from omitting programming steps that trigger DTCs.

**(37) Select the item “028 Type of drive” depending on the vehicle, 2WD/4WD type parameter will be written.**

1. Download an EEC file from Field Rewrite Network to a USB storage device.
2. Connect XENTRY Diagnostics & navigate to adaptations in the EEC.
3. Choose Data transfer then copy the file from the USB storage device
4. Go to coding, then manual settings.
5. Under item #28 TYPE OF DRIVE, select 2wd or all-wheel drive, depending on the vehicle's configuration.

6. Click Apply changes.
7. Choose Data transfer then copy to the USB storage device.
8. Upload the changes to the Field Rewrite Network.
