Dealer Operator/General Manager	Sales New Vehicles	Sales Used Vehicles	Business Manager (F&I)	Service	Parts & Accessories	Administration
Date: June 22, 2020		Source: Zero Motorcycles Customer Service Department		Program Period: Commencing June 22, 2020

## Long-Term Storage Mode Firmware Update Service Campaign

**New Firmware Versions: MBB Rev 30, BMS Rev 37.**

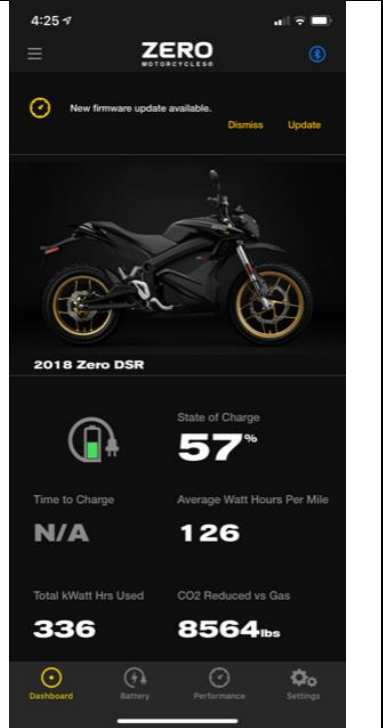
4. Once paired and connected to the motorcycle with the app, you should see a “New firmware update available” alert at the top of the app screen. Press the “Update” button.

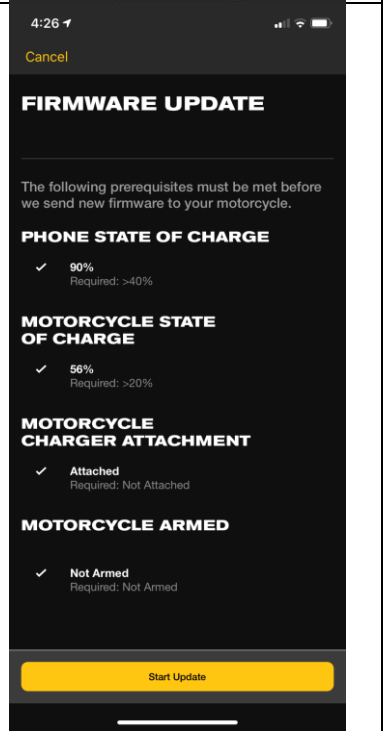
5. The mobile app will display the Firmware Update prerequisites screen. Note that your smart phone must be charged to greater than 40%. The motorcycle should be charged to more than 20%. The motorcycle should NOT be plugged in and NOT charging. The motorcycle should not be armed, which means the kickstand is down and the run switch is off so that the motorcycle won't move when the throttle is applied.

Note that the picture to the right indicates that the charger is attached. If you find that the app indicates the charger is attached, but it is not, press the Start Update button anyway.

Once the above prerequisites are met, press the Start Update button.

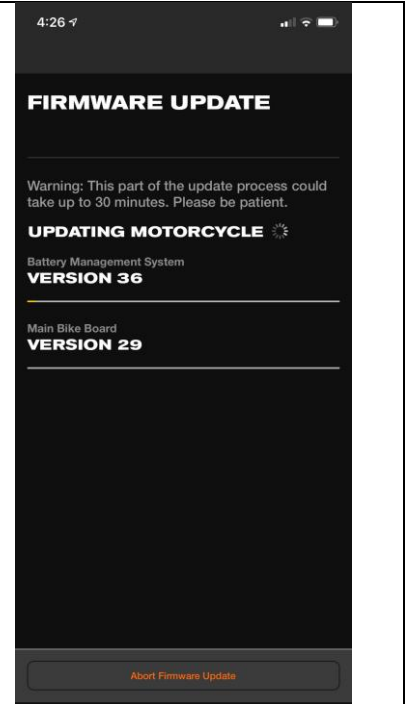
6. The Firmware Update screen will display the progress of the update, which can take as long as 30 minutes.

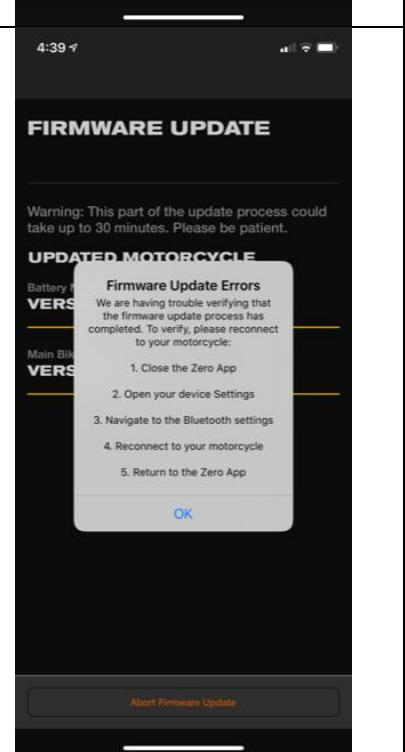
7. If the update process reaches the end but reports “Firmware Update Errors,” key off the motorcycle and wait for one minute. Kill the app. Then, key on the motorcycle and restart the app. After a few moments, the app should show it is connected again.

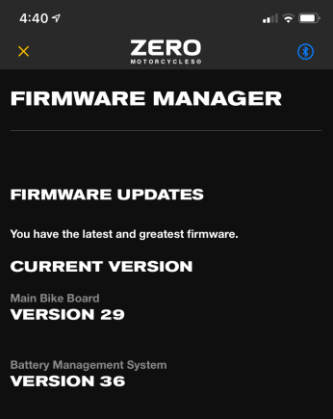
8. After powering off the motorcycle and then back on after one minute, you can check the firmware versions by pressing the Menu button in the upper left portion of the mobile app home screen and selecting the Firmware Update.

Note that the new versions will be MBB version 30 and BMS version 37, which are newer than the picture to the right.

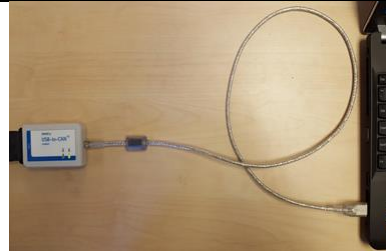
2. Connect the IXXAT USB-CAN bridge of the Diagnostic Cables to your diagnostic computer via the USB connections.

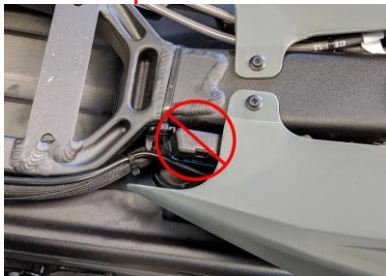
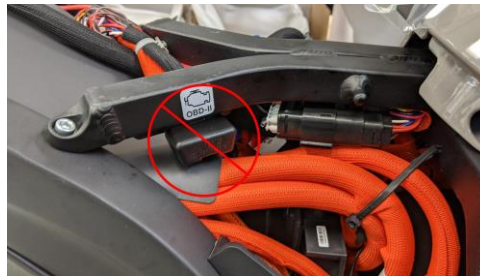
3. Connect the Diagnostic Cables to the motorcycle via the diagnostic port. For Zero SDS platform motorcycles, it is under the seat on the rider's left-hand side. For the Zero XMx platform motorcycles, it is behind the left side front bodywork between the horn and front power pack. Consult the Service Manual, if needed, for more information regarding port locations.

**NOTE: For the MY20 motorcycles an additional OBD-II connector was added under the seats on the rider's right-hand side. Do not use this port as it does not support firmware updates.**

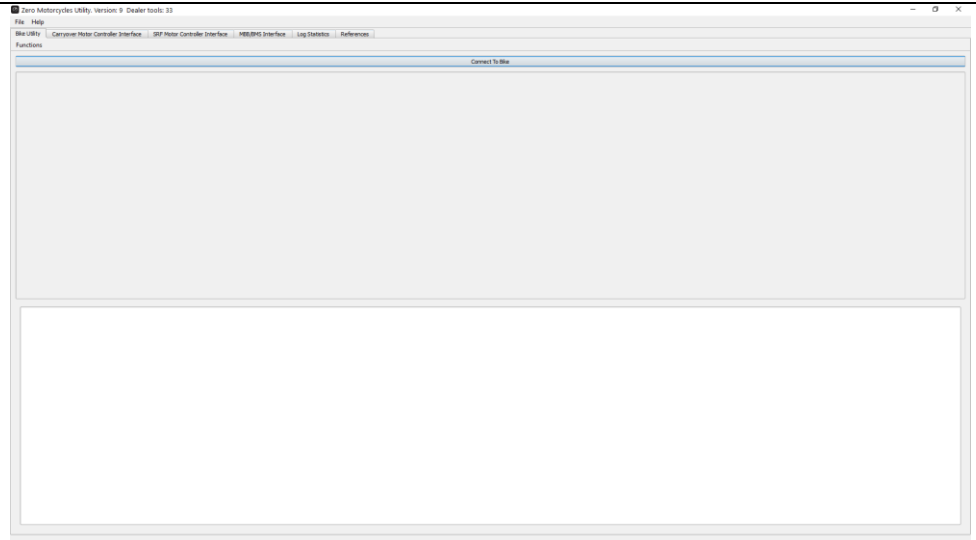
5. Within the ZDU user interface, select the Bike Utility tab and then press the “Connect to Bike” button.

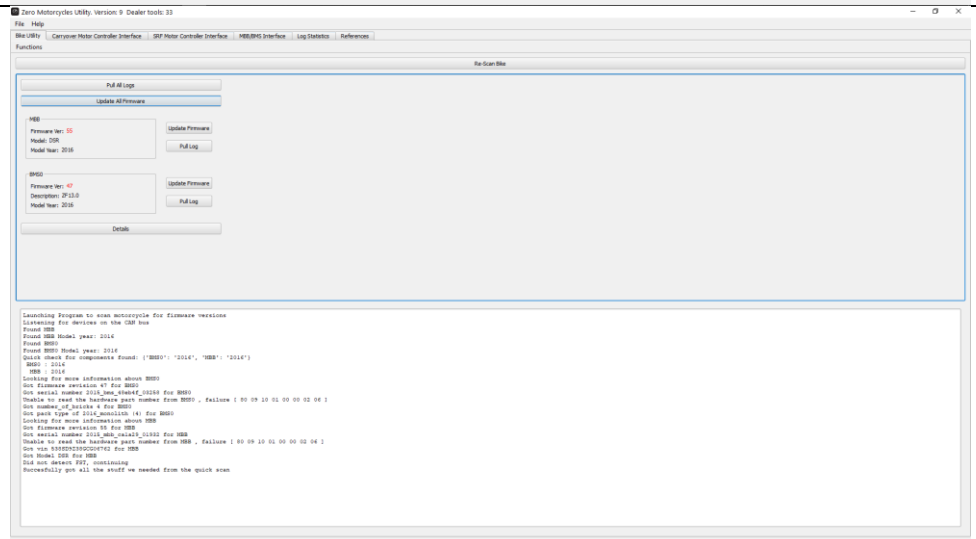
6. The ZDU will report the current MBB and BMS firmware versions. Generally, if they are displayed in **RED**, then they are out of date. For the purposes of this service campaign, motorcycles should be updated to the following versions or newer.

**MBB: Version 30**  
**BMS: Version 37**

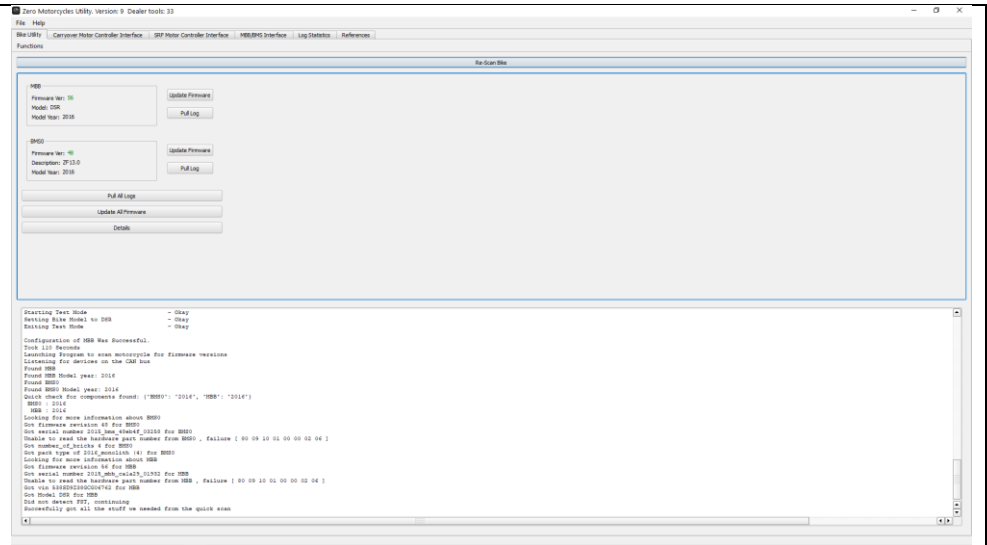
7. To update the firmware, press the “Update Firmware” button to the right of the MBB box, and wait for the update to complete. Then, press the “Update Firmware” button to the right of the BMS box, and wait for the update to complete.

If the motorcycle has multiple BMSs, which will be shown on the interface, update each individually in the same manner.
