GLOBAL SAFETY FIELD INVESTIGATIONS
DCS5456
URGENT - DISTRIBUTE IMMEDIATELY

Subject: A202304840-01 - Service Update
Camshaft Actuator Oil Control Valve Center Bolt Binding
Revised service procedure, parts information, warranty information,
and added floor plan.

Models: 2020 – 2021 Buick Encore GX
2021 Chevrolet Trailblazer
Equipped with 1.3L Turbo Engine(RPO L3T)

A202304840 Camshaft Actuator Oil Control Valve Center Bolt Binding

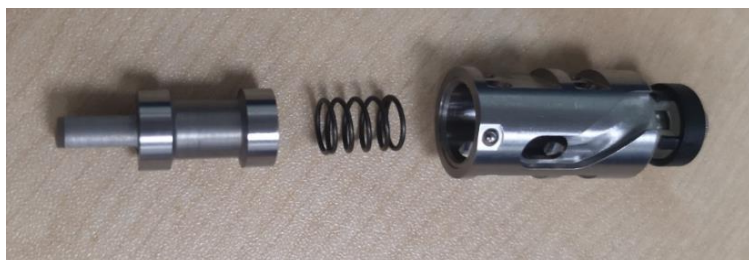
5627953

7. The removed bolt sleeve kit should look as shown – a plastic over molded sleeve.
