GLOBAL SAFETY FIELD INVESTIGATIONS
DCS5444
URGENT - DISTRIBUTE IMMEDIATELY

Subject: N192285071 – Customer Satisfaction Program
Tonneau Cover Retention

Models: Hard tri-fold tonneau covers (Part Numbers 84060327, 84060328 and current part numbers 84679033, 84679034) sold as accessories for:
2019 Chevrolet Silverado 1500 Series LD (New Model)
2020 Chevrolet Silverado 1500 Series LD
2019 GMC Sierra 1500 Series LD (New Model)
2020 GMC Sierra 1500 Series LD

N192285071 Tonneau Cover Retention

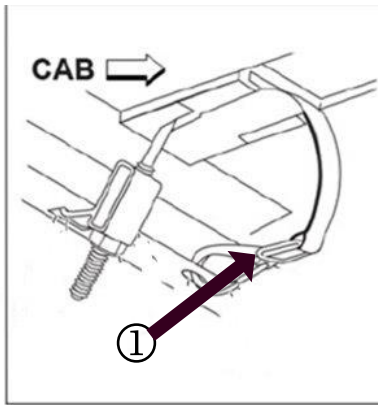
5613815

Open the front section of the tonneau cover and locate the outboard ends of the front hinge track. If the cover already has tethers (1) installed, it is up to date and no further action is required.

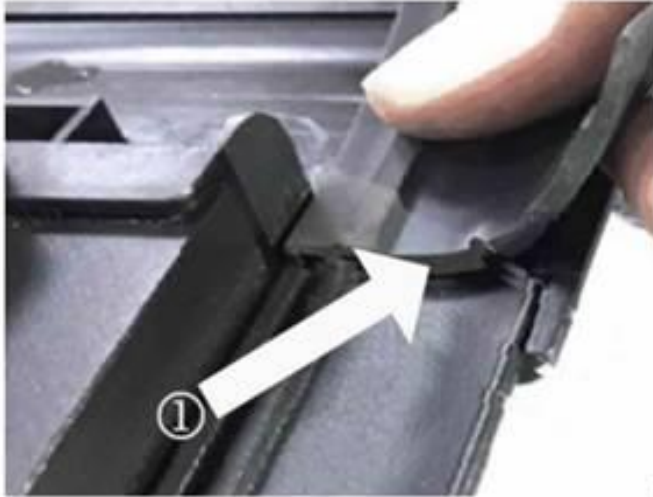
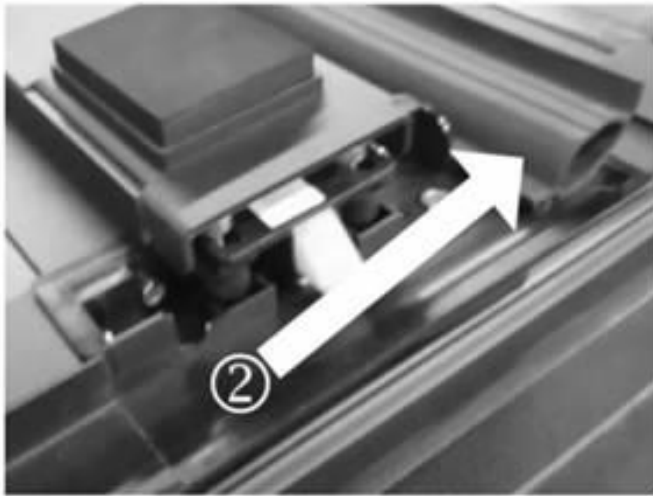
Important: Verify the front tonneau cover seal is the revised “fin” style seal (1). If the “bulb” style seal is installed (2), replace the seal. Refer to steps 1-5 of the Adjustment Instructions for Vehicles That Have NOT Had Recall N192217500 performed below.
