GLOBAL SAFETY FIELD INVESTIGATIONS
DCS5394
URGENT - DISTRIBUTE IMMEDIATELY

Subject: N192282860-01 - Service Update
Software Update for Internal Range Sensor Failure
Updated Labor Time

Models: 2020 Cadillac CT4
2020 Chevrolet Express, Silverado
2020 GMC Savana, Sierra
Equipped with Transmission-Auto 8 SPD (RPO M5N, MQD or M5U, MQE)

N192282860 Software Update for Internal Range Sensor Failure

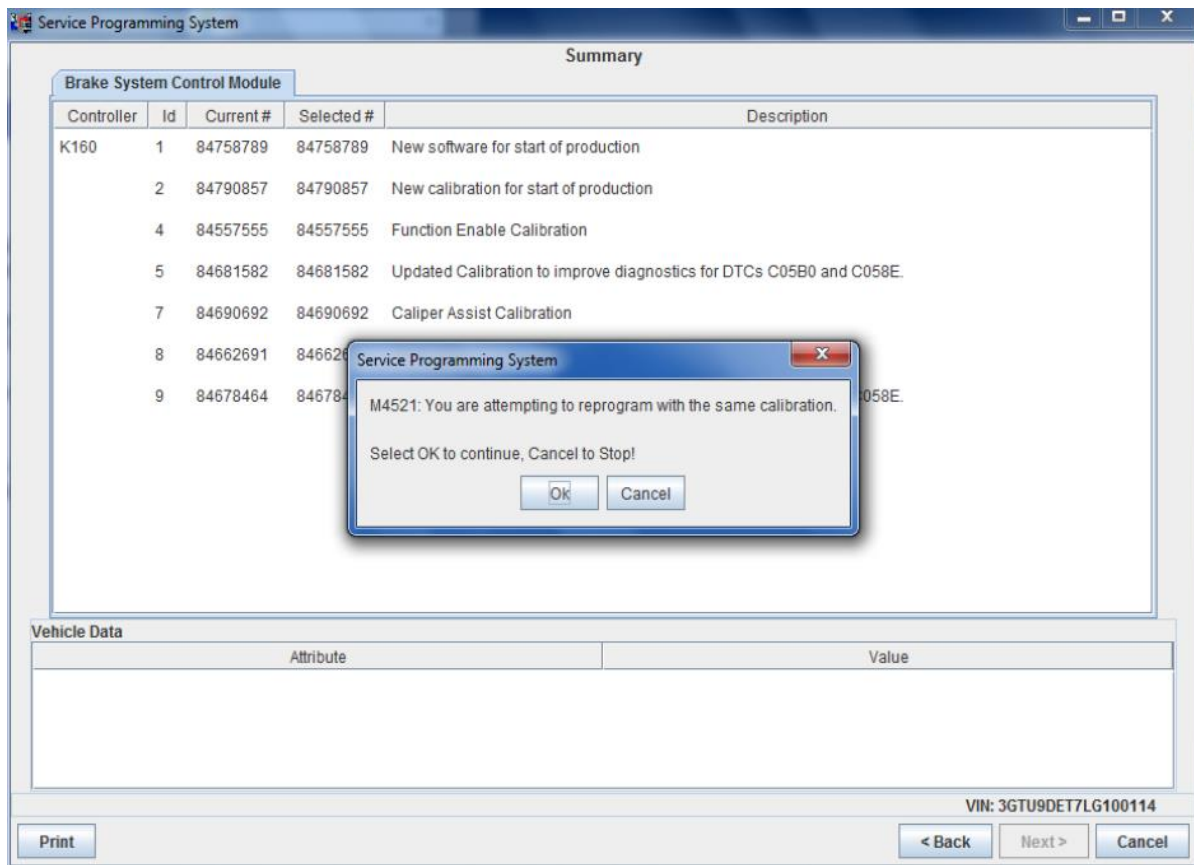
5431207

Important: TIS2WEB screen shown. Techline Connect screen is similar and will be included in the near future.

Important: If the Same Calibration/Software Warning is noted on the SPS screen, select OK and follow screen instructions. After a successful programming event, the WCC is located in the Service Programming System dialogue box of the SPS Summary screen. No further action is required. Refer to the Warranty section of the bulletin.

1. Reprogram the Transmission Control Module. Refer to *K71 Transmission Control Module: Programming and Setup* in SI.
 - Perform a shift adapt learn procedure. Refer to *Reset Transmission Adapts* in SI.

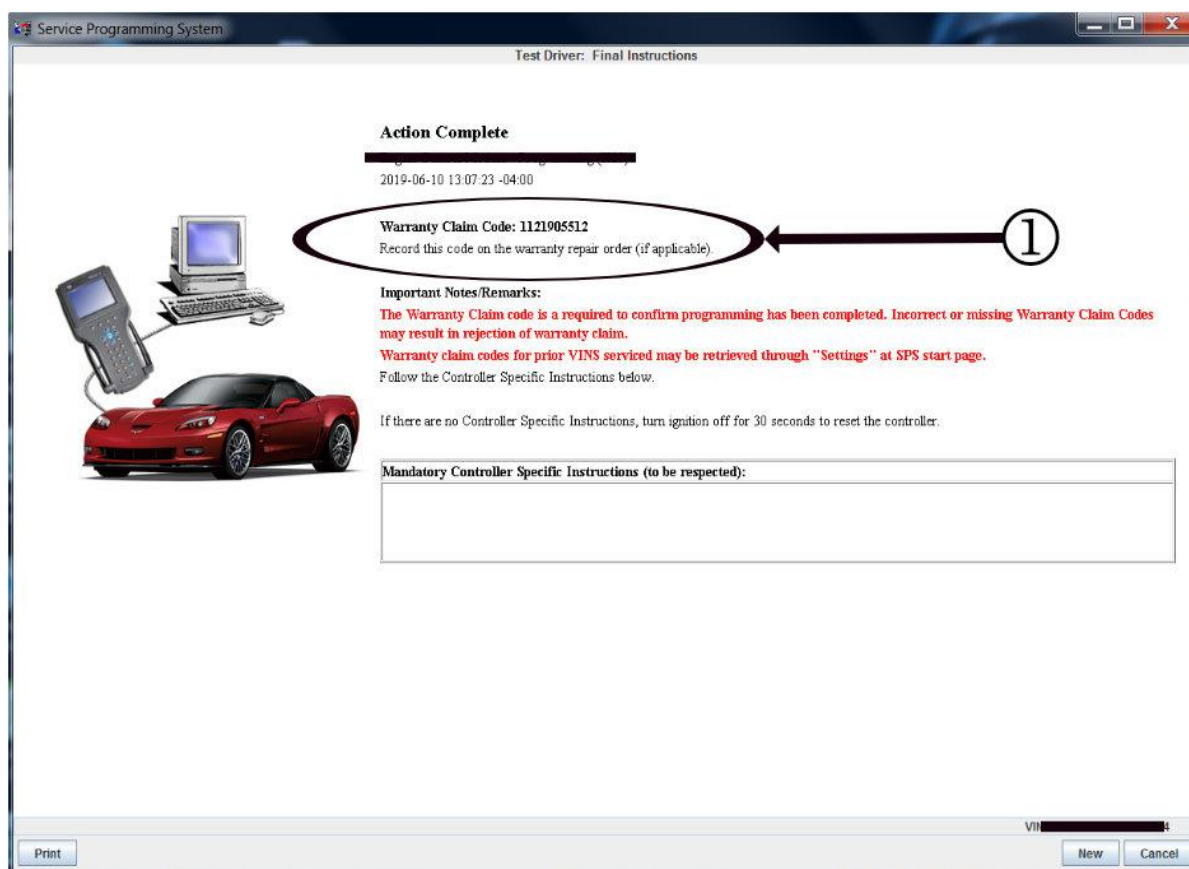
Important: TIS2WEB screen shown. Techline Connect screen is similar and will be included soon.

Important: To avoid warranty transaction rejections, you **MUST** record the warranty claim code provided on the SPS Warranty Claim Code (WCC) screen on the job card. Refer to callout 1 above for the location of the WCC on the SPS screen.

2. Record SPS Warranty Claim Code on job card for warranty transaction submission.
