Service Update

N202297530 Brake Pad Sensor Wear

Release Date: August 2020

Subject: N202297530 - Service Update
Brake Pad Sensor Wear

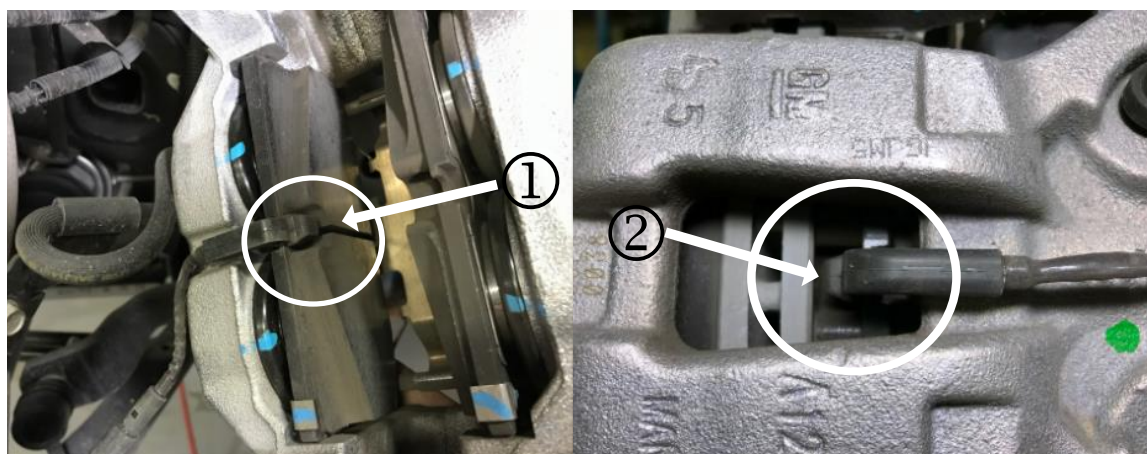
5445355

1. Remove the driver side front and passenger side rear tire and wheel assemblies for inspection. Refer to *Tire and Wheel Removal and Installation* in SI.

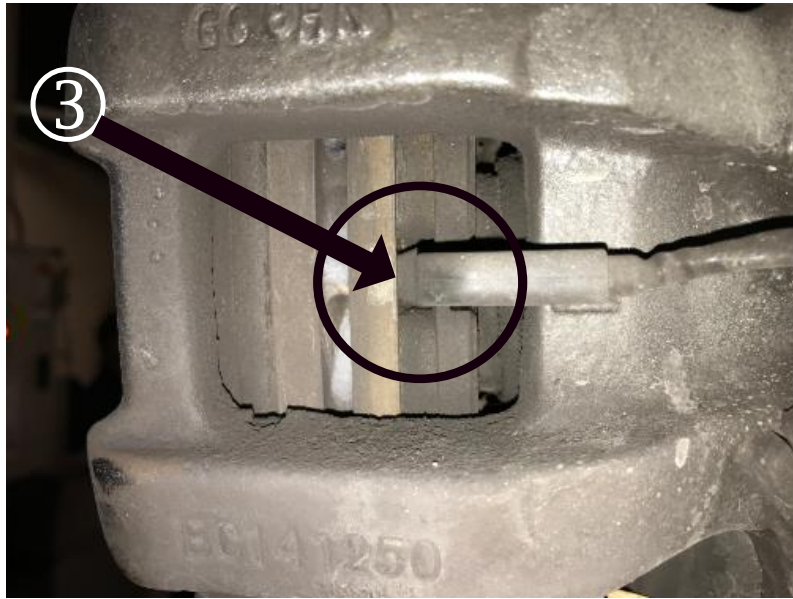
5445357

2. Remove the left front brake wear sensor (1,2,3-views of the sensor) from the caliper. When removing the sensor verify that the small piece of metal is also removed and discarded. It may come out with the sensor, if it does not, be sure to remove it.

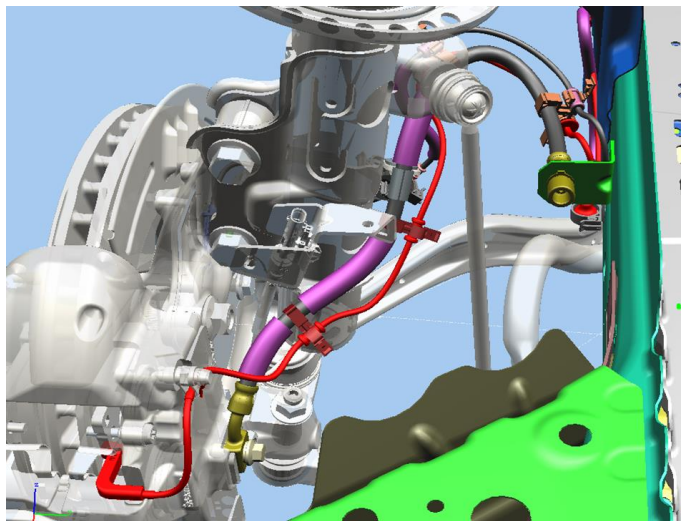
5636467

3. Follow the path of the left front brake wear sensor wiring and disconnect. Ensure the bleeder cap and brake hose clips are closed after the sensor wire removal.

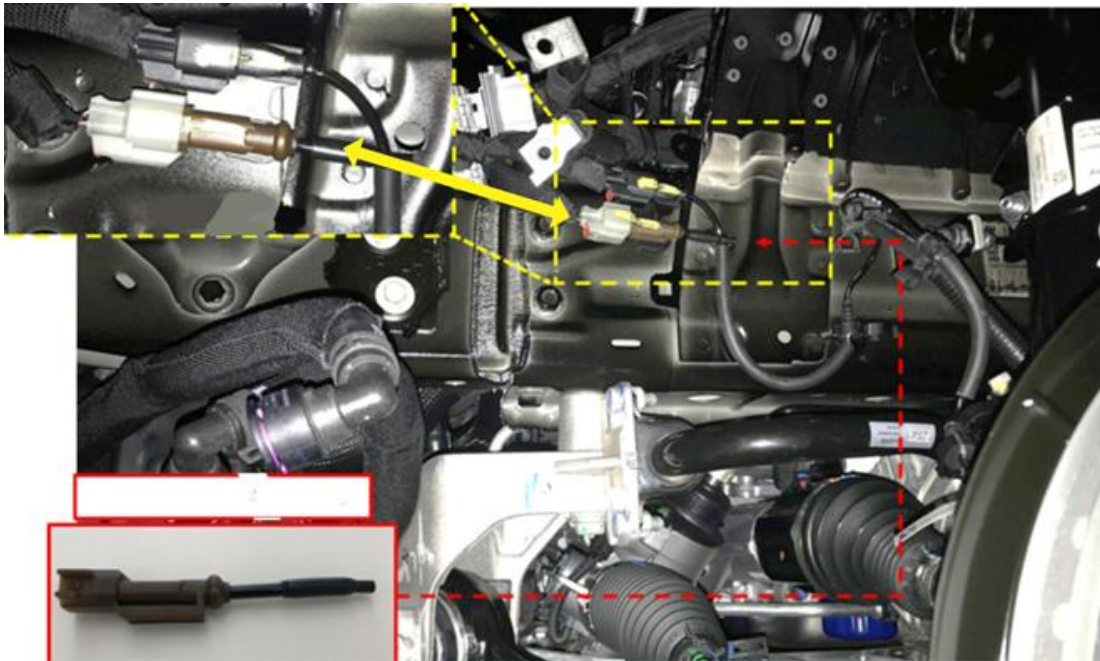
5636465

4. Install plug 84878468 into left front harness connector where the left front pad wear sensor connector was previously installed; slide the plug into the slotted bracket that is mounted at the rail.
5. Remove the right rear brake wear sensor from the caliper.

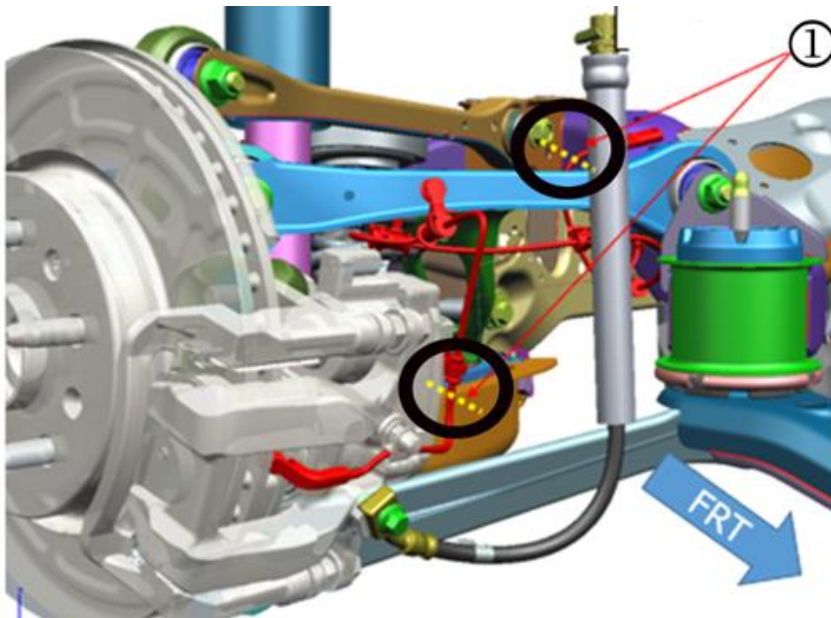
5636466

6. Follow the path of the right rear brake wear sensor wiring and cut off the right rear sensor head and connector (1) as shown.
7. Install plug 84884492 into right rear harness connector where the right rear pad wear sensor connector was previously installed.
8. Install the tire and wheel assemblies. Refer to *Tire and Wheel Removal and Installation* in SI.
9. Lower the vehicle. Refer to *Lifting and Jacking the Vehicle* in SI.
