Subject: N192268380 - Special Coverage
Driver Seat Belt Anchor Pretensioner Cable

Models: 2019-2020 Chevrolet Camaro

Special Coverage Adjustment

N192268380 Driver Seat Belt Anchor Pretensioner Cable

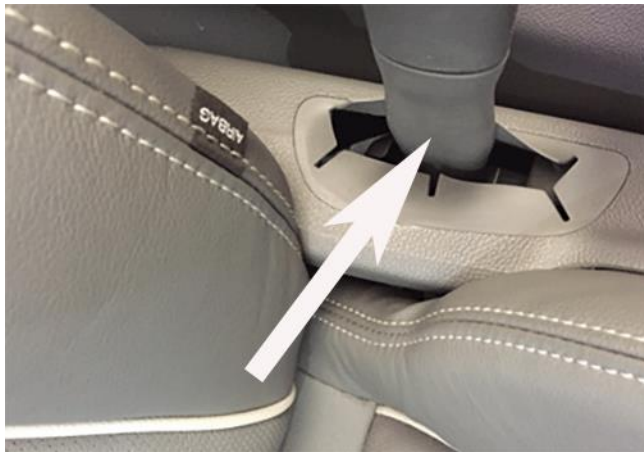
5483528

1. Move the driver seat to the full forward and full down position.
2. Inspect the seat belt pretensioner cable cover for damage. Inspect the complete cable cover from the base of the cable to the latch. Damage includes any splits, holes or cracks.

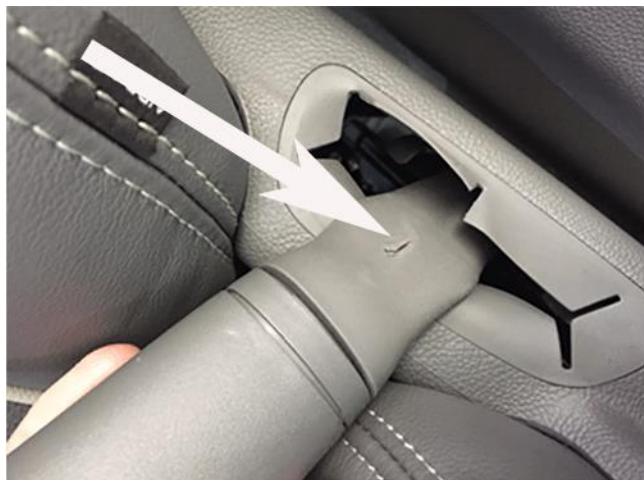
5483529

3. Flex the seat belt in an outboard direction and look on inboard side of driver seat seatbelt anchor cover for damage.

- If any damage is found, replace the driver side front seat belt anchor plate pretensioner and the front seat cushion outer finish cover, refer to step #5.
- If no damage is found, no further action is required. Inform the customer that the special coverage condition is not present on their vehicle at this time and to keep monitoring as described in the customer letter.

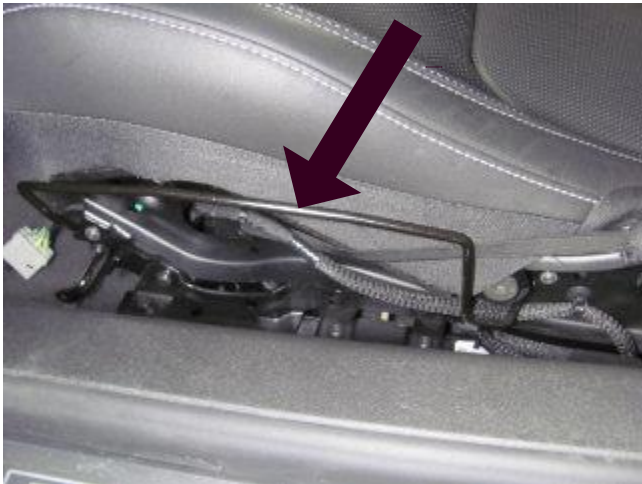
5483531

Revised Cover Retainer

NOTE: When replacing the front seat cushion outer finish cover, it is also necessary to replace the metal cover retainer and pivot bolt mounted bracket.

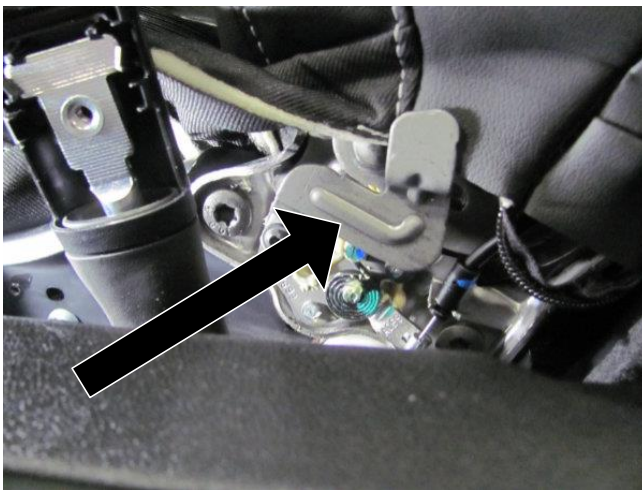
5483534

Revised Pivot Bolt Bracket

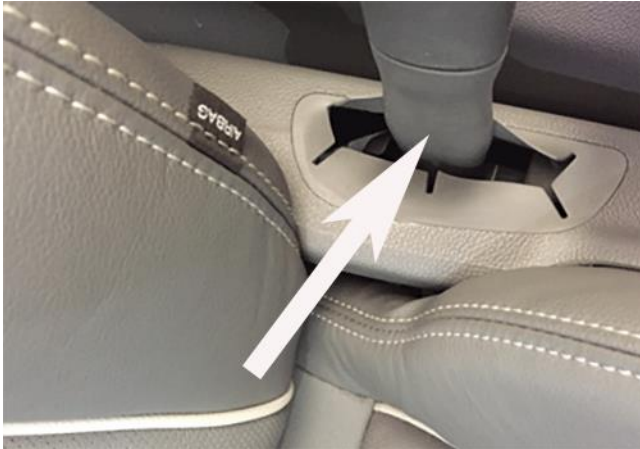
1. Move the driver seat to the full forward and full down position.
2. Inspect the seat belt pretensioner cable cover for damage. Inspect the complete cable cover from the base of the cable to the latch. Damage includes any splits, holes or cracks.

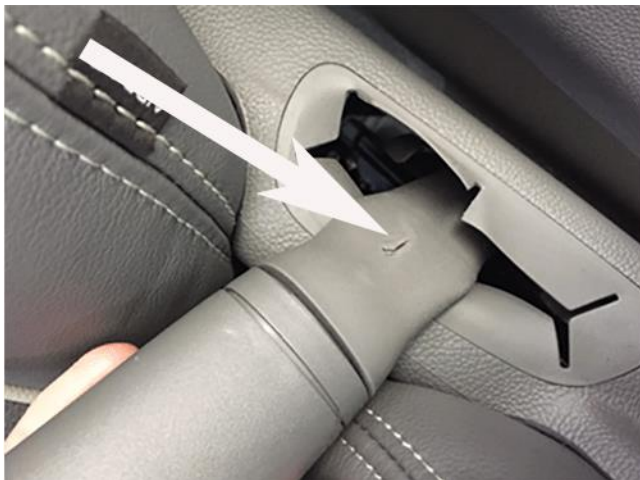
3. Flex the seat belt in an outboard direction and look on inboard side of driver seat seatbelt anchor cover for damage.

4. Flex the seat belt to the inboard side and look on outboard side of driver seat seatbelt anchor cover for damage.
 - If any damage is found, it will be necessary to take the car to your dealer for repairs.
 - If no damage is found, monitor the condition at regular 7,500 mile (12,000 km) intervals as described in the owner manual.
