GLOBAL SAFETY FIELD INVESTIGATIONS
DCS5485
URGENT - DISTRIBUTE IMMEDIATELY

Subject: A202304840-02 - Service Update
Camshaft Actuator Oil Control Valve Center Bolt Binding
Revised parts information and added population.

Models: 2020 – 2021 Buick Encore GX
2021 Chevrolet Trailblazer
Equipped with 1.3L Turbo Engine(RPO L3T)

A202304840 Camshaft Actuator Oil Control Valve Center Bolt Binding

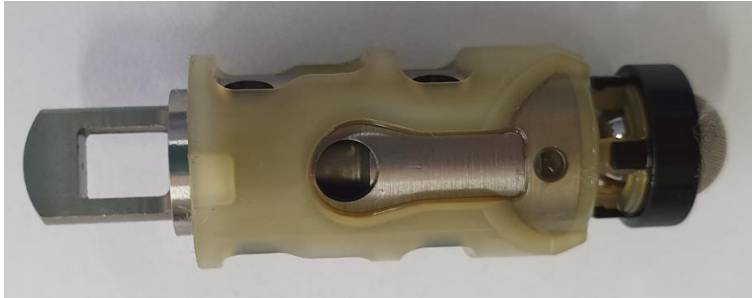
5627952

- The removed bolt sleeve kit should look as shown – a plastic over molded sleeve.
