GLOBAL SAFETY FIELD INVESTIGATIONS
DCS5491
URGENT - DISTRIBUTE IMMEDIATELY

Subject: N192285071 01 – Customer Satisfaction Program
Tonneau Cover Retention
Revised Warranty and Service Procedure

Models: Hard tri-fold tonneau covers (Part Numbers 84060327, 84060328 and
current part numbers 84679033, 84679034) sold as accessories for:
2019 Chevrolet Silverado 1500 Series LD (New Model)
2020 Chevrolet Silverado 1500 Series LD
2019 GMC Sierra 1500 Series LD (New Model)
2020 GMC Sierra 1500 Series LD

N192285071 Tonneau Cover Retention

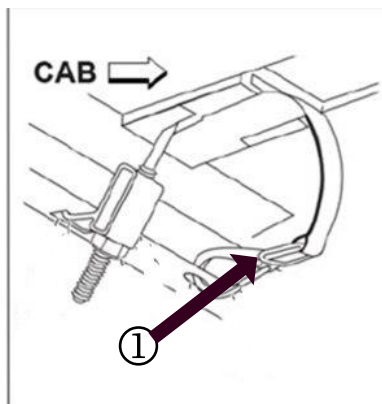
5613815

Open the front section of the tonneau cover and locate the outboard ends of the front hinge track. If the cover already has tethers (1) installed, it is up to date and no further action is required.

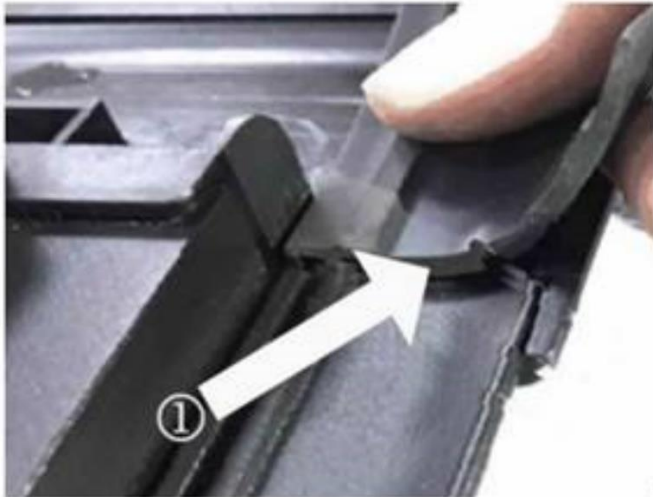
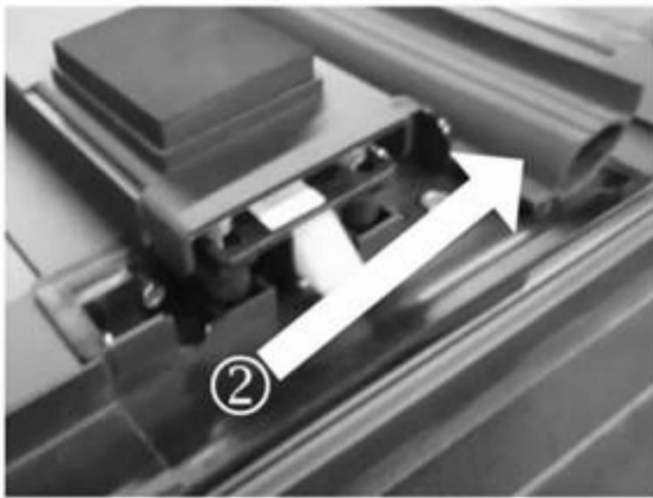
Important: Verify the front tonneau cover seal is the revised “fin” style seal (1). If the “bulb” style seal is installed (2), replace the seal. Refer to steps 1-5 of the Adjustment Instructions for Vehicles That Have NOT Had Recall N192217500 performed below.
