| S.A.T. | 248 MV |

# Service Bulletin

Subject: **Electric system sheath new routing**

Product: **Superveloce 800 (all versions)**  
**VIN from ZCGF110ABLV001230 up to ZCGNKGNU7MV001812**

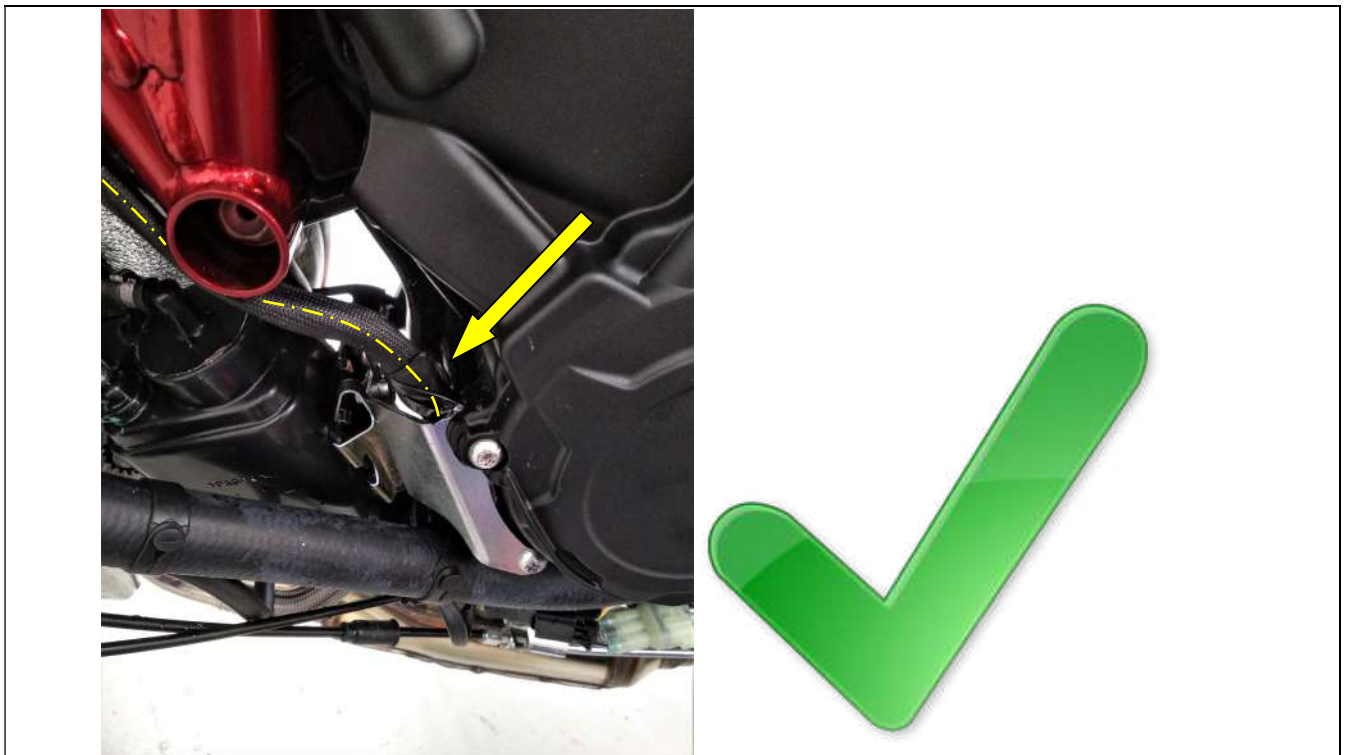
In fact, we have found that on some vehicles the sheath could move until it touches the exhaust manifold, resulting in a failure of the insulation and therefore a malfunction of the related electrical systems. It will therefore be necessary to constrain the passage of the sheath by following the instructions below.

**Cable positioning:** the final result must be as shown in the picture below.
