# Service Bulletin

Date: 10 July 2020

Subject: Wiring repositioning

Product: Brutale 1000 Serie Oro from vin ... LV000011 to vin ... LV000130  
excluding the attached list:

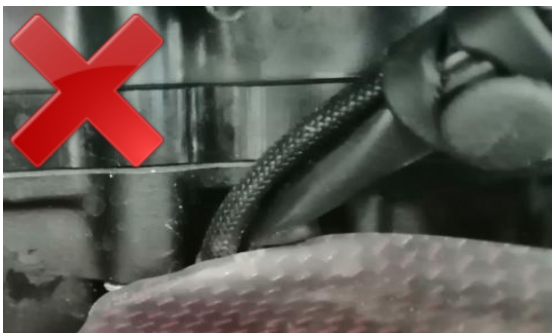
Following continuous monitoring of the quality of our product, it has been found that for the Brutale 1000 Serie Oro motorcycle you purchased, it may have the branch of the wiring directly to the side stand switch \ oil pressure sensor not positioned correctly with respect to the oil pan protection cover.

It will be possible to identify the incorrect position of the branch of the wiring in question by observing, on the left side of the motorcycle, the branch of the system directed to the side stand switch and oil pressure sensor; it is necessary that the indicated wiring branch is NOT pressed by the oil pan protection cover. The possible incorrect positioning (on the left) and the correct positioning (on the right) are shown below;

We kindly ask you to reposition the cables BEFORE delivering the vehicle to the final customer during the pre-delivery phase. For the motorcycles already sold, we ask you to reposition the cable during a maintenance service or on the first useful occasion at your workshop.
