Service Bulletin

Date: 10 July 2020

Subject: Clutch drive flange replacement

Product: Brutale 1000 Serie Oro - RR - from vin ... LV000011 a vin ... MV000293
EXCEPT FOR THE VIN LISTED IN THE ATTACHMENT AT THE END OF THE BULLETIN

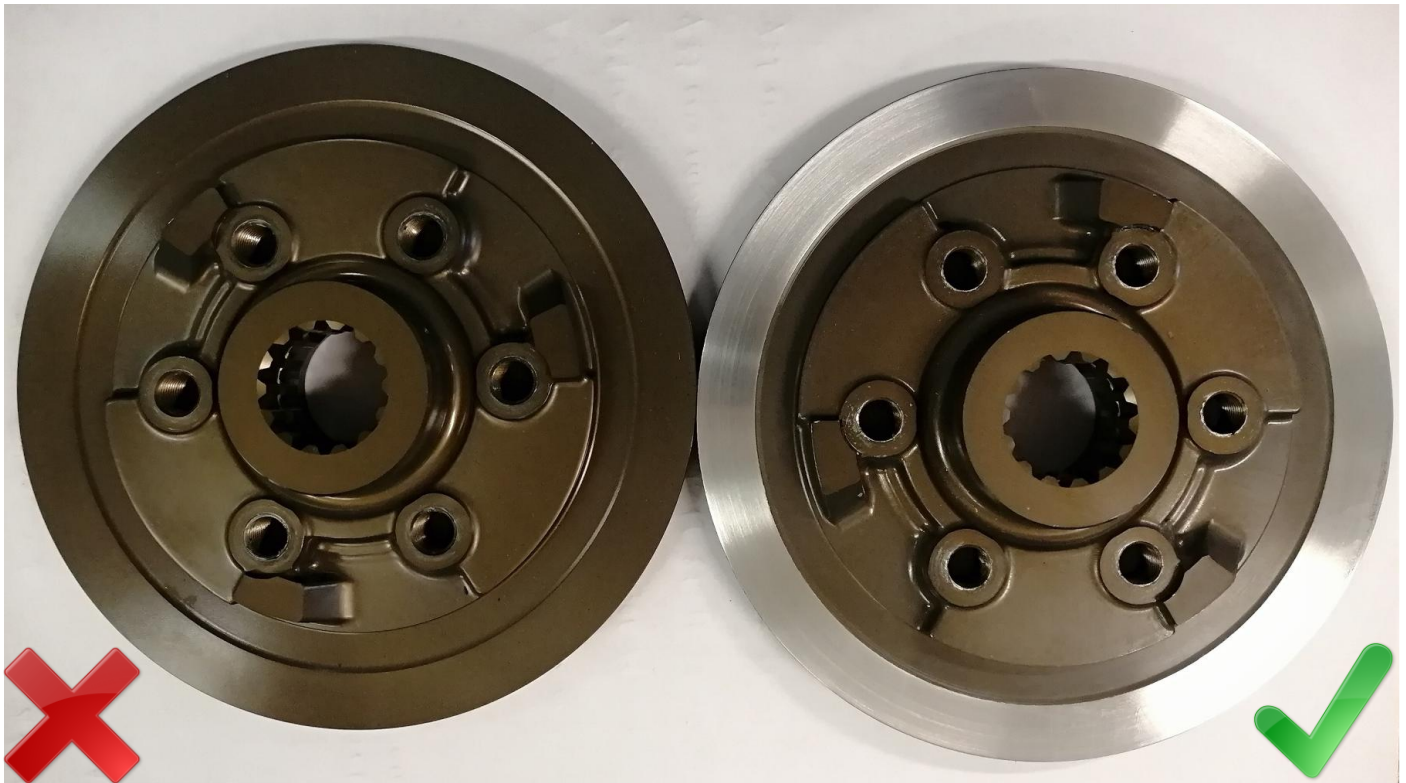
It will be possible to identify the part that needs to be replaced once the components involved in the motorcycle have been removed by paying attention to the surface of the flange in contact with the first drive clutch disc which requires the presence of a process that removes the anodization:
