STAR ONLINE PUBLICATION

Case Number: S2008000102

Symptom/Vehicle Issue: Radio And Instrument Cluster Backlighting Brightness Cannot Be Controlled

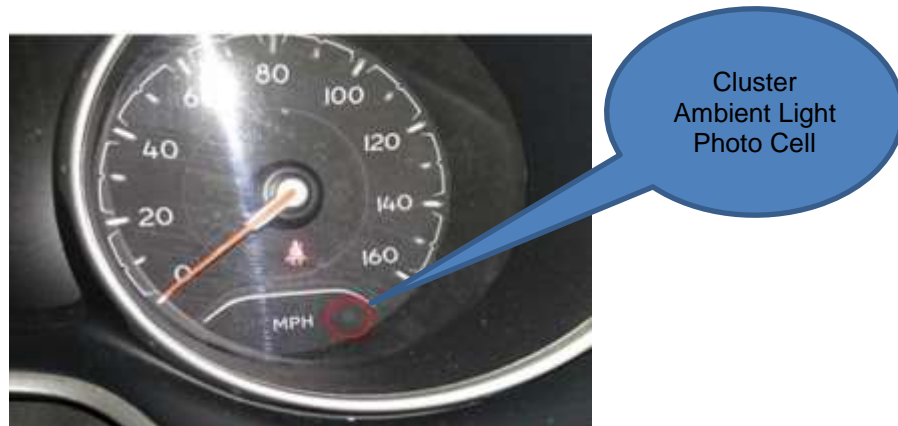
Fig 1

Discussion: Owners may complain that the headlamp switch thumb wheel dimmer does not change the cluster panel backlighting as expected. The thumb wheel will only function during cluster night mode. "Cluster Night Mode" is solely controlled by the cluster ambient lighting photocell Fig 1,2.

NOTE: The thumb wheel dimmer controls will only operate when the cluster ambient light photo cell senses that it is (DARK) and the head lamp switch is in the park lamps on position. The Instrument Panel Cluster (IPC) and the Integrated Center Stack (ICS) use the electronic dimming level messages to control the illumination intensity of their own back lighting. In addition, when the interior lighting thumbwheel of the dimmer module is moved to the PARADE (or funeral) mode detent position, all of the electronic display units are illuminated at their full intensity levels. The PARADE mode has no effect on the illumination intensity of incandescent panel lamps. See below testing.

To test to see if the cluster illumination dims, place the headlamp switch in the lights on headlamp/park position to simulate night time driving. Using a business card or shop rag, block the ambient light sensor in the cluster. The cluster can take up to 8 seconds to switch between modes from day to night. If cluster lights adjust do not replace any parts; operation is normal.
