NUMBER: 08-057-20 REV. A

Navigation Feature Missing

2020 (M7) Jeep Compass

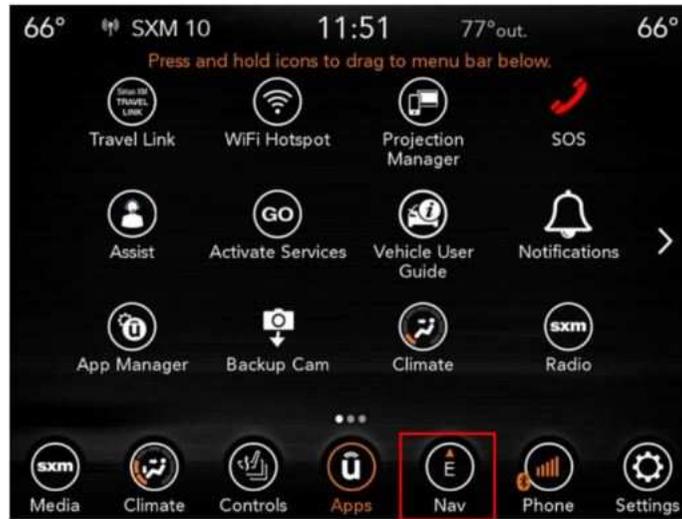
Fig. 1

- Put the ignition in the “RUN” position and turn on the radio. Check for a “Nav” icon on the bottom of the radio display (Fig. 1) .

Nav Icon Location on Display Screen

- Was the “Nav” icon **missing** on the radio display screen?
 - YES>>> Proceed to [Step 1](#) of the Repair Procedure.
 - NO>>> This bulletin has been completed. Use inspection LOP (18-19-02-S1) to close this active RRT.

- **Using wiTECH, “Restore Vehicle Configuration”. This routine is available under the “Vehicle Preparations” tab found on the home, “Vehicle View”, page of wiTECH.**
- Perform a “Proxi Configuration Alignment” and follow all prompts:
 - Cycle the ignition “OFF”, unplug wiTECH pod and close the doors to let all modules go to sleep.
 - Reconnect wiTECH.
 - Cycle the ignition “ON” again.
- Clear any DTC’s which may have been set during this repair procedure.
- Is the “Nav” icon on the radio display screen?
 - YES>>> This bulletin has been completed.
 - NO>>> Normal diagnostic should be performed.
