NUMBER: 08-072-20

GROUP: 08 - Electrical

Loose Wiper Arms

2019 - 2020	(D2)	RAM 3500 Pickup
2019 - 2020	(DD)	RAM 3500 Cab Chassis
2019 - 2020	(DF)	RAM 3500 <10K Cab Chassis
2019 - 2020	(DJ)	RAM 2500 Pickup
2019 - 2020	(DP)	RAM 4500/5500 Cab Chassis

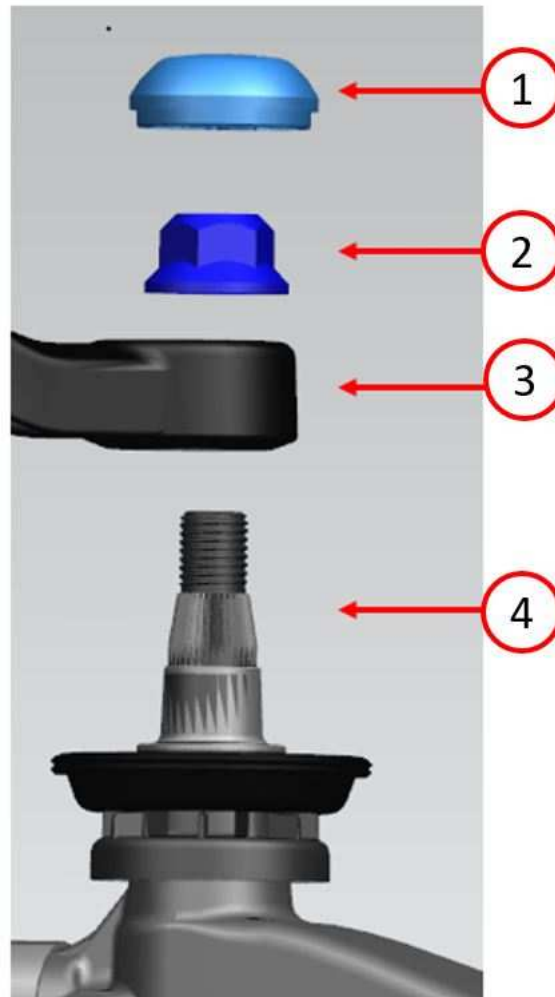
Fig. 1
Wiper Arm Assembly

The customer may describe one or both of the windshield wiper arm are loose and may stop moving at times.

1. Turn off the wiper switch and make sure the wiper blades are in the home/parked position.
2. Remove both wiper arm plastic nut caps (Fig. 1) .

- 4. For the loose arm(s) re-torque wiper arm nut to 27.5 N·m (20 ft lb) and then rotate the nut an additional 90 degree turn.
- 5. For an arm that is not loose, no re-torque is required, only tighten the nut for an additional 90 degree turn.
- 6. Install both nut caps back onto the wiper arms.
