NUMBER: 18-059-20

DATE: August 7, 2020

Flash: Powertrain Control Module (PCM) Updates

2019	(DJ)	RAM 2500 Pickup
2019	(D2)	RAM 3500 Pickup

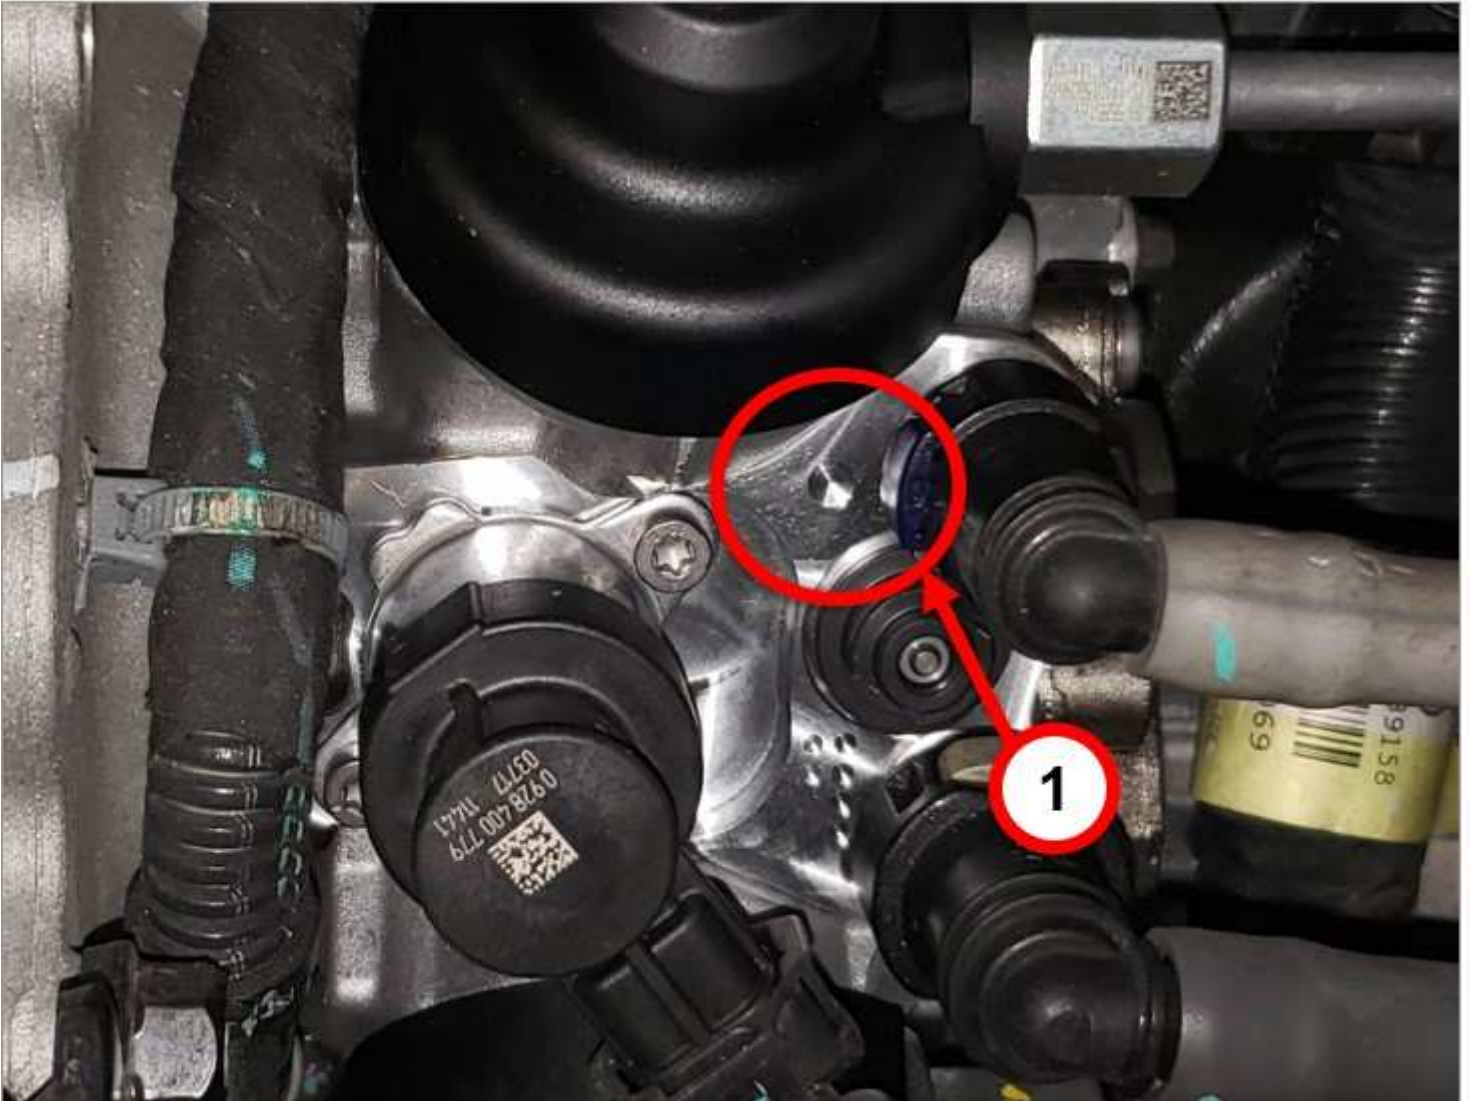
Fig. 1

New Style Symmetrical Cam Design Pump

1 - One large Single Dot on Housing

1. Inspect the fuel injection pump to see which pump the vehicle has:
 - Vehicles with the new style Symmetrical Cam design pump will have one large single dot embossed in the pump housing (Fig. 1) .
 - For vehicles equipped with a Symmetrical Cam pump, choose the calibration labeled Symetric Cam, or Sym Cam.

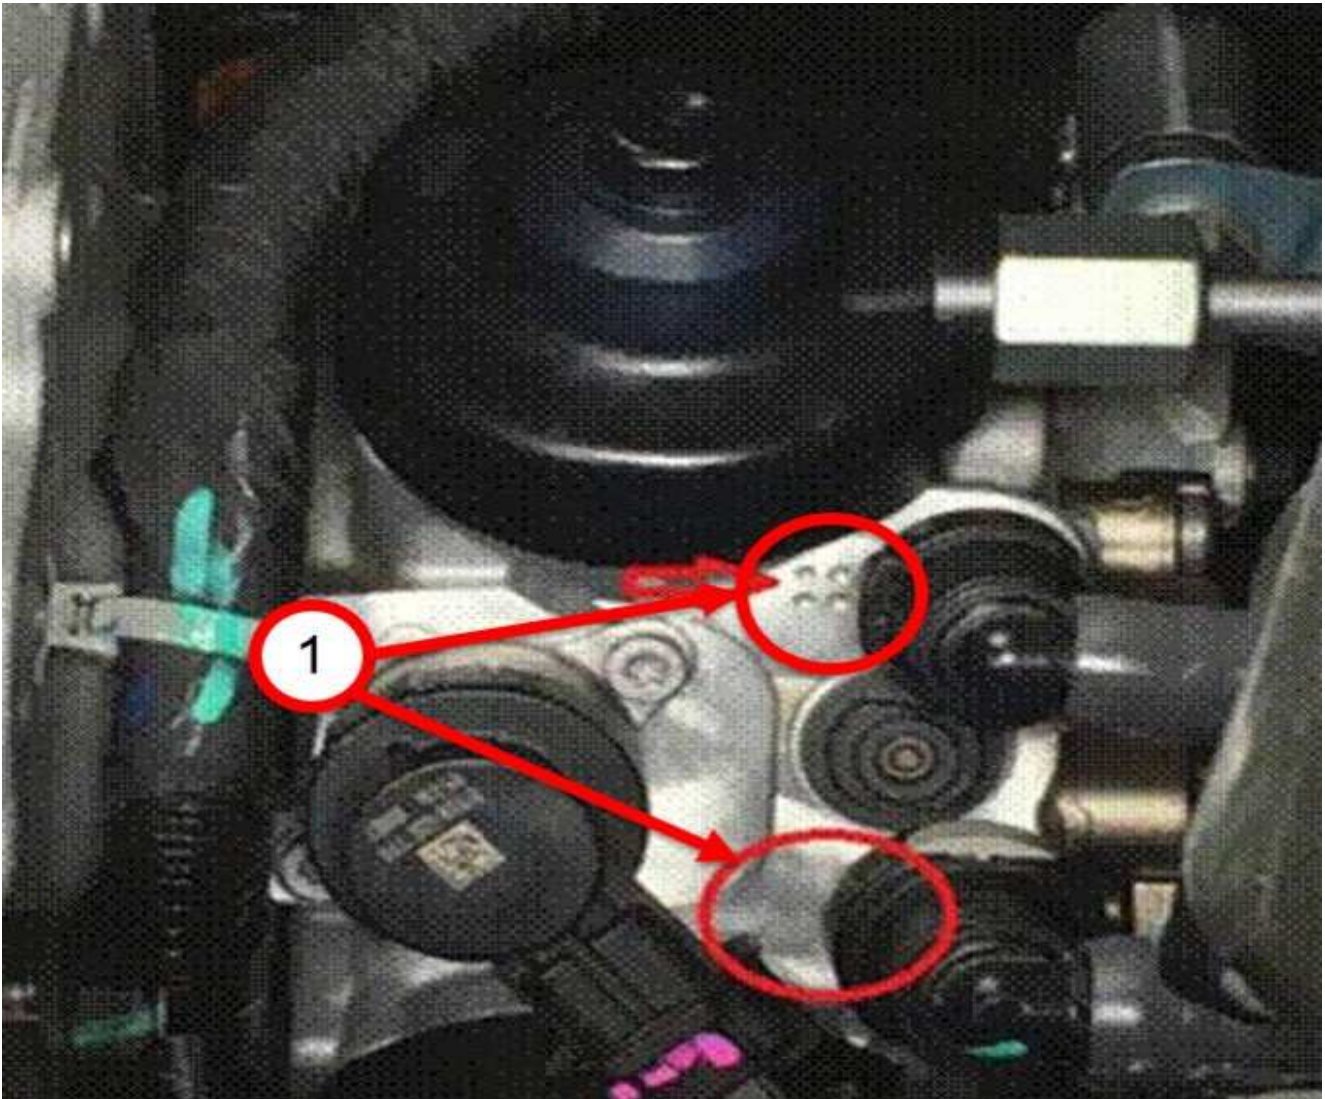
Fig. 2
Old Style Asymmetrical Cam Design Pump

1 - Multiple Dots on Housing**

- Vehicles with the old syle Asymmetrical Cam design will have multiple dots embossed in the pump housing (Fig. 2) .
- For vehicles with an Asymmetrical Cam pump, choose the calibration labeled Asymmetric Cam or Asym Cam.
