NUMBER: 08-075-20

Video Routing Module (VRM) Enhancements For Rear Seat Entertainment System

This bulletin involves updating the VRM software level to 19.38.11.

2017 - 2020 (RU) Chrysler Pacifica

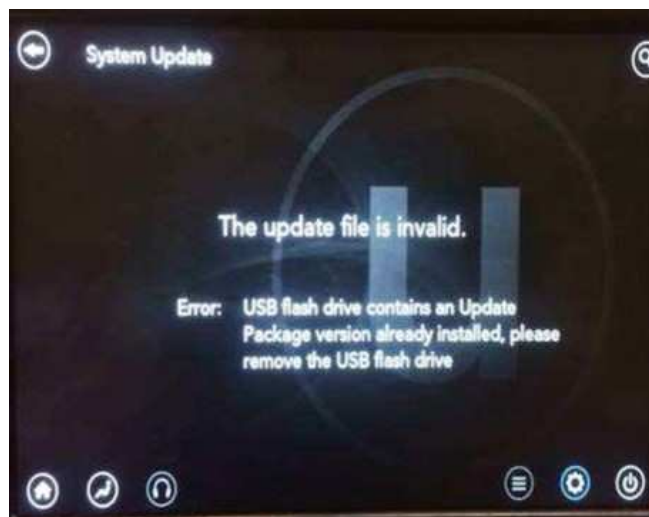
Fig. 4
Rear Seatback Video Screen Error

NOTE: If the USB flash drive is left in the port after system reboot, there will be a pop-up on the rear seat back video screen that states "The update file is invalid" (Fig. 4). This is not a concern as the system is already up to date.
