**NUMBER:** 23-020-20

Tailgate Slam Bumpers Pull Off

2020 (DT) RAM 1500 Pickup

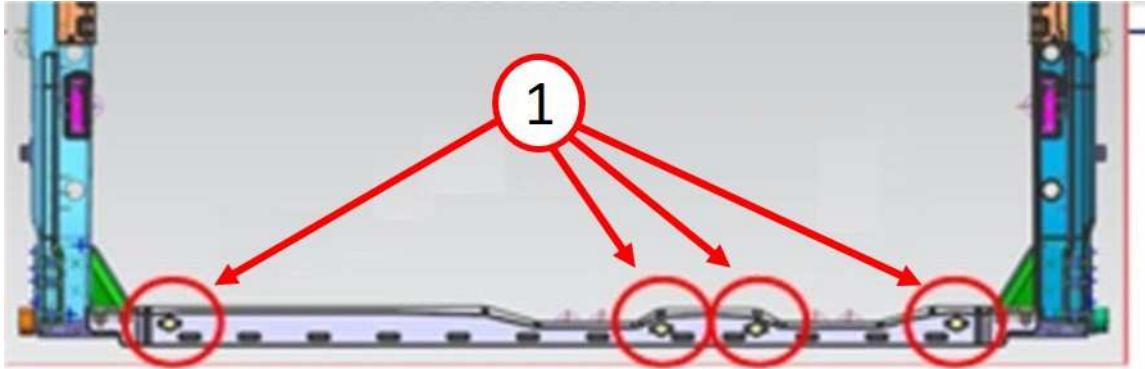
Fig. 1  
Over-Slam Bumper Locations

The customer may comment that when the multi-function tailgate swing door is opened, the over-slam bumper sticks to the door and pulls out of the U-frame.

1. Remove all four over-slam bumpers from multi-function tail gate. (Fig. 1) . Replace any that are missing as needed.

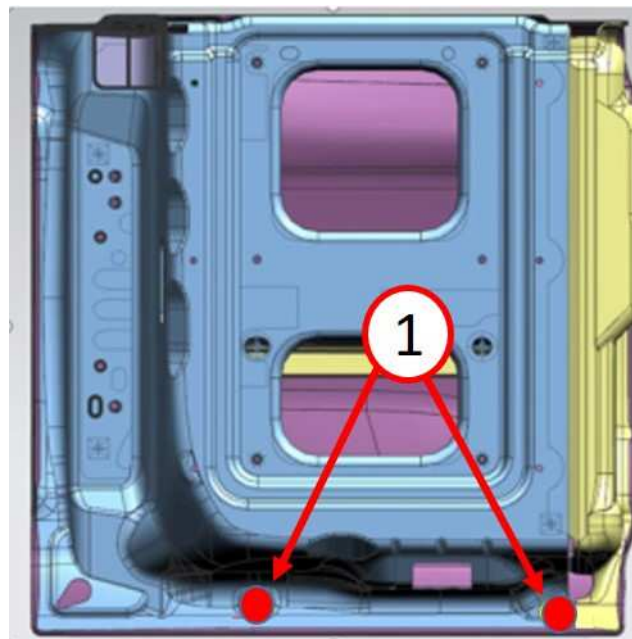
**Fig. 4**  
**U-Frame Mylar Bumper Tape Location (40% Door)**

**NOTE: Some mylar patches may have shifted or even fallen off the tailgate. It is suggested to tape replacement mylar patch to slam bumper and then shut tailgate to get patch to stick where it needs to be located.**

5. Remove the old mylar tape, wipe the surface with isopropyl alcohol and allow to dry (Fig. 4) and (Fig. 5) .

6. Apply a new mylar patch P/N 68185697AA in place of the old patch.
