NUMBER: 23-021-20

A-Pillar Water Leak

2020 (KL) Jeep Cherokee

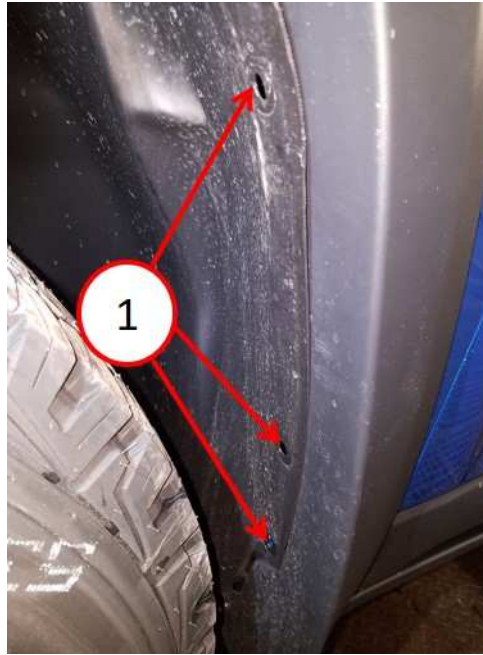
Fig. 1
Rear Push Pins Removed

1 - Three Rear Push Pin Holes

1. Raise and support the vehicle. Refer to the detailed service procedures available in DealerCONNECT/Service Library under: Service Info> 04 - Vehicle Quick Reference/Hoisting/Standard Procedure.
2. Remove the three rear push pins from the splash shield (Fig. 1) .

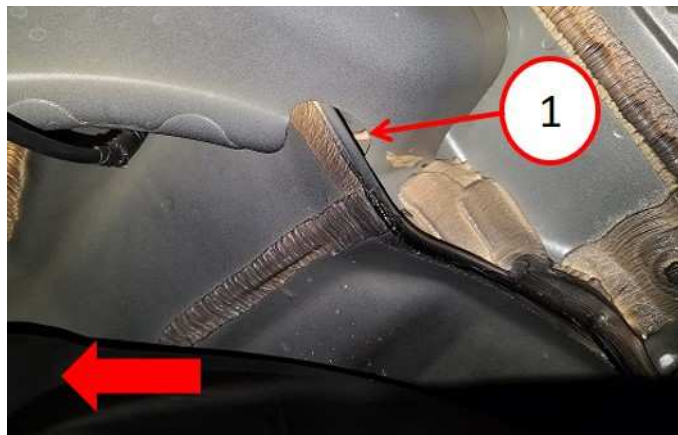
Fig. 2
Body Load Beam End

1 - Cavity To Fill With Foam (Large Arrow - Front Of Vehicle)

3. Pull down the splash shield to have access to the load beam inner to cowl plenum (Fig. 2) .
