NUMBER: 23-024-20

Passenger Seatbelt Reminder Active Without Occupant

This bulletin involves replacing the passenger seat cushion and occupant detection sensor.

2020 (M7) Jeep Compass

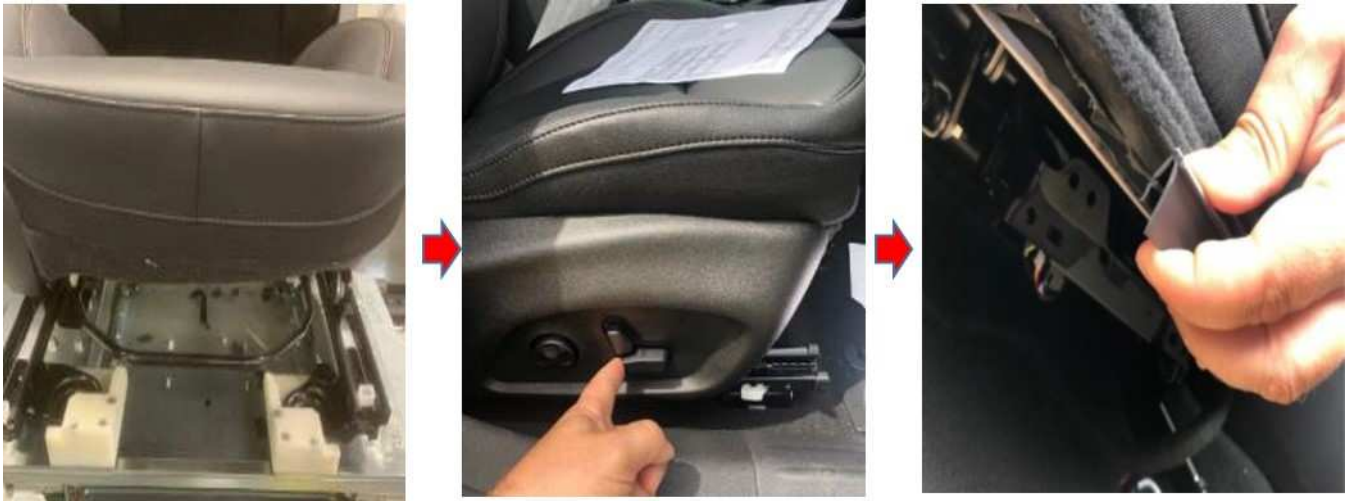
1. Put the passenger front seat in the full rearward position (Fig. 1) .
2. Disconnect frontal cushion plastic profile J-hook with hands (Fig. 1) .

Fig. 1
Seat Inspection

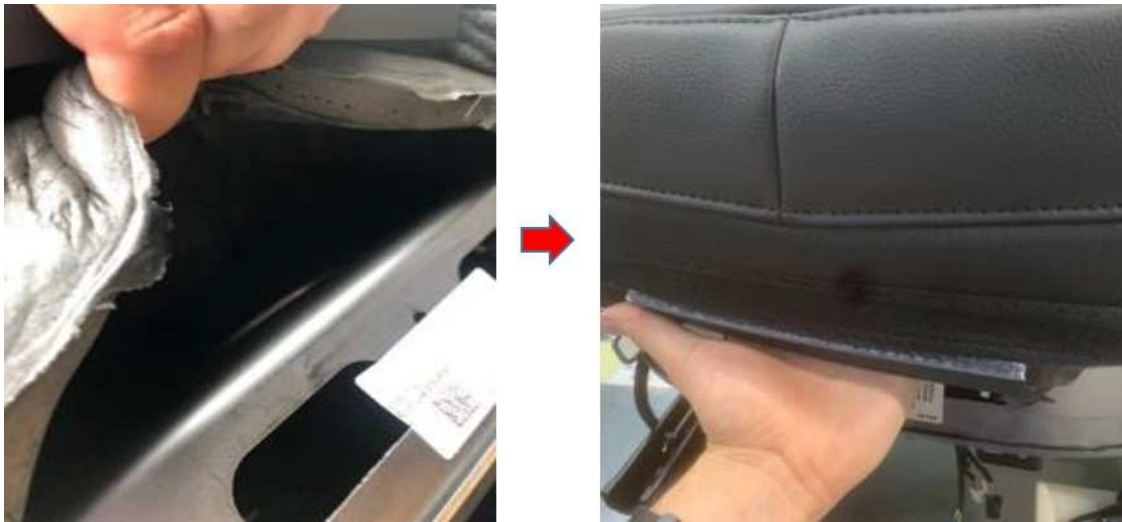
3. Lift right seat cushion to check padding (Fig. 2) .
4. Insert your hand in the space between the padding and the metal structure, and check that the central padding is free of foam protrusions (Fig. 2) .

Fig. 2
Inspecting Central Padding

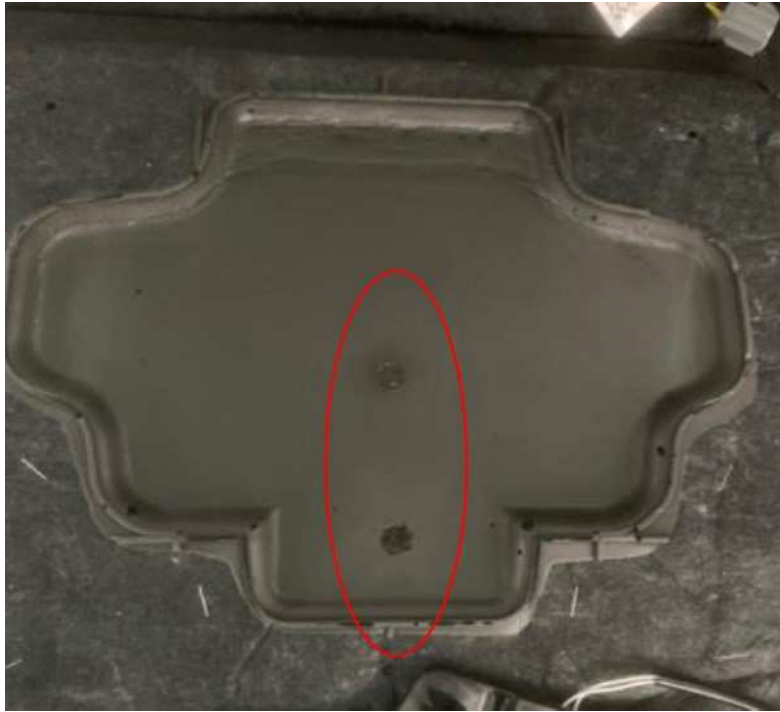
5. Are foam protrusions felt in a north south direction on the central padding (Fig. 3) ?

Fig. 3
Not OK

1. Remove and replace the passenger front seat cushion. Refer to the detailed service procedures available in DealerConnect> Service Library under: Service Info> 23 - Body / Seats, First Row / Cover, Seat Cushion, Front / Removal and Installation.

NOTE: While the cushion is off replace the occupant detection sensor. Refer to the detailed service procedures available in DealerConnect> Service Library under: Service Info>10 - Restraints / Sensor, Occupant Detection / Removal and Installation.

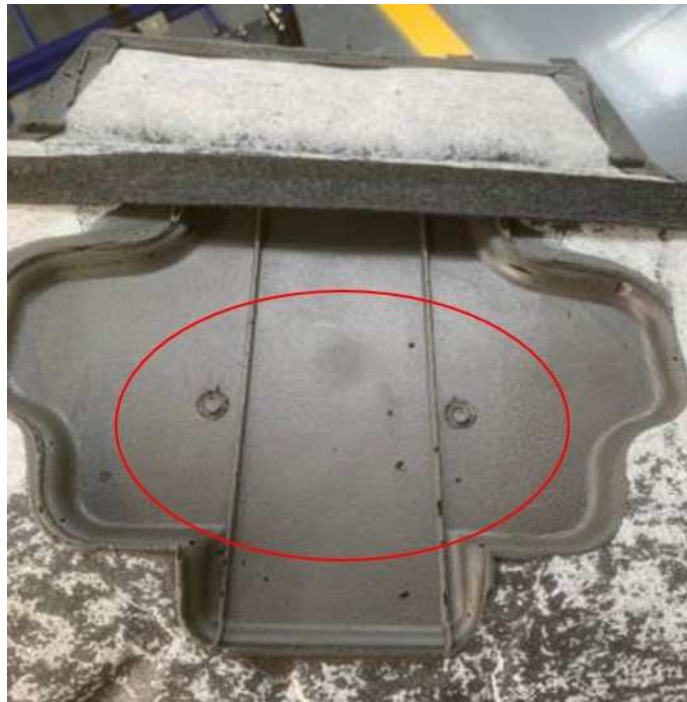
- YES>>> Proceed to [Step 1](#) of the Repair Procedure.
- NO>>> Seat protrusions are going in an east and west direction ([Fig. 4](#)) . Proceed to [Step 6](#).

Fig. 4
OK

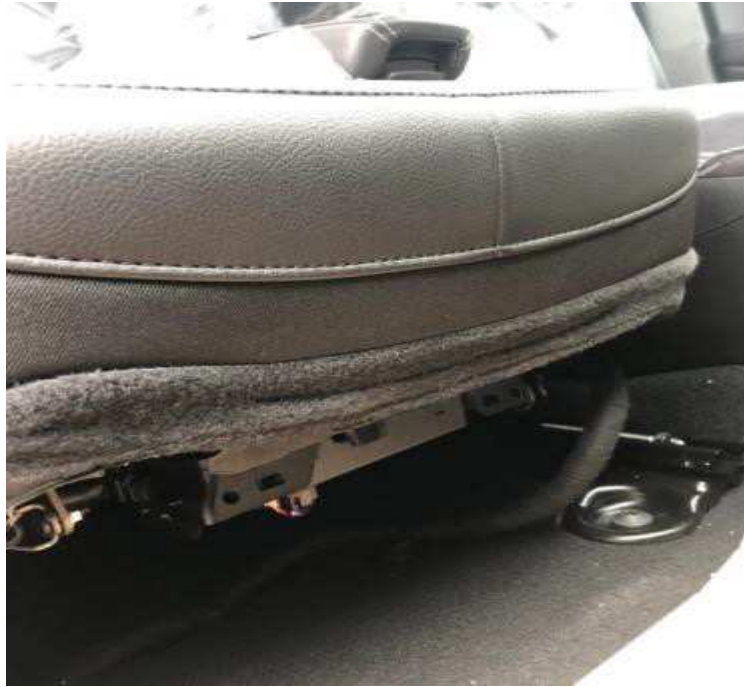
Fig. 5

Reposition Cushion to the Frame

6. Re-position the cushion on the frame (Fig. 5) .
7. Connect frontal cushion plastic profile J-hook (Fig. 5) . This bulletin has been completed, use inspect LOP (23-20-36-97) to close the active RRT.
