STAR ONLINE PUBLICATION

Case Number: S2023000029

Symptom/Vehicle Issue: Drone Pop Noise From Passenger Side Floor Area

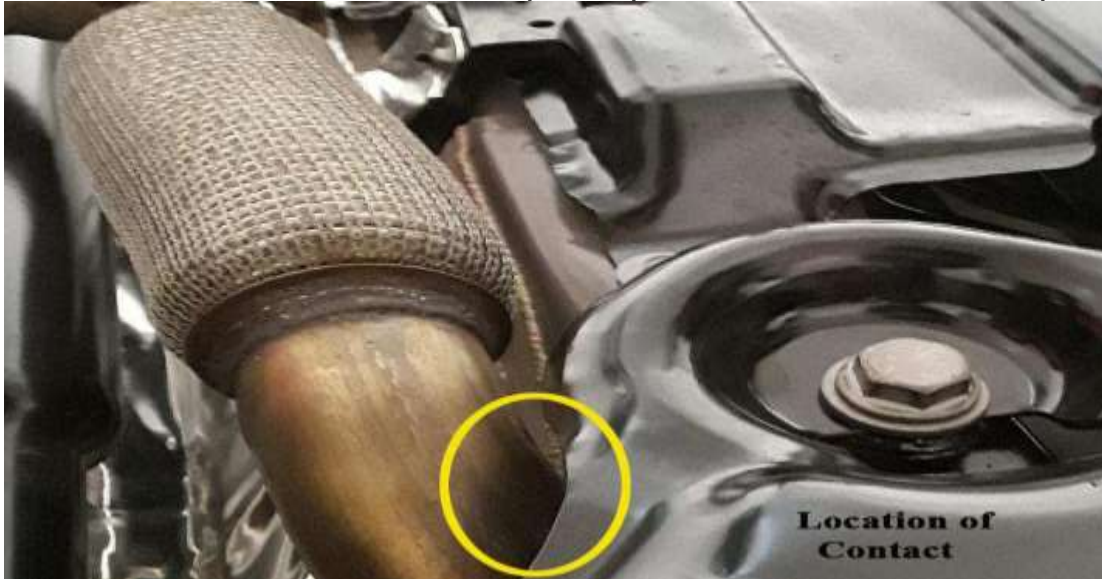
Fig 1

Inspect the exhaust routing and in particular around the skid plate if equipped. Check for contact between the exhaust and skid plate- paint rubbed off the skid plate (fig 1).

Inspect powertrain mounting, exhaust for proper installation. Correct fit as needed. If mounting and exhaust are properly installed, slight modification of the skid plate flange can be performed using a cutoff or grinding tool. Corrosion protect the edge of the skid plate with a rust preventative paint coating.
