STAR ONLINE PUBLICATION

Case Number: S2008000092

Symptom/Vehicle Issue: Compass Inoperative Or Stuck In One Direction

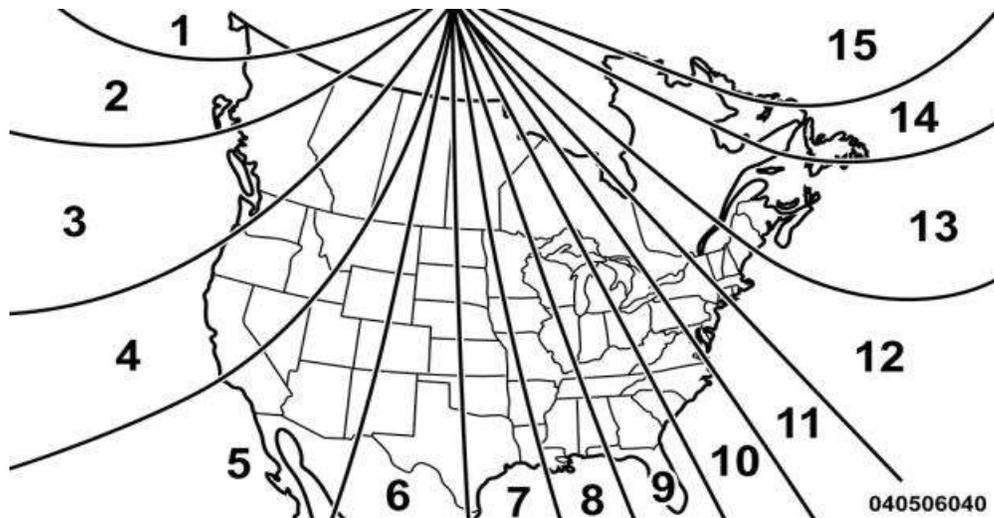
When the "Compass Variance" feature is selected, it allows the compass variance to be set to any number from 1 to 15 per the compass variance zone map figure.

Compass Variance is the difference between Magnetic North and Geographic North.

To compensate for the differences, the variance should be set for the zone where the vehicle is being driven, illustrated in the zone map. Once properly set, the compass will automatically compensate for the differences when calibrated, and provide the most accurate compass headings.

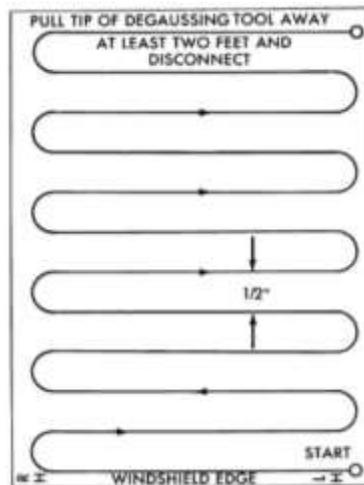
Example tool usage – DS truck – 8M Message center -COMPASS DEMAGNETIZING

If the above actions fail, the vehicle may have an electromagnetic field interfering with the compass module, thus requiring a degaussing procedure.

Use Mopar tool number 6029 to demagnetize the following suspect areas in order as needed. Slowly pass the degaussing tool over these areas listed below in an east/west direction several times and up to as many as 6 times depending on the strength of the magnetism, this to demagnetize the areas completely; recalibrate and test drive in an open area to complete and calibrate.

Top of I.P.

Glove box area – with box open.

Front and rear roof from interior – without removing headliner

Rear cargo area – remove load floor – and roof area

Front and rear seats, Front and rear foot wells
