**NUMBER:** 21-037-20

**GROUP:** 21 - Transmission and Transfer Case

Transmission Case Oil Leak

2019 (VM) RAM ProMaster City

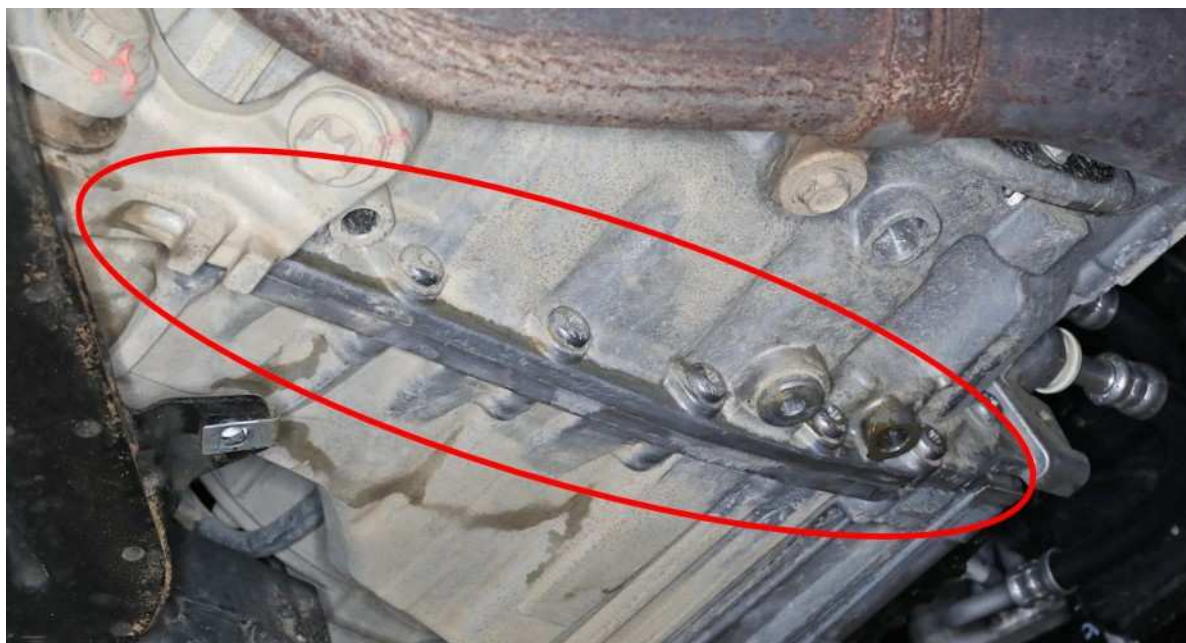
**Fig. 2**  
**(Reference Picture) Potential Leak Area at Case Split**

Customers may notice (possibly transmission) fluid leaking on the ground from the left front of the vehicle.

8. Remove the belly pan (if equipped). Refer to the detailed service procedures available in DealerCONNECT> Service Library under: 13 - Frame and Bumpers/Under Body Protection/ Belly Pan/Removal.
9. Verify the leak is at the split in the transmission case (Fig. 2) .
10. Is the leak at the split in the transmission case location and not leaking from higher up or any other location (Fig. 2) ?
  - YES>>> Proceed to [Step 1](#) of the Repair Procedure.
  - NO>>> This Bulletin does not apply. Normal diagnosis should be performed.

7. Start the vehicle and verify the transmission fluid temperature is above 50 °C (122 °F).
8. Verify the transmission fluid is not leaking at the repair area (Fig. 2) , if a leak is still detected further diagnosis should be performed.

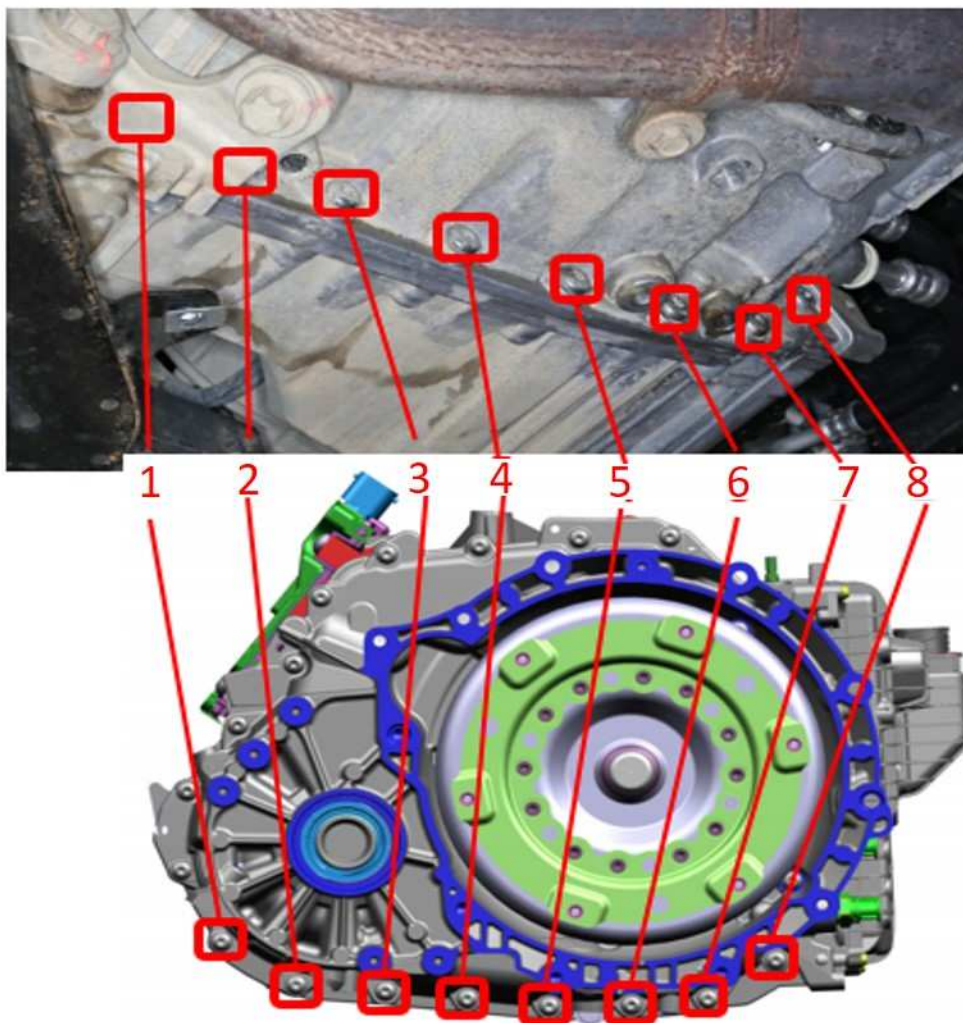
Fig. 4

(Reference Picture) Eight Bolts to be Torqued to Specifications at Potential Leak Area at the Case Split

3. Starting at bolt #8 and then working to bolt #1, torque bolts to 35 N·m (26 ft. lbs.) (Fig. 4) .

**CAUTION! Do not rotate the bolts counter clockwise.**
