NUMBER: 08-064-20

RAN and RAP Radio Software Enhancements

2020	(GA)	Alfa Romeo Giulia
2020	(GU)	Alfa Romeo Stelvio

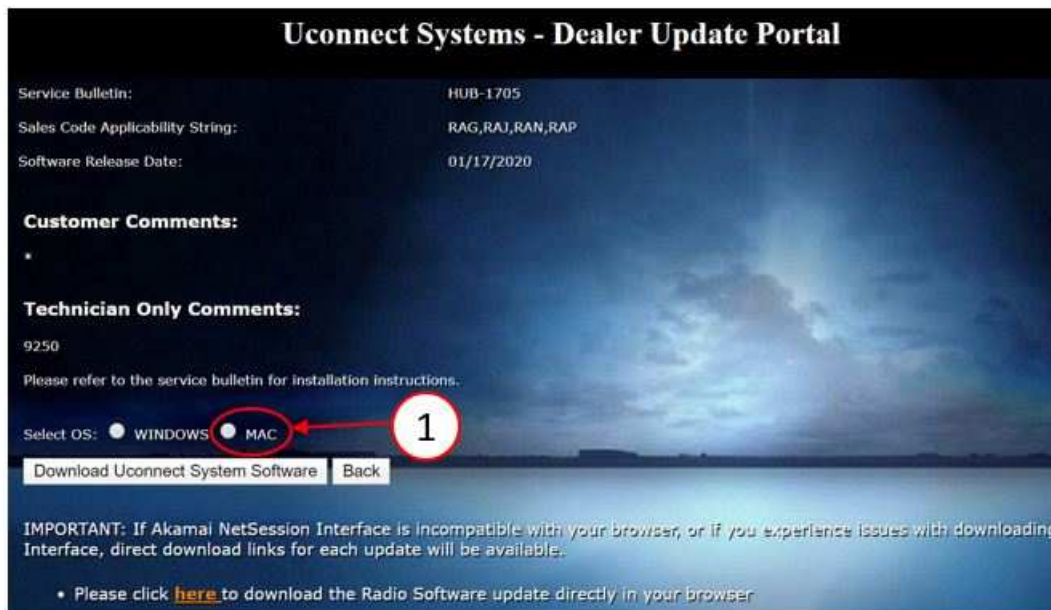
Fig. 2
Uconnect Update Portal

1 - Select the "MAC" only

4. To download the software files to USB flash drives, follow the on-screen instructions and perform the following:
 - Acquire a blank USB flash drive with at least 4GB.
 - A blank USB flash drive will be needed for each software update (one for each software update). Additional updates can not be on the same USB flash drive.
 - Once the file is saved to the USB flash drive, it is recommended to label the USB flash drive with the bulletin number.
 - The USB flash drives must be formatted as New Technology File System (NTFS) structure.
 - Download the software update files to your local PC’s desktop. Make sure to select the “MAC” for downloads only ([Fig. 2](#)) .
