NUMBER: 07-001-20 REV. C

Water Pump Inlet Tube Fastener Torque

2018 - 2020 (JL) Jeep Wrangler

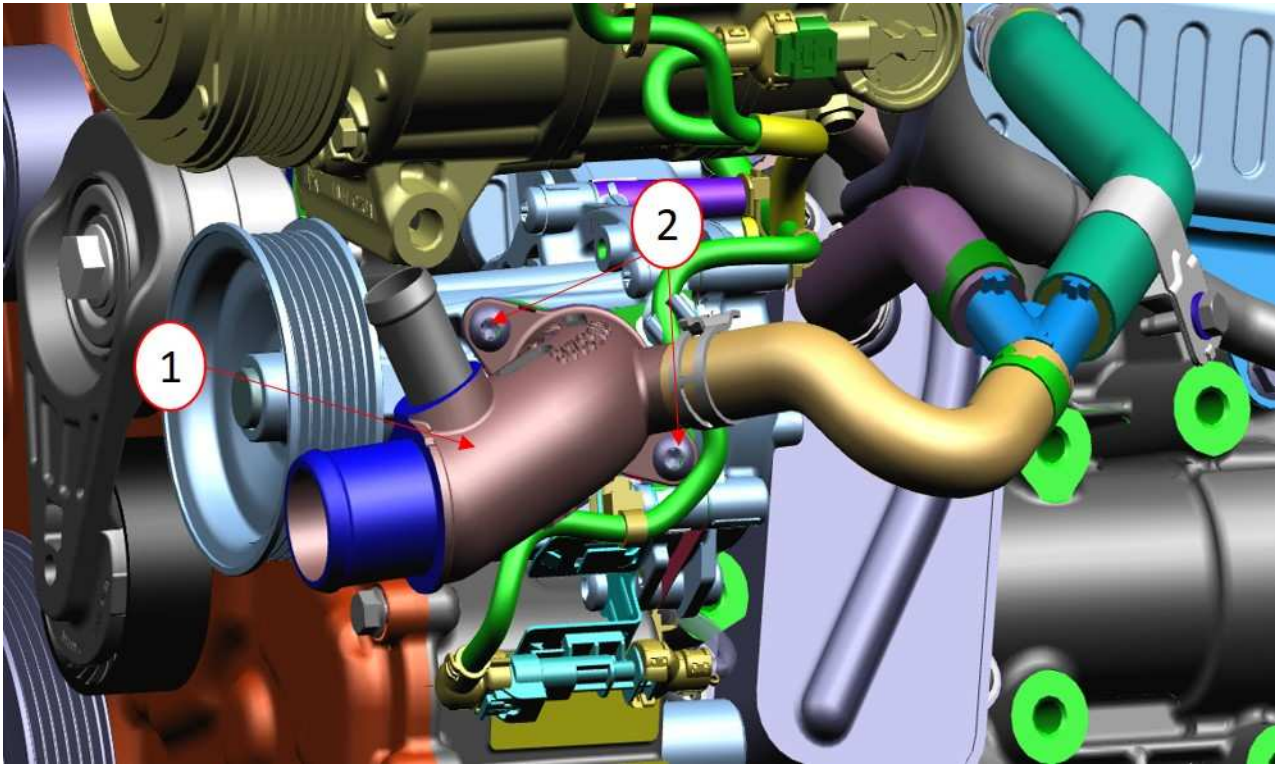
Fig. 1
Water Pump Inlet Tube Fasteners

The customer may describe either a coolant leak or the coolant level is low.

1. Pressure check the coolant system. Refer to the detailed service procedures available in DealerCONNECT> Service Library under: Service Info>07 - Cooling / Diagnosis and Testing >Leak Testing>Pressure Tester Method.
2. Was coolant found to be leaking from the water pump inlet tube at the engine (Fig. 1) ?
 - YES>>> Proceed to [Step 1](#) of the Repair Procedure.
 - NO>>> Coolant was not leaking from this area. This Bulletin does not apply. Normal diagnosis should be performed.

1. Torque the water pump inlet tube fasteners to exactly 11 N·m (97 in. lbs) (Fig. 1) .

2. Pressure check the coolant system. Refer to the detailed service procedures available in DealerCONNECT>Service Library under: Service Info>07 - Cooling / Diagnosis and Testing >Leak Testing>Pressure Tester Method.
3. Is coolant still leaking from the water pump inlet tube at the engine (Fig. 1) ?
 - YES>>> Further diagnosis should be performed.
 - NO>>> This bulletin has been completed.
