NUMBER: 08-095-20

Starter Solenoid Electrical Connection Interference

2020 (B1) Jeep Renegade

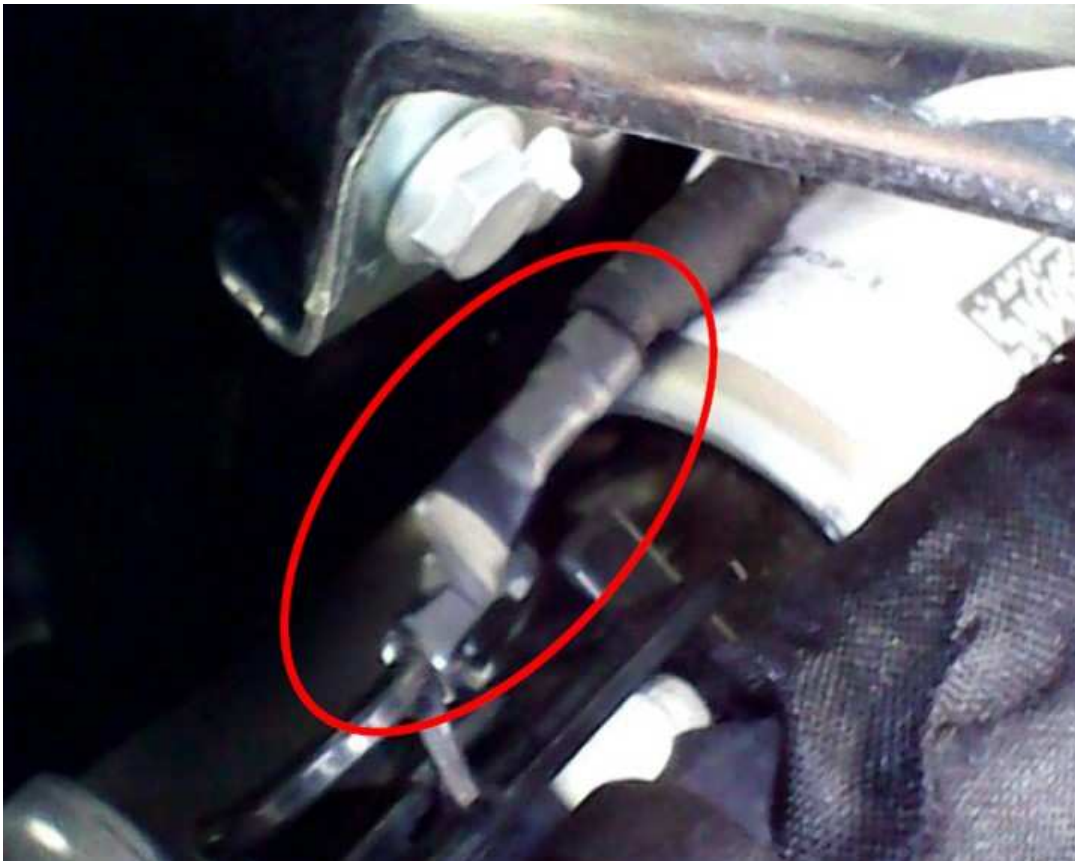
Fig. 1

- YES>>> Cable is interfering with the starter motor solenoid (Fig. 1) . Proceed to [Step 1](#) of the Repair Procedure.

Not OK Cable is Interfering with Starter Motor

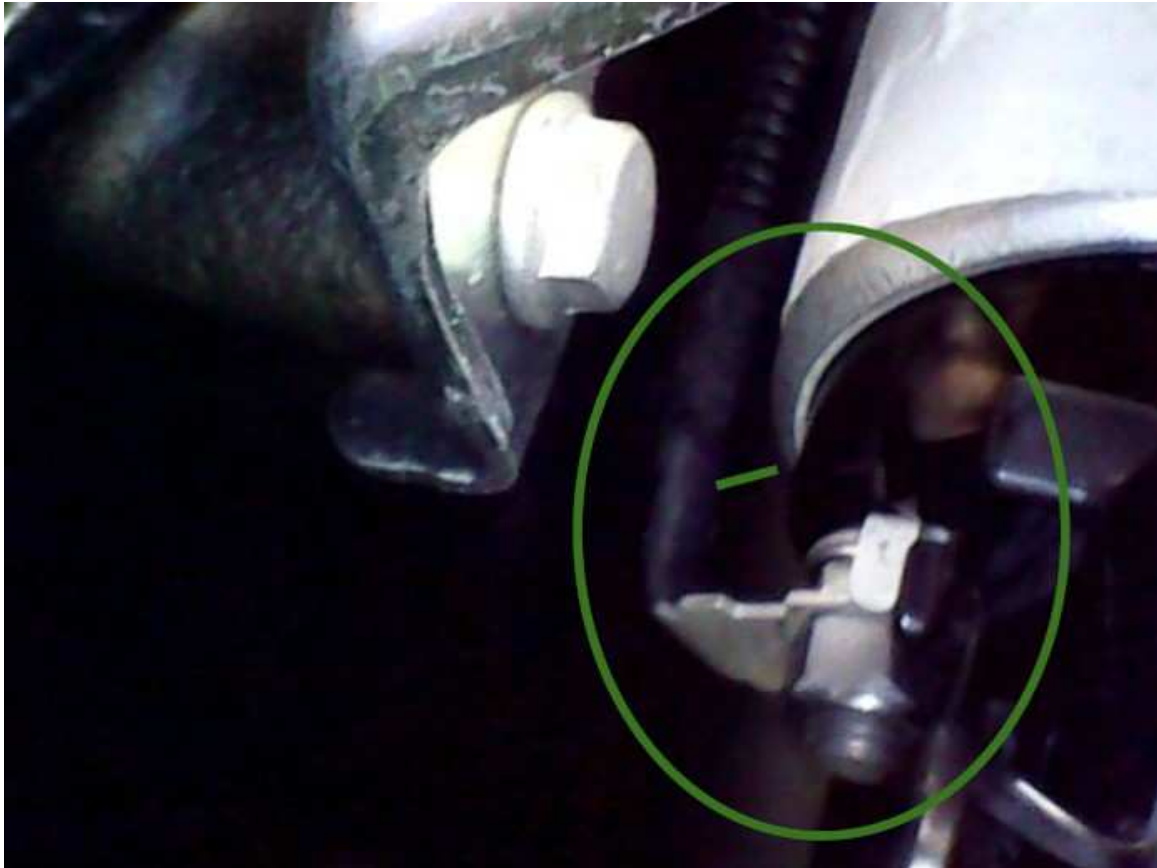
Fig. 2

- NO>>> There is a gap between cable and starter motor solenoid (Fig. 2) . This bulletin has been completed, use inspect LOP (08-90-23-90) to close the active RRT.

OK Cable is not Interfering with Starter Motor

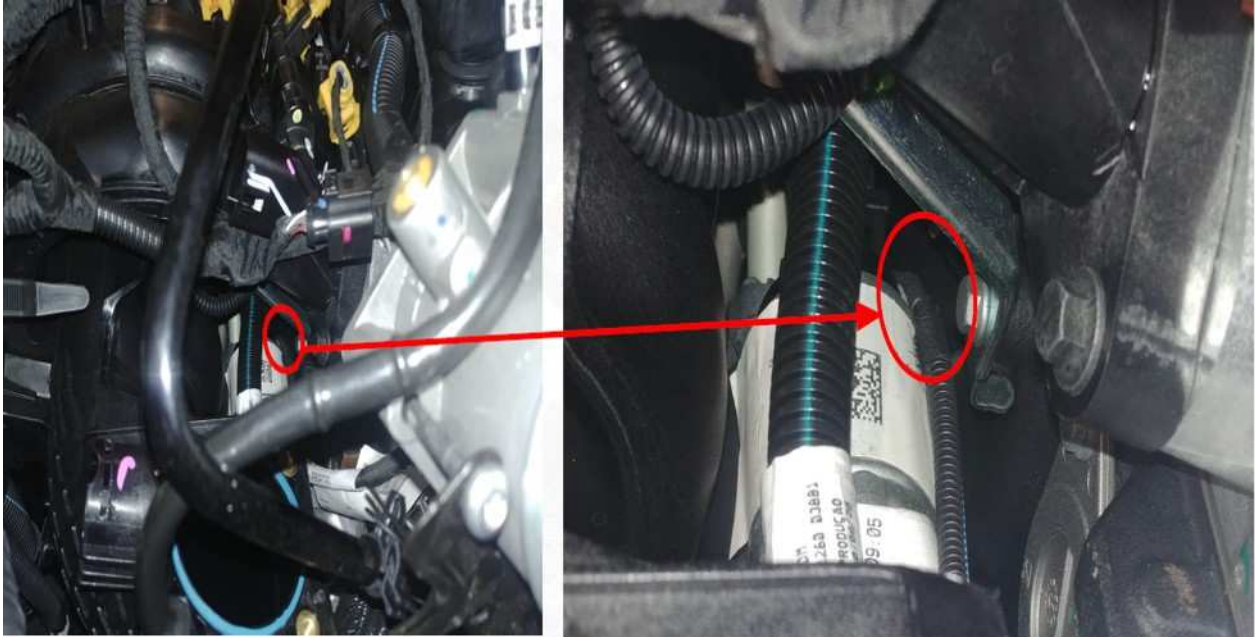
Fig. 3

Is there visual contact with the starter and cable (Fig. 3) ?

Starter Cable is Making Contact with the Starter Motor

- YES>>> Proceed to [Step 1](#) of the Repair Procedure..
- NO>>> This bulletin has been completed, use inspect LOP (08-90-23-90) to close the active RRT.

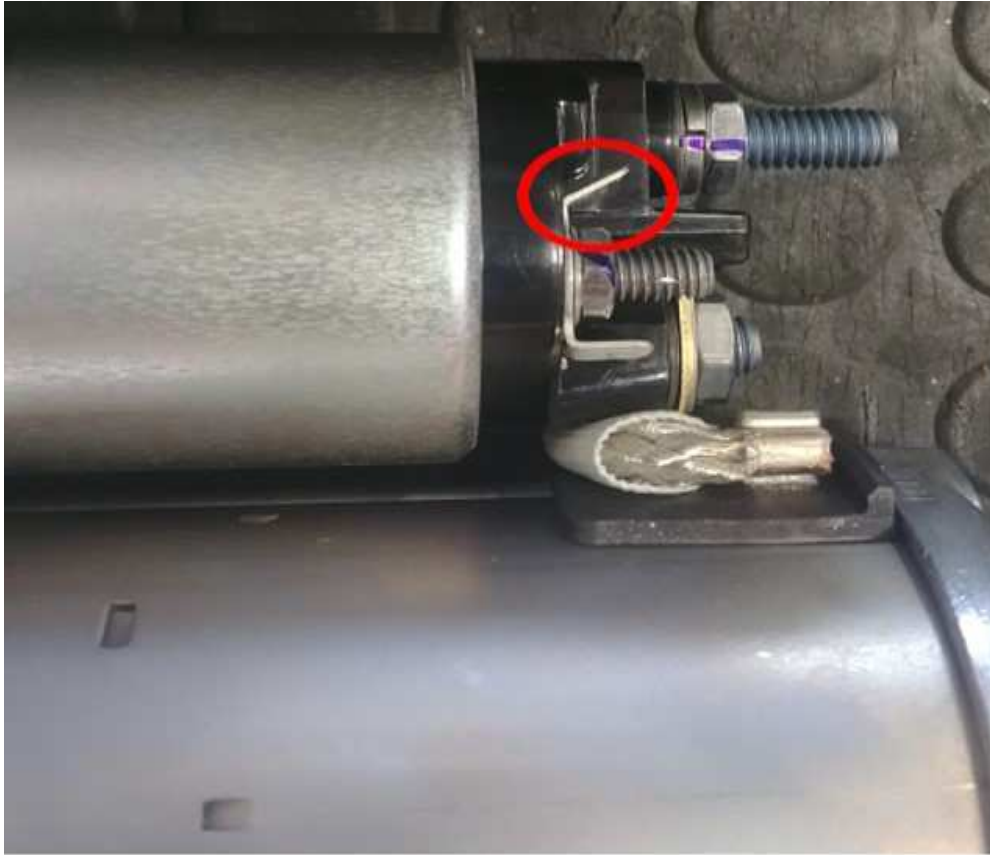
4. Check the anti rotation tab on the starter. Verify the tab is not bent outward (Fig. 5) .
If the tab is bent outward.

Fig. 5
Tab is Bent Outward
