**NUMBER:** 23-031-20

**DATE:** November 14, 2020

Door Glass Run Channel Weather Stripping Split Or Torn

2020 (JC) Dodge Journey

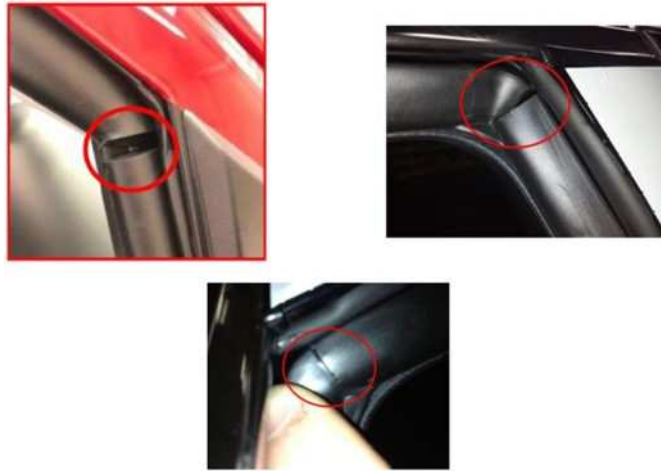
2. Visibly inspect all four door glass channel weatherstripping for splits and tears, specifically at the stripping joints (Fig. 1) .  
If each weatherstripping is not visibly cracked, check the joint by applying pressure on the molded joint, pressing the joint in all the way and then letting go (Fig. 2) . Repeat pushing each joint five times.

**Fig. 1**  
**Examples Of Weatherstripping Splits And Tears**

- 4. Does any of the door glass channel weatherstripping have a split or tear?
  - YES>>> Replace the door glass channel weatherstripping. Proceed to [Step 1](#) of the Repair Procedure.
  - NO>>> No Further diagnosis necessary. This bulletin has been completed, use LOP (23-33-20-9T) to close the active RRT.

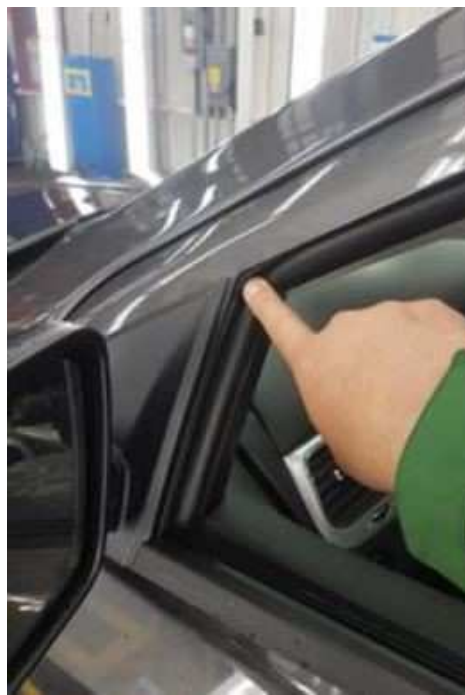
**Fig. 2**  
**Pushing On Molded Joint**

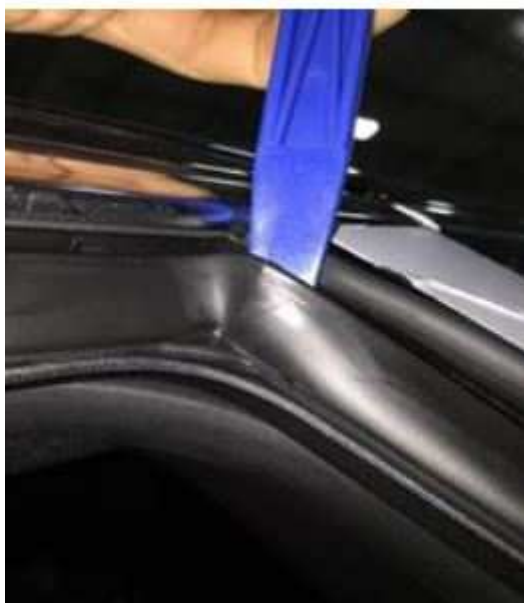
- 3. Using a trim stick or equivalent, gently lift the lip of each door glass channel weatherstrip at the molded joint (Fig. 3) .

**Fig. 3**  
**Using Trim Stick**
