NUMBER: 08-068-20 REV. B

UGQ Radio Enhancements

This bulletin involves inspecting and if required, updating the radio software level to ****39.2****.

2019 - 2020 (MP) Jeep Compass

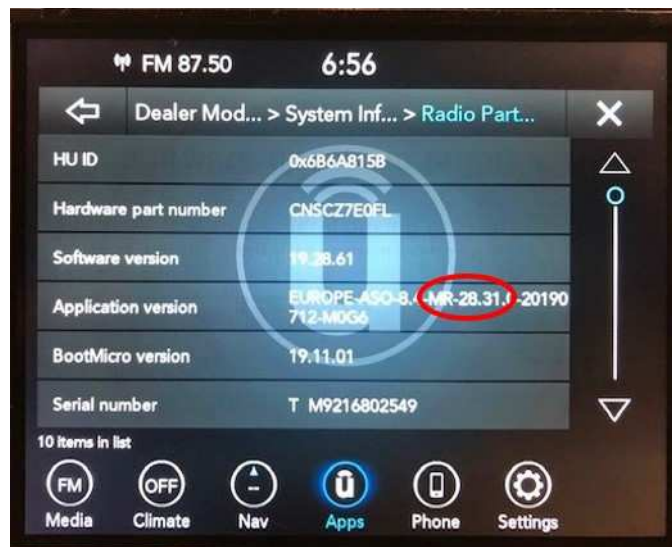
Fig. 1

1. Verify the radio software version. Radio must be in Dealer Mode to verify by following these steps:
 - a. Press and hold both lower corners of the display screen, until the Dealer Mode screen appears (approximately seven seconds). Release screen.
 - b. Select "Radio Part Information". The software version will be listed next to "Application Version" (Fig. 1).

Radio Software Level Screen

2. Is the radio software level (Application Version) at or higher than 39.2?
 - YES >>> The radio software is already up to date. Normal diagnostics should be performed.
 - NO >>> Proceed to [Step 1](#) of the Repair Procedure.

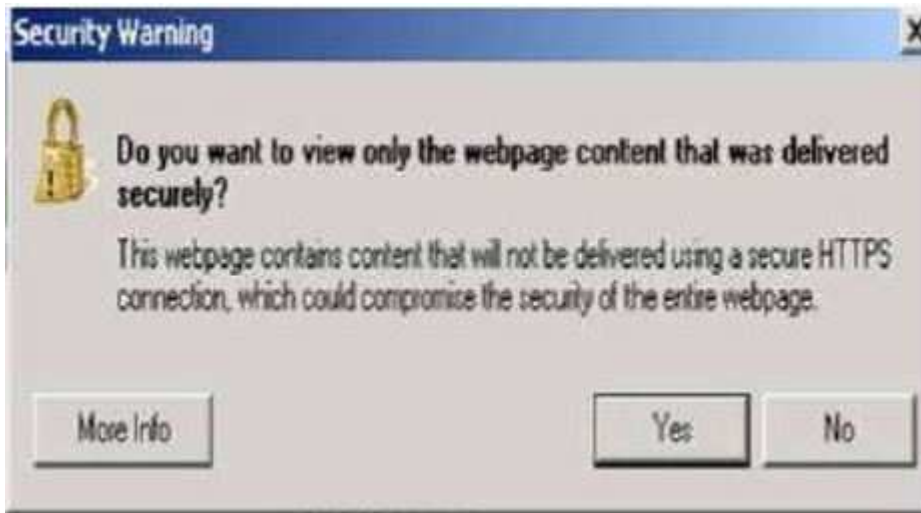
2. Go to DealerCONNECT>Service>Uconnect Command Center>Uconnect>More Information >Dealer software downloads to download the files.
3. If a security message appears “Do you want to view only the web page content that was delivered securely?” ([Fig. 2](#)) . Press “No” to continue.

Fig. 2
Pop-Up Security Message

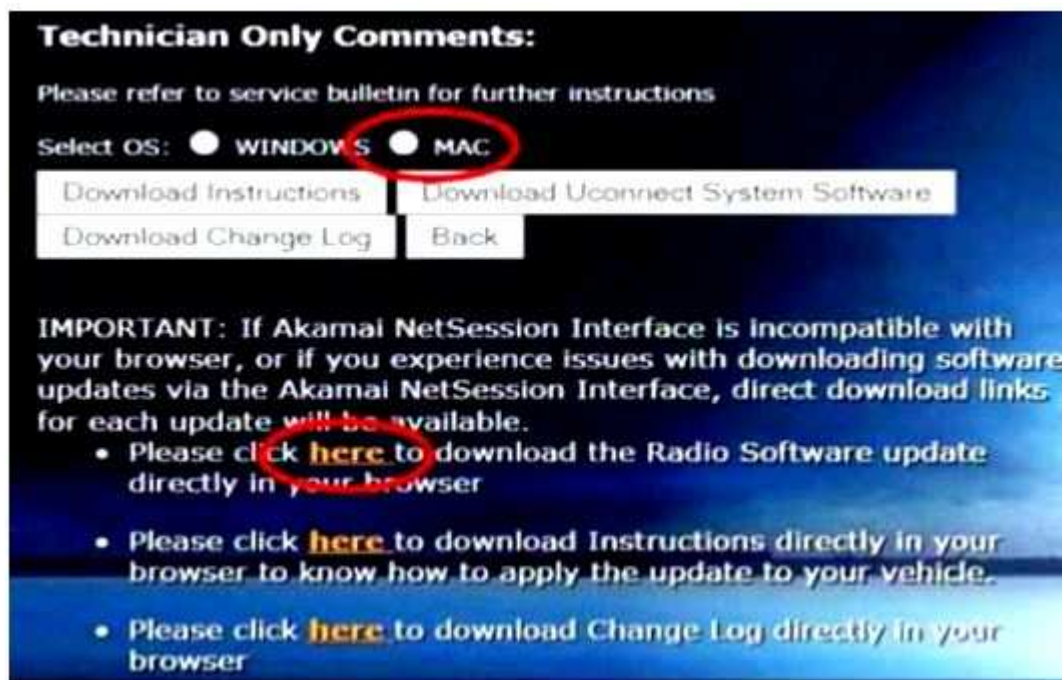
5. Download the software update file to your local PC's desktop. Make sure to select the "MAC" radial button for all downloads (Fig. 3) .

Fig. 3
MAC Download Steps

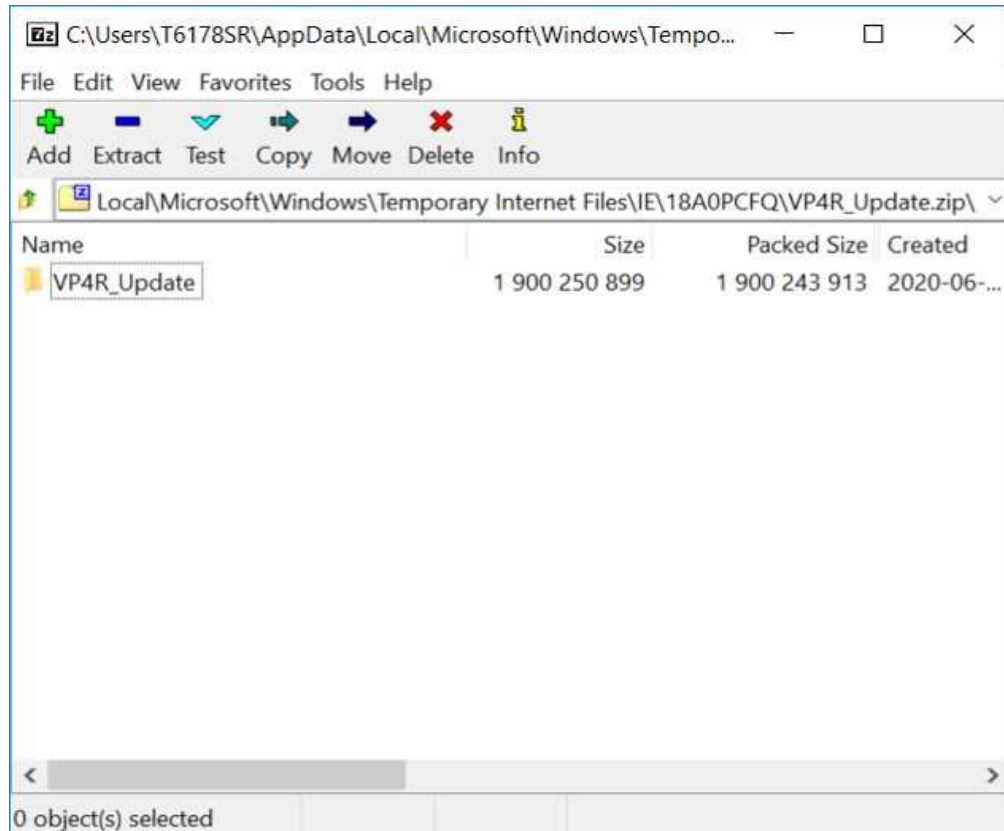
- Unzip all the files to the root folder of USB flash drive. Files should not be within a zip folder. Your USB files should look like (Fig. 4) when you open it, displaying multiple files/folders.

Fig. 4
Files/Folders In The USB Flash Drive

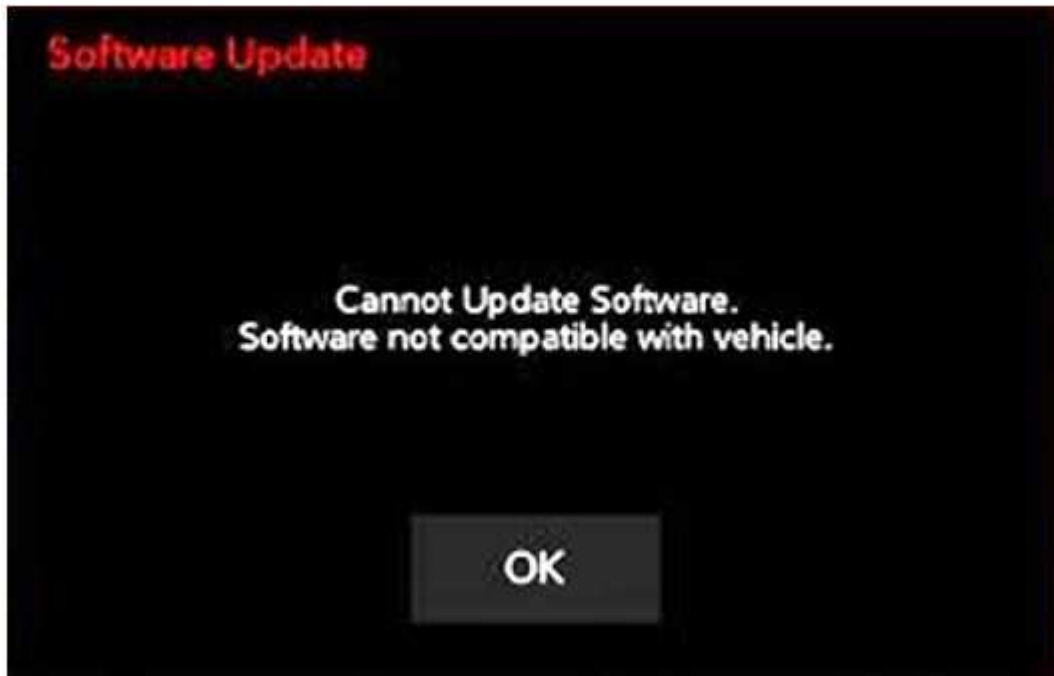
Fig. 5

Software Not Compatible Screen

10. If the screen in (Fig. 5) is displayed, the USB flash drive was not set up correctly. Use a top name brand USB flash drive, like Kingston, create a new USB flash drive and start the update again.

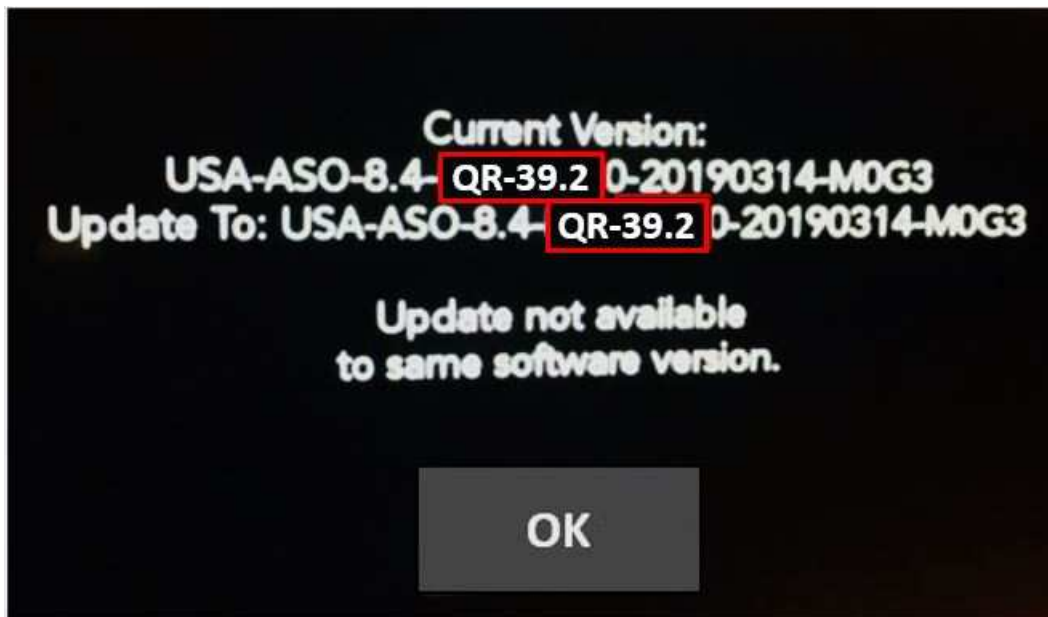
Fig. 6

11. If the radio software is up to date, the screen in (Fig. 6) will be displayed. Press "OK" and remove the USB flash drive.

Screen Displayed When Radio Software Level Is Up To Date

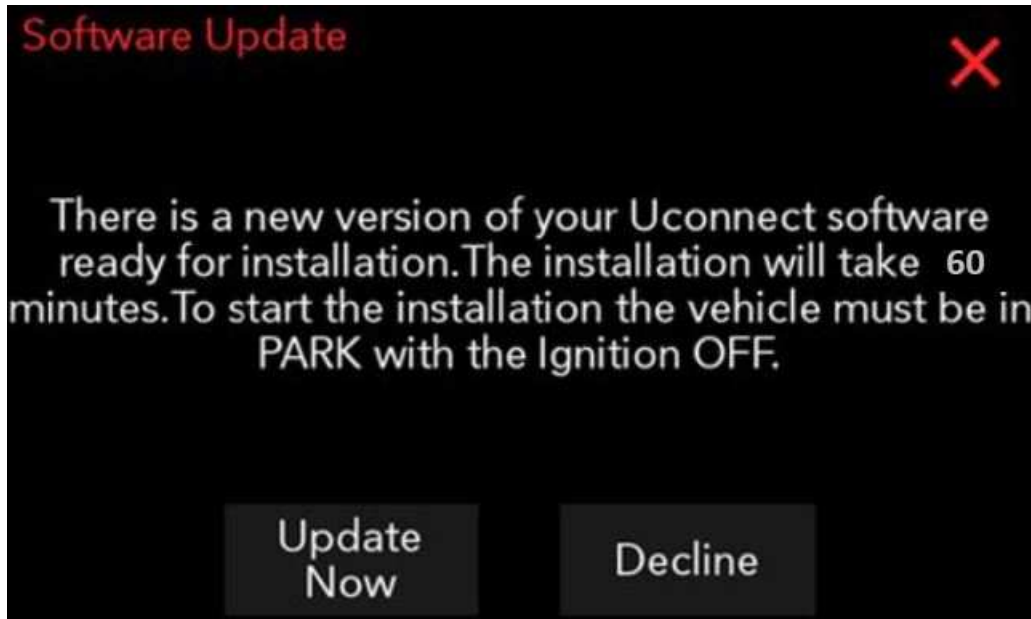
- 12. Once the system has verified there is an available update, press the “Update Now” button. Make sure the vehicle is in park, **DO NOT** turn off the ignition (Fig. 7) .

Fig. 7
Software Update Is Available

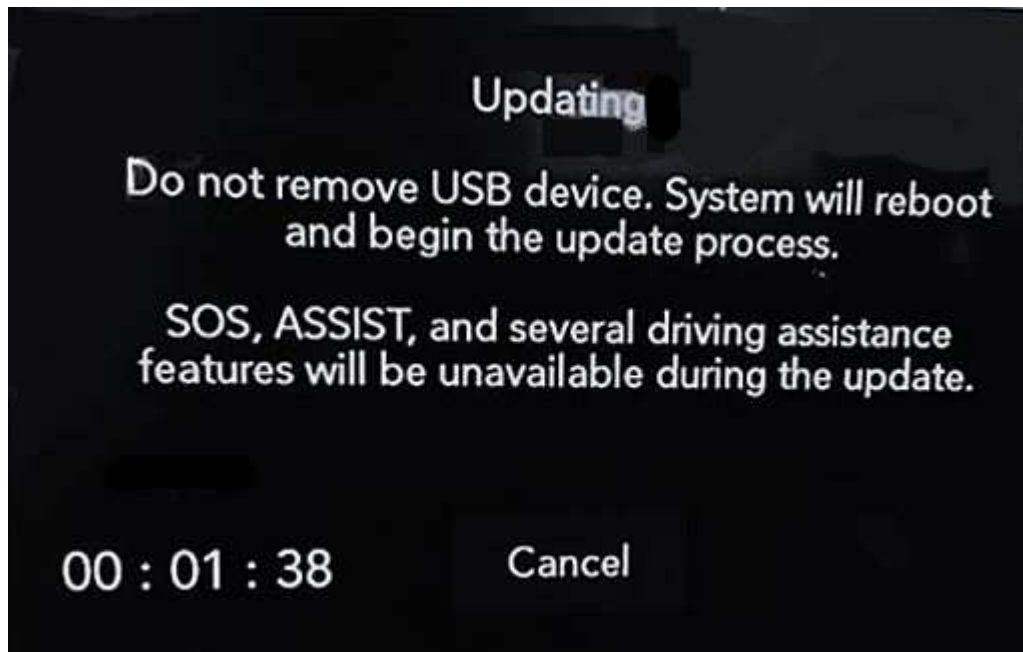
- 13. When the radio starts updating, the screen in (Fig. 8) will be displayed.

Fig. 8
Updating Screen

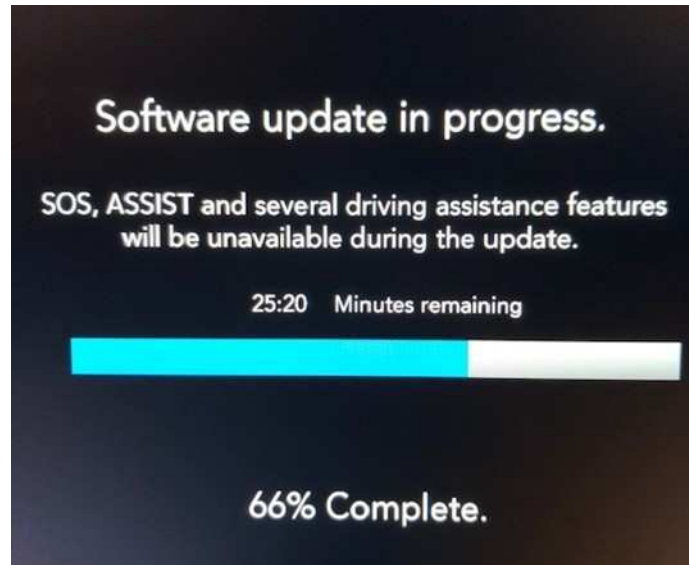
Fig. 9

14. The radio will reboot and the update will begin. The update should only take 25 minutes, the timer on the screen may display the incorrect time remaining, (Fig. 9) .

Software Update In Progress

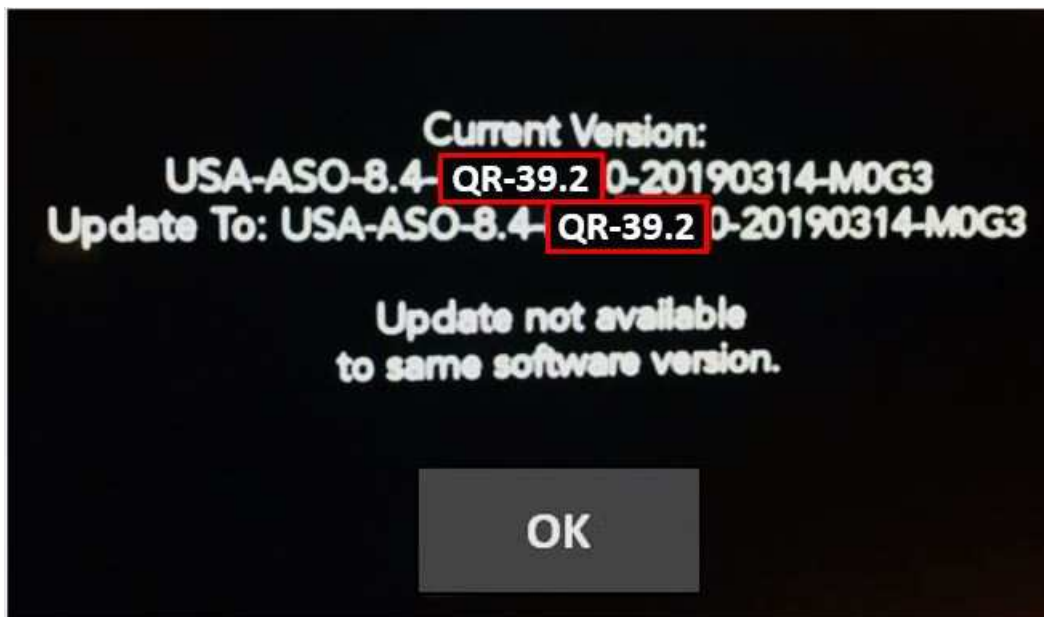
Fig. 10

15. After the update has completed, the radio will shut down. With the USB flash drive still inserted in the USB port, cycle the ignition back to the run position. If the radio has been updated correctly, the screen in (Fig. 10) will be displayed. Press "OK" and remove the USB flash drive.

Radio Software Has Been Updated
