Volvo Chassis - Air Leak At Wet Tank - Model VNL

QJ 1-12337163670

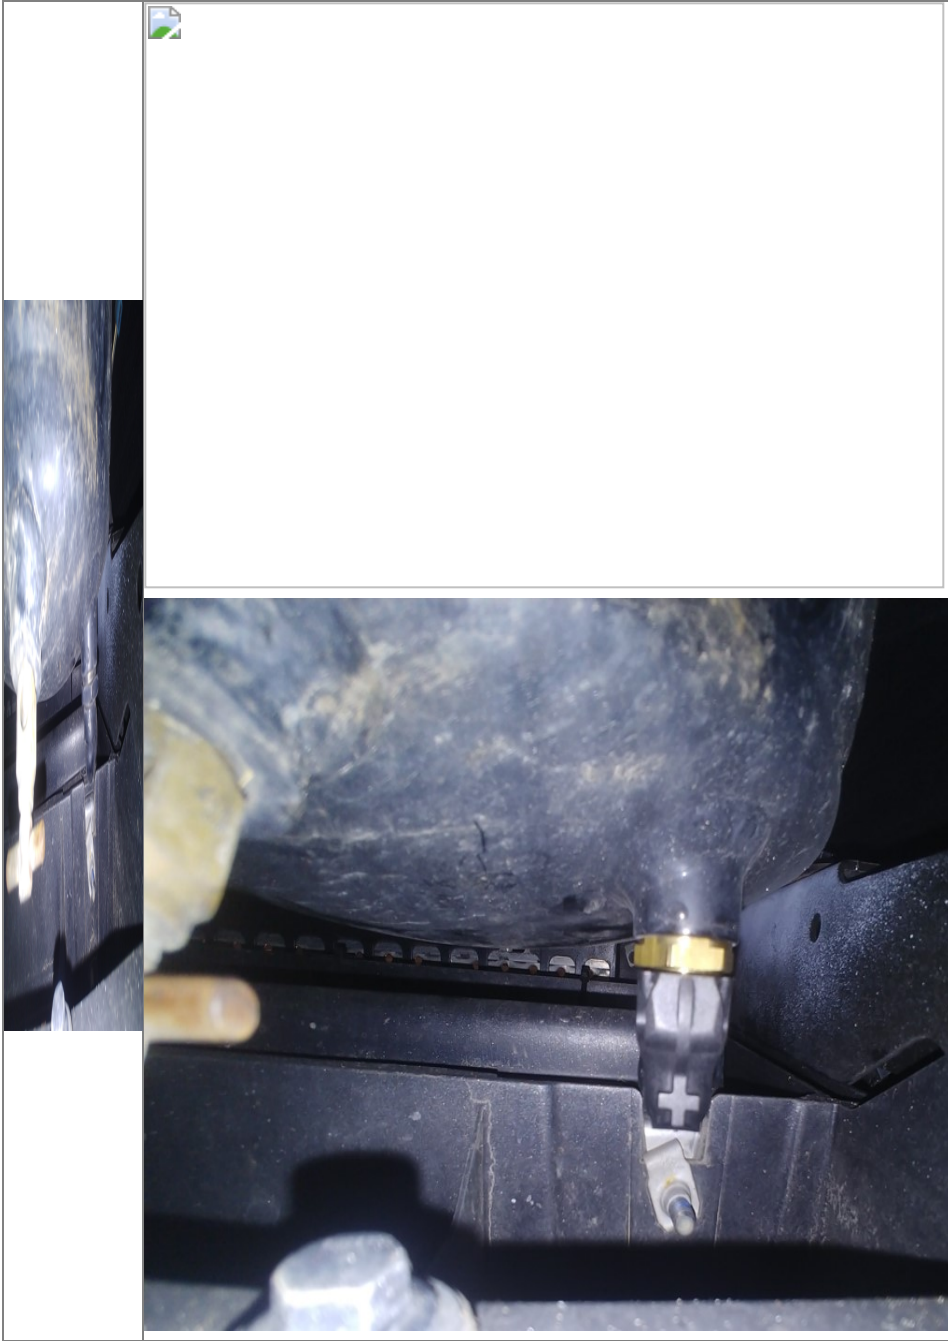
Volvo VN models have been reported having the wet tank, located on the front (outside) side of the wet tank, air line rub the chassis fairing. If the truck was built starting March 11, 2019 with air tank 22945941 and air fittings 991083 or 991965, in the front port of the air tank, this issue is possible. To correct this issue, replace fittings 991083 or 991965 with fitting 20999390.

Fitting - 20999390	Global Fitting - 991083 / 991965
--------------------	----------------------------------
