STAR ONLINE PUBLICATION

Case Number: S2019000004

Release Date: 7/14/2020

Symptom/Vehicle Issue: Click Or Pop From Drag Link

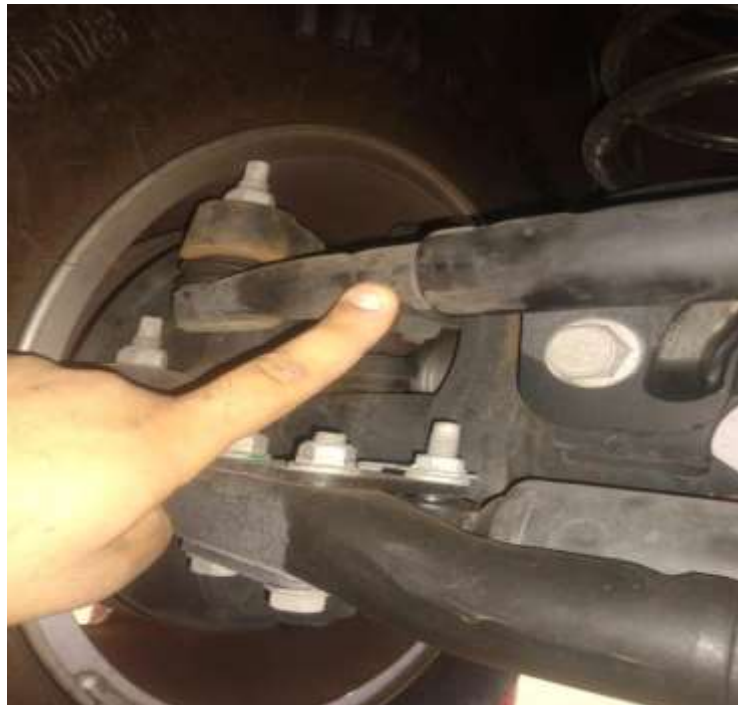
Discussion: Check the swedge joint where the tube and forged end meet for movement. If movement is found replace the drag link assembly to correct the noise condition. Suggested to use parts packaged after 3/2020
