NUMBER: 21-041-20

GROUP: 21 - Transmission and Transfer Case

Transmission Case Oil Leak

2019	(KL)	Jeep Cherokee
2019	(K4)	Jeep Cherokee (China)

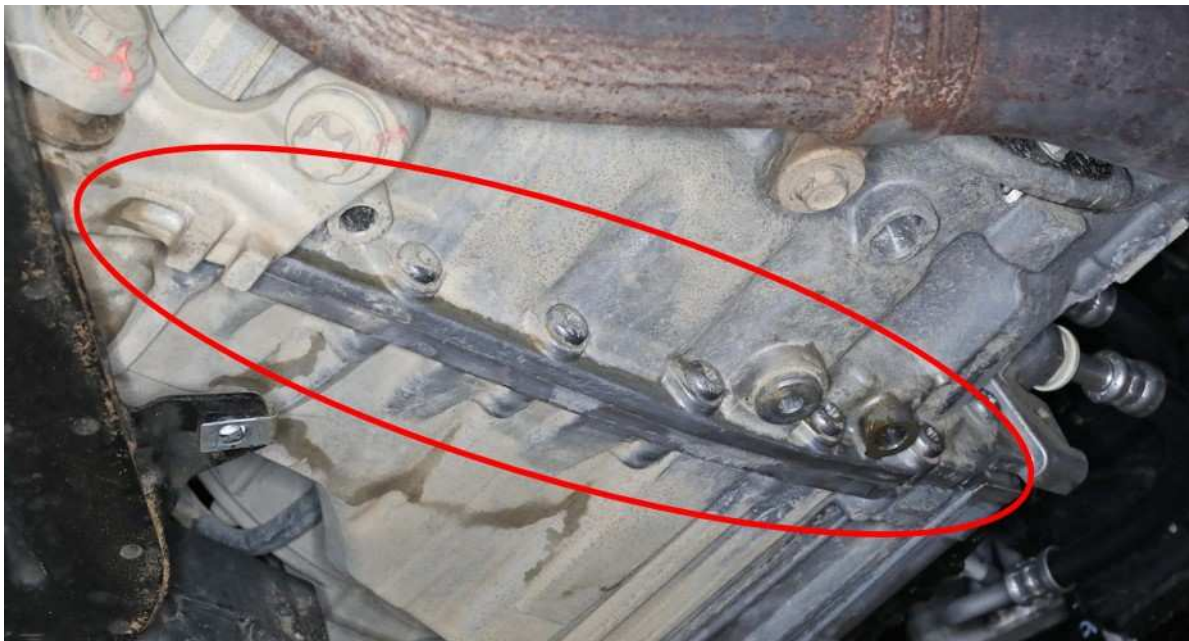
Customers may notice (possibly transmission) fluid leaking on the ground from the left front of the vehicle.

Fig. 2
Potential Leak Area at Case Split

7. Start the vehicle and verify the transmission fluid temperature is above 50 °C (122 °F).
8. Verify the transmission fluid is not leaking at the repair area (Fig. 2) , if a leak is still detected further diagnosis should be performed.

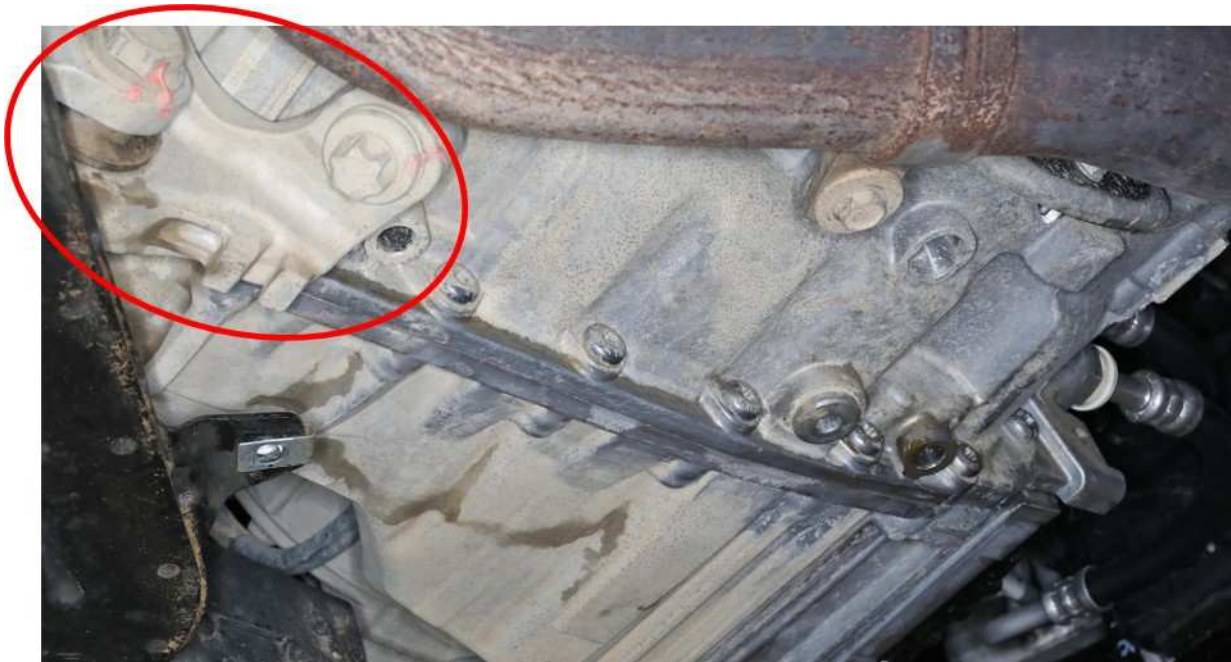
Fig. 3
Support Bracket to be Removed

1. Remove the cross under exhaust pipe for access (if necessary). Refer to the detailed service procedures available in DealerCONNECT> Service Library under: 11 - Exhaust System / Pipe, Exhaust Crossunder / Removal .
2. Remove the transmission mount bracket to gain access to bolts 1 & 2 (Fig. 3) .

4. Install the transmission mount bracket (Fig. 3) .
5. Install the cross under exhaust pipe (if removed). Refer to the detailed service procedures available in DealerCONNECT> Service Library under: 11 - Exhaust System / Pipe, Exhaust Crossunder / Install.

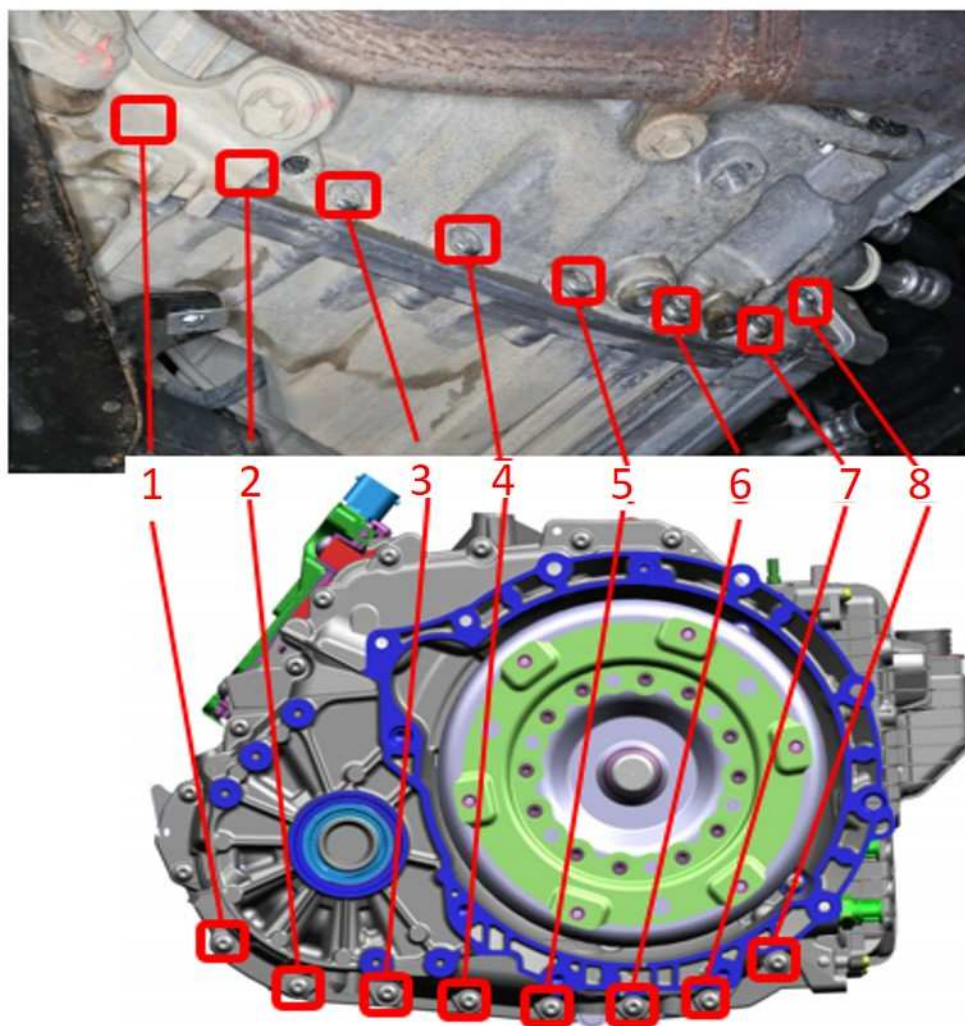
Fig. 4

Eight Bolts to be Torqued to Specifications at Potential Leak Area at the Case Split

3. Starting at bolt #8 and then working to bolt #1, torque bolts to 35 N·m (26 ft. lbs.) (Fig. 4) .

CAUTION! Do not rotate the bolts counter clockwise.
