NUMBER: 08-067-20

UGQ Radio Enhancements

This bulletin involves inspecting and if required, updating the radio software. level to 34.2

2019 - 2020 (BV) Jeep Renegade

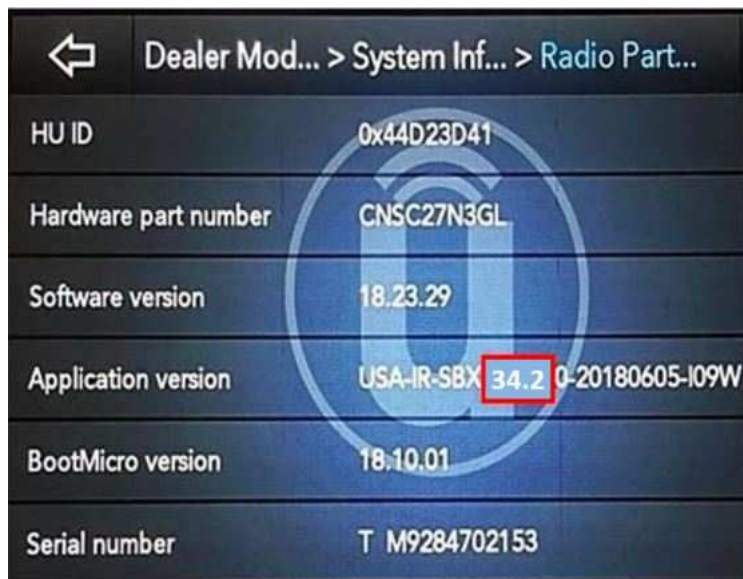
Fig. 1

2. Is the radio currently at software level 34.2 or higher (Fig. 1) ?
 - YES >>> The radio software is up to date. Normal diagnostic should be performed.
 - NO >>> The radio software needs to be updated. Back out of 'Dealer Mode' and proceed to [Step 1](#) of the Repair Procedure.

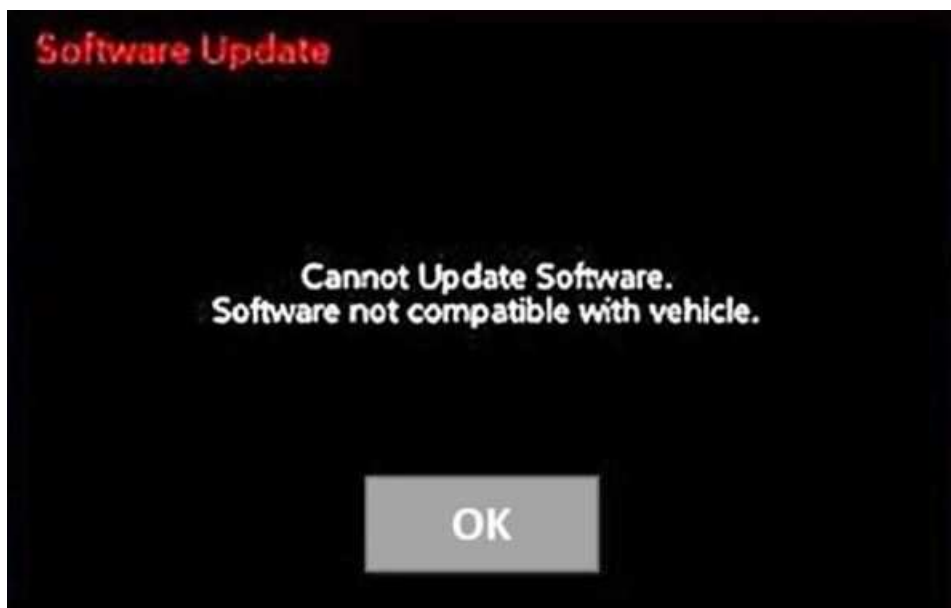
Fig. 7
Software Not Compatible

- 12. If the screen in (Fig. 7) is displayed, the USB flash drive was not set up correctly. Use a top name brand USB and create a new flash drive, then start the update again.
