NUMBER: 08-037-20 REV. A

UAV and UCV Radio Enhancements

2019 - 2020 (WK) Jeep Grand Cherokee

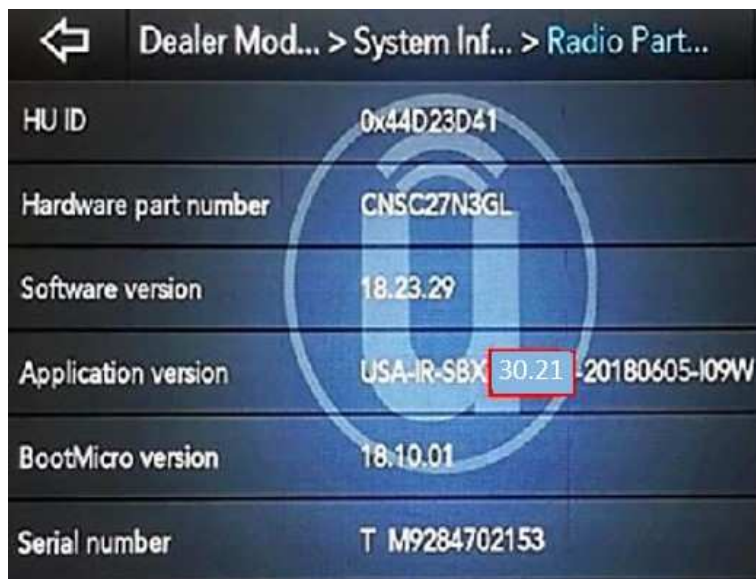
Fig. 1
Radio Software Level Screen

3. Is the radio software level "Application Version" lower than 28.0 ([Fig. 1](#)) ?
 - YES >>> This bulletin does not pertain, Normal diagnostic should be performed.
 - NO >>> The radio software needs to be updated. Back out of Dealer Mode and proceed to [Step 1](#) of the Repair Procedure.

CAUTION! If the radio software level is under version 28.0, do not use this software. If this software (30.21/34.2) is used on a radio with software lower than 28.0, it could lock up the radio. The radio will need to be replaced to correct this condition.

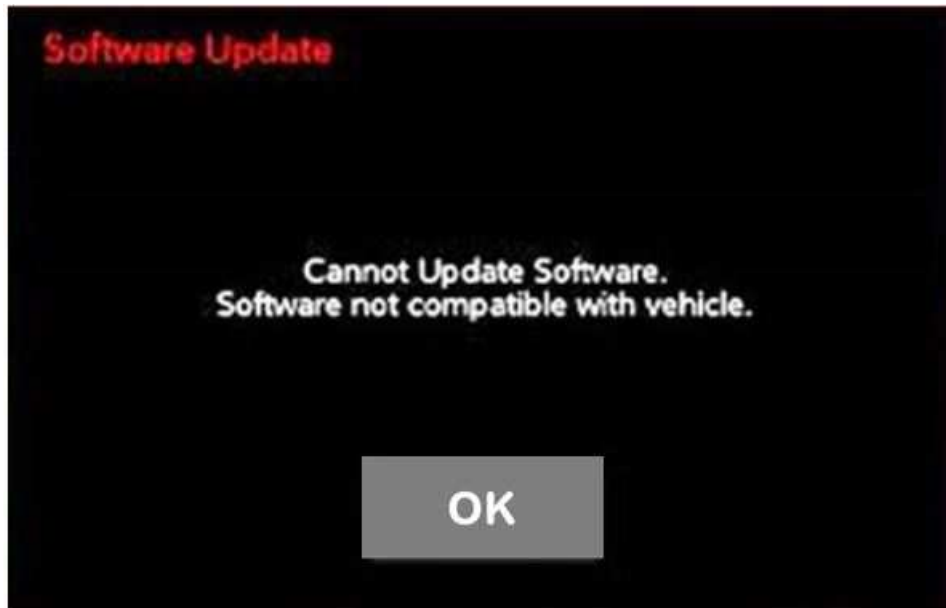
Fig. 7
Software Not Compatible

12. If the screen in (Fig. 7) is displayed, the USB flash drive was not set up correctly. Use a top name brand USB flash drive like Kingston and create a new flash drive and start the update again.
