Type: Technical Service Bulletin

MODEL: Revero GT**TITLE: Ground Torque Inspection**

This document instructs to check the torque on the fastener for Ground 109A (GD109A).

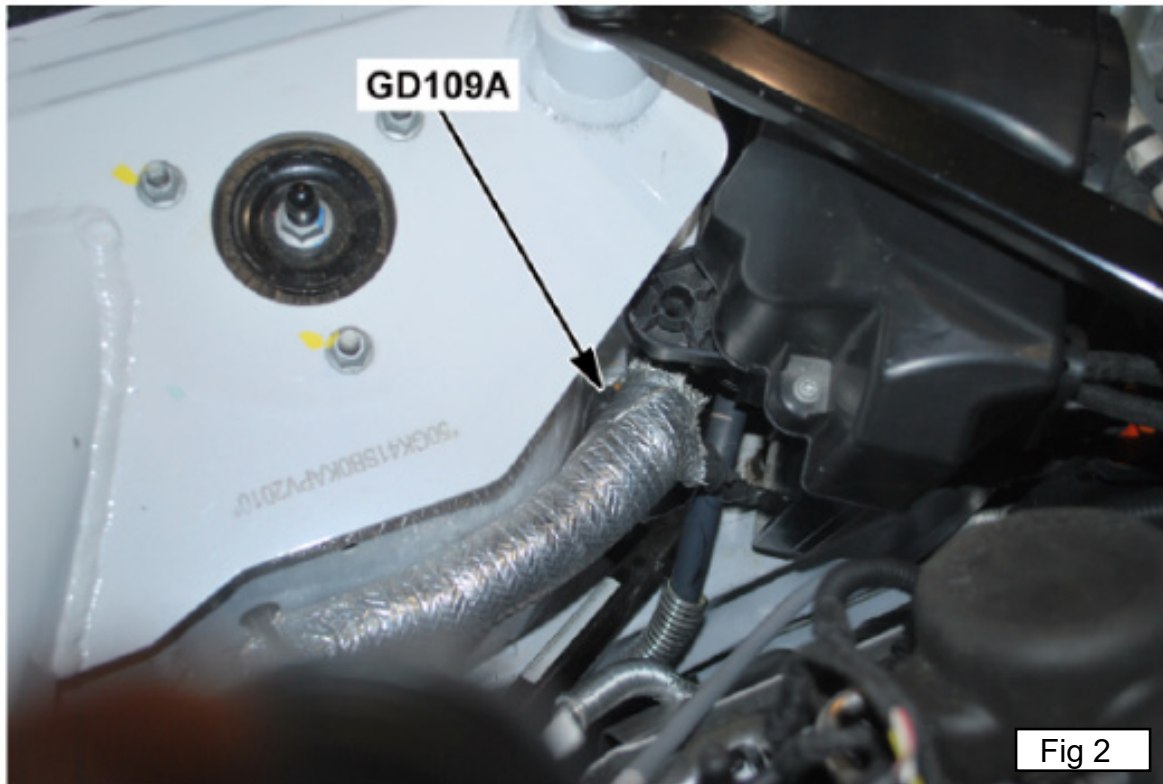
Fig 2

As indicated in the image (Fig 2) the ground is located on the passenger side shock tower. The HV cable bundle should maintain the alignment with the new bracket installed.

Right side of the engine compartment, next the ECM
