Rattling or Clicking from the Panoramic Glass Roof

AFFECTED VEHICLES

Year	Model	Trim Level	VIN Range
2019	RDX	AWD	5J8TC2***KL000001 to 5J8TC2***KL043969
2019	RDX	2WD	5J8TC1***KL000001 to 5J8TC1***KL025375

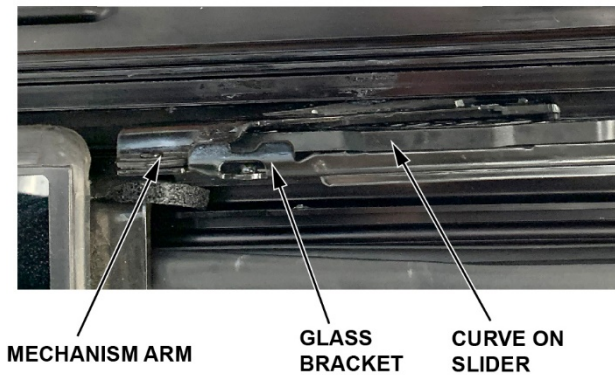
While driving over rough roads or bumps, you hear a rattling or clicking from the panoramic glass roof.

There is not enough clearance between the rear panoramic glass roof mechanism arm and the plastic curve on slider.

Increase the clearance between the curve on slider and the mechanism arm by bending the arm. If this does not fix the issue, replace the panoramic glass roof frame.

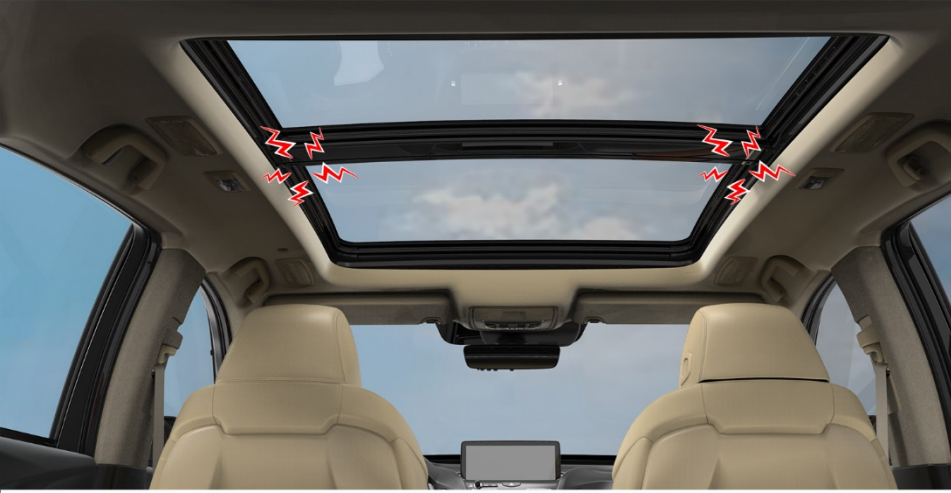
1. Drive the vehicle with the panoramic front glass closed. Check if the rattling or clicking is coming from the back corners of the front glass.

- If the noise is coming from this area, go to REPAIR PROCEDURE A.
- If the noise is not coming from this area, this bulletin does not apply. Continue with normal system troubleshooting.

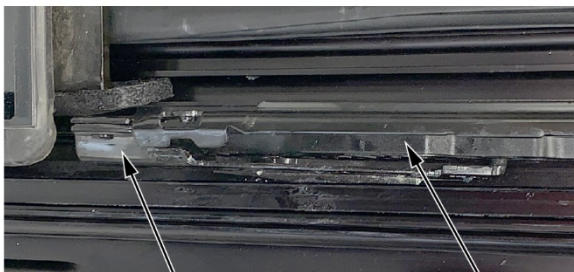
2. Once the glass is removed, press the panoramic glass roof switch to the closed position.
3. Locate the mechanism arm, as shown below, on the side where you heard the noise. Then, lightly wiggle the rear portion of that arm enough so it contacts the curve on slider. Do this on both sides of the panoramic glass roof.

MECHANISM ARM

CURVE ON
SLIDER

- If you hear a clicking from that area, go to step 4.
- If you do not hear a clicking from that area, continue with normal system troubleshooting

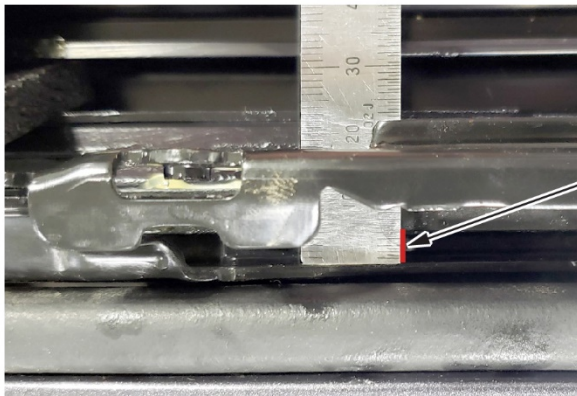
4. Move the panoramic roof switch to the full tilt position, and check the gap between the curve on slider and the mechanism bracket. Record the gap as a starting point.

Measure the gap.
