Product Upgrade Bulletin 201217REV

Fleetwood Brand:
Discovery
Pace Arrow LXE

Holiday Rambler Brand:
Endeavor
Navigator

Adjusting the position of the engine oil fill attachment bracket to eliminate interference between the oil fill tube and adjacent chassis components

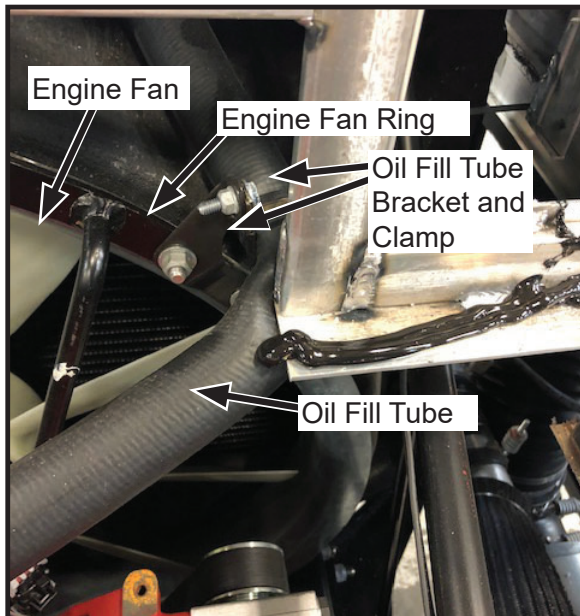
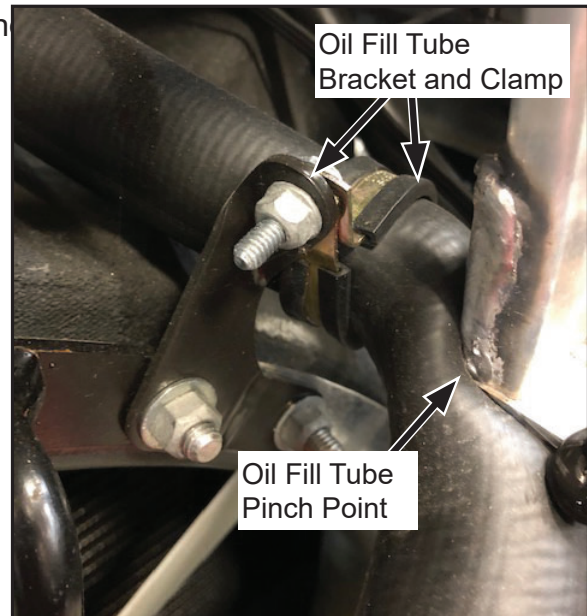
On motorhomes affected by this Product Upgrade, there may be inadequate clearance between the oil fill tube and adjacent chassis components.

- If the oil fill tube is in contact with any chassis component(s) or framing which may impede oil flow through the tube, take several clear photos of the area showing the obstruction(s) and attach them to a draft claim in the warranty portal, and then continue to Step 4, Repair Procedure.

- Locate the bracket on the chassis securing the oil fill tube. Refer to Figures 2 and 3.
- Remove the three nuts, three bolts and the clamp from this bracket. Leave the clamp on the oil fill tube; it will be resecured in a later step. Retain two (each) of the bolts and nuts that were removed.
