Technical Service Bulletin

01 MIL on with hissing noise, DTC P227900 is stored in the ECM

01 21 95 2054795/2 January 12, 2021. Supersedes Technical Service Bulletin Group 01 number 19-15 dated April 23, 2019 for reasons listed below.

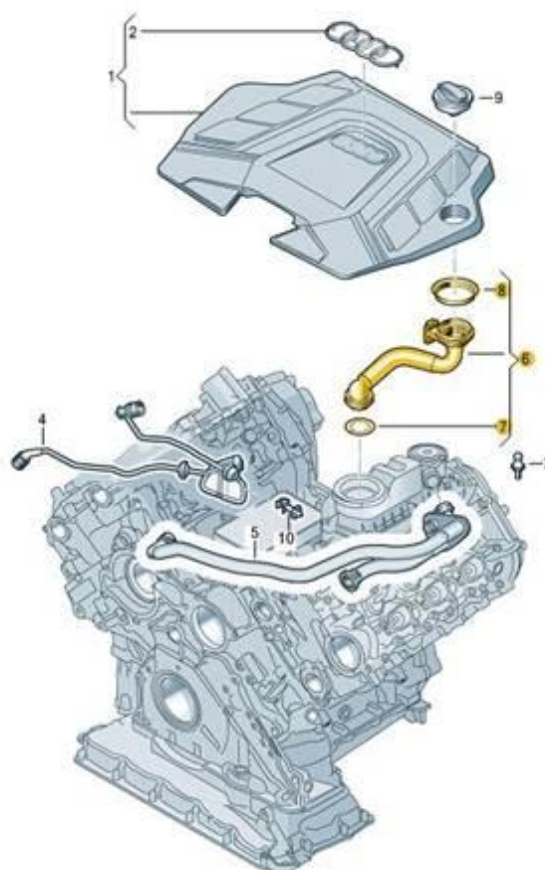
During assembly, the oil fill extension tube (Figure 1) may have been assembled incorrectly. If this extension tube is cross-threaded, an intake/vacuum leak may be generated at the interface between the extension tube and the valve cover (Figure 1, 7).

Figure 1. Oil fill extension tube (see possible cross-threading at number 7 on diagram).

If an intake/vacuum leak is suspected, please inspect this component and verify proper sealing. If any components are damaged from cross threading, replace as necessary.
