## Technical Service Bulletin

#### 20 Noises from the fuel line

20 21 33 2059997/2 January 15, 2021. Supersedes Technical Service Bulletin Group 20 number 20-27 dated July 7, 2020 for reasons listed below.

Model(s) Year		Year	VIN Range	Vehicle-Specific Equipment
	Q3	2019 - 2021	All	Not Applicable

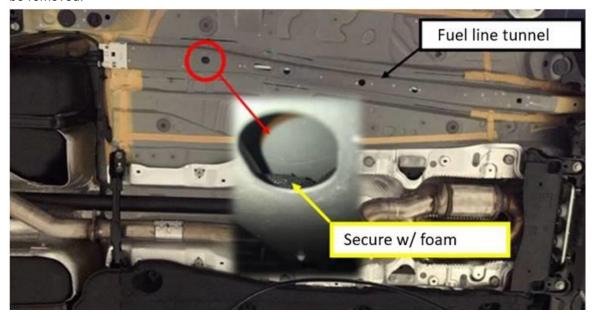
• The fuel/EVAP lines in the longitudinal member start to vibrate in certain operating situations and this creates the noise.

Due to pressure pulsation from the high-pressure pump on engine side the underfloor line in the underbody tunnel vibrates. This vibration causes noise that can also be heard in the vehicle interior.

Figure 1. Location of the vibrating fuel line.

2. Coat the fuel and EVAP line tunnel or fill the space around the fuel and EVAP line with closed-pore foam (foam that doesn't soak up water) part number 321 201 299. This means the fuel/EVAP line does not have to be removed.
