Technical Service Bulletin

68 Noises from the MMI screen

68 21 31 2061722/2 January 14, 2021. Supersedes Technical Service Bulletin Group 68 number 20-28 dated December 17, 2020 for reasons listed below.

Model(s)	Year	VIN Range	Vehicle-Specific Equipment
Q5, SQ5	2019 - 2020	All	Not Applicable
Q5. SQ5	2021	000001 - 027758	Not Applicable

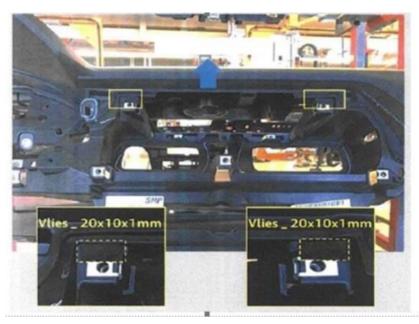
• The noises originate from the area of the MMI screen.

Relative movement between the MMI screen and its mounting surfaces in the dash panel.

Figure 1. Apply two pieces of felt tape to the dash panel in the area shown.

- Felt strips with part number 533867910A (dimensions: 20x10x1 mm).
- 1. Remove the MMI screen according to the Elsa repair manual.

Attach two pieces of felt tape to the MMI screen mounting surfaces in the dash panel (Figure 1).

- 3. Reinstall the MMI screen according to the Elsa repair manual.
- 4. Test drive vehicle to verify the repair.
