Technical Service Bulletin

PSS 91 Rear MMI control panel (SCON) shows the message: "software update could not be downloaded"

91 21 59 2061670/1 January 8, 2021.

ſ	Model(s)	Year	VIN Range	Vehicle-Specific Equipment
	A8	2021	All	SCON

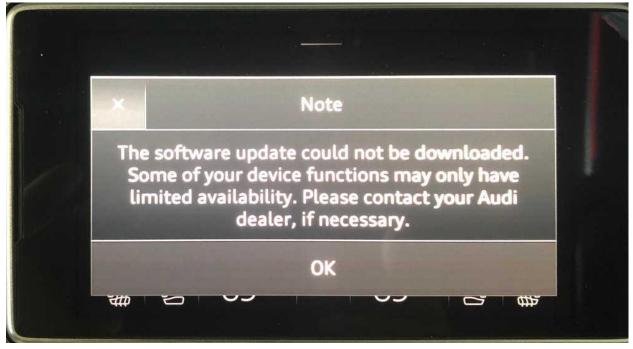
• The message "The software update could not be downloaded..." is displayed on the wireless control head (Figure 1).

Figure 1. Message displayed on the wireless control head.

A software malfunction in MIB3 vehicles causes the message to be displayed erroneously.

- 1. Explain to the customer that a solution is forthcoming for the 3rd quarter of 2021 and that no repairs are necessary at this point. Do not replace any components for this condition since this will not resolve the customer's concern.
- 2. Create a PSS record in the PSS application through the Pending Service Solutions (PSS) link in AccessAudi (under *Related Links >> Service*), or through the Technical Assistance page in Elsa.
