Business Class M2
Cascadia
108SD/114SD
> New Cascadia

Freightliner
Service Bulletin

General Information

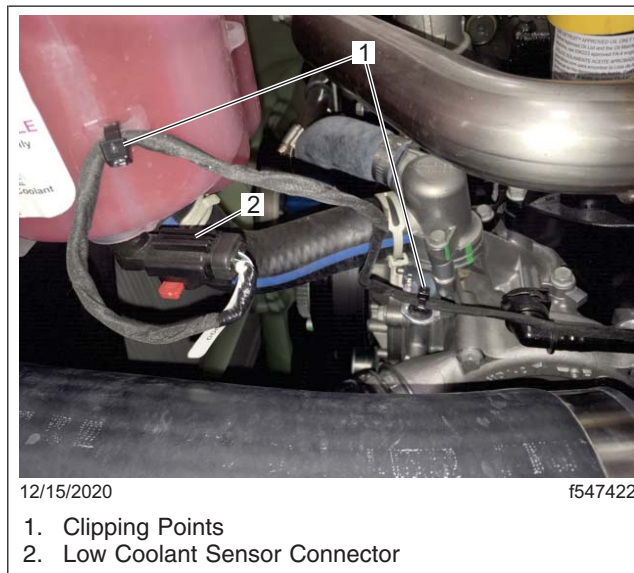
On New Cascadia™ vehicles, depending on the tension applied to the harness located at the coolant level sensor and its mounting locations, wiring damage can occur, resulting in one or more of the below listed fault codes.

1. Park the vehicle on a level surface, shut down the engine, and set the parking brake. Chock the tires.
2. Disconnect the negative battery cables.
3. Open the hood.
4. Inspect the low coolant sensor and the wiring harness area near the clipping points and within two feet of the sensor connector for broken or chafed wires. See [Fig. 1](#) and [Fig. 2](#).

Fig. 1, Inspection Areas for Detroit Engines

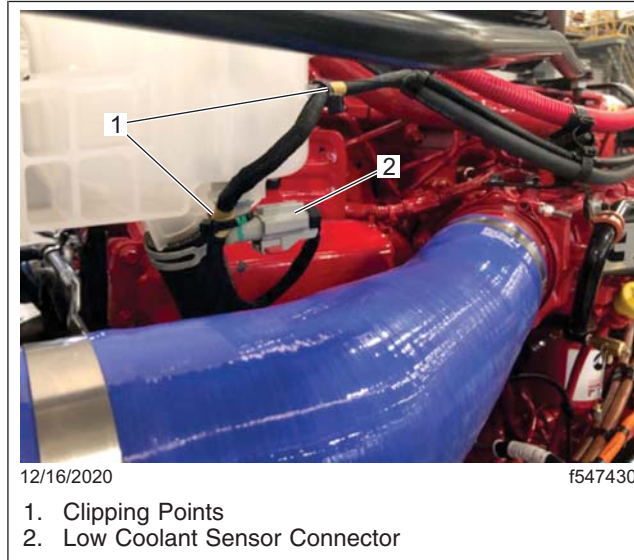
Fig. 2, Inspection Areas for Cummins Engines

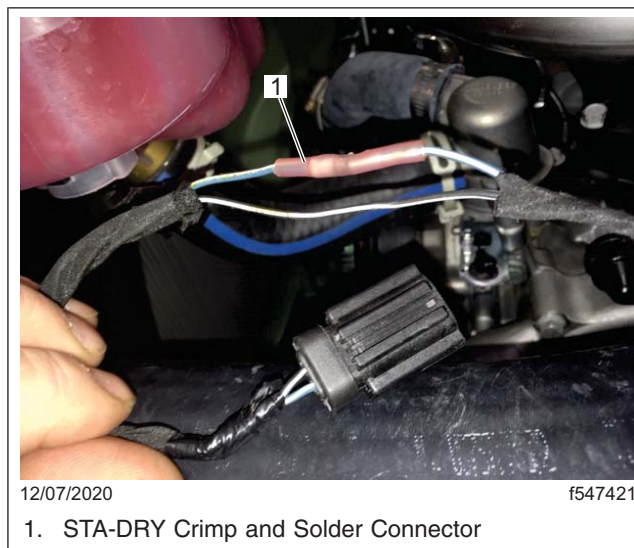
Fig. 3, Wire Repaired with STA-DRY Connector

5. Repair the damaged wiring using a Phillips STA-DRY crimp and solder connector (PHM 1 1863). See [Fig. 3](#). Use a heat gun to shrink the seal and melt the internal solder after crimping the Sta-Dry connector and then wrap it with tape. See [Fig. 4](#).

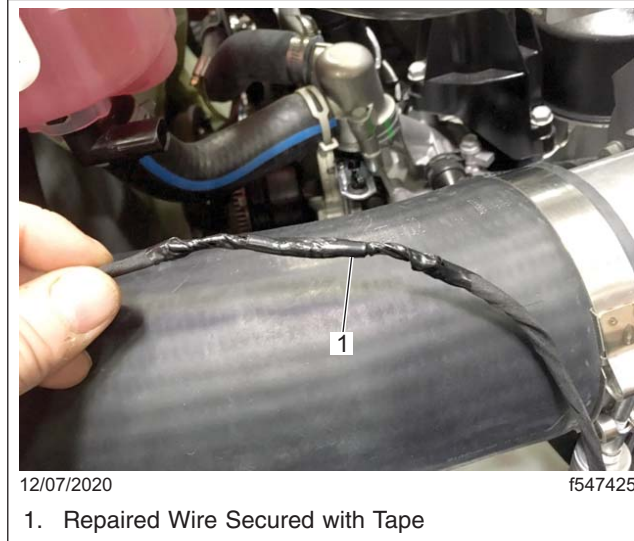
Fig. 4, Tapped Wire after Repair

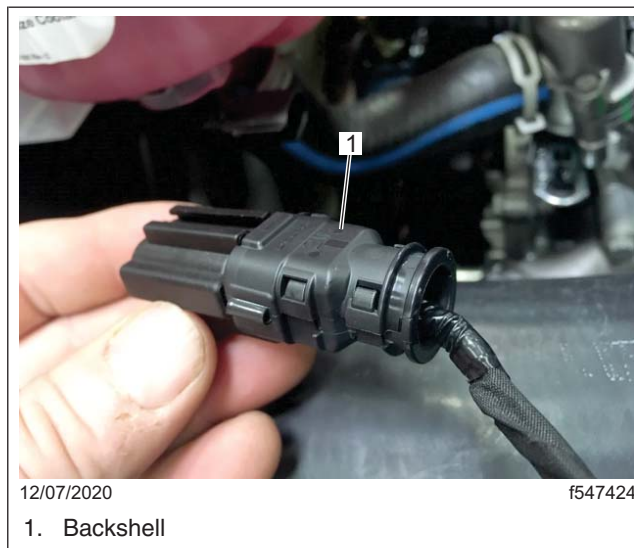
Fig. 5, Backshell Installed

6. If there is a damaged wiring near the sensor connector, replace the wire and install a new connector terminal (FCI 10757690 or 23-13211-000).
7. Install the backshell (23-13302-633) on the low coolant sensor connector. See [Fig. 5](#).

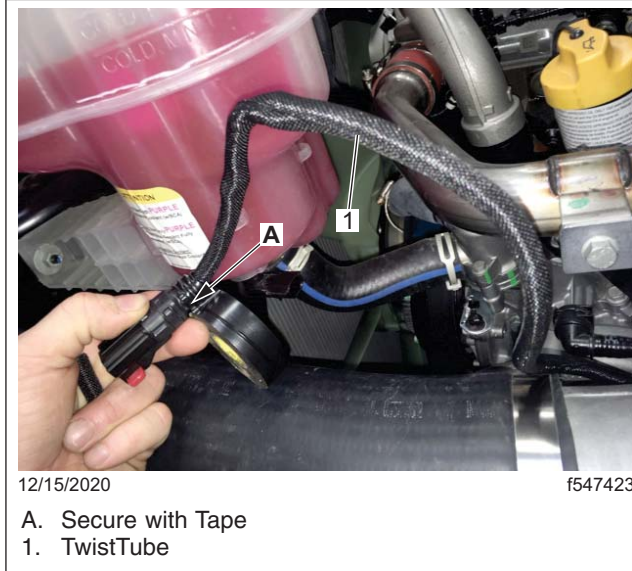
Fig. 6, TwistTube Added to the Wiring

8. Add two feet of 8 mm TwistTube to the low coolant sensor wiring from the connector to the engine clipping point. Insert a half-inch of the TwistTube into the connector backshell and secure it with tape. See [Fig. 6](#).

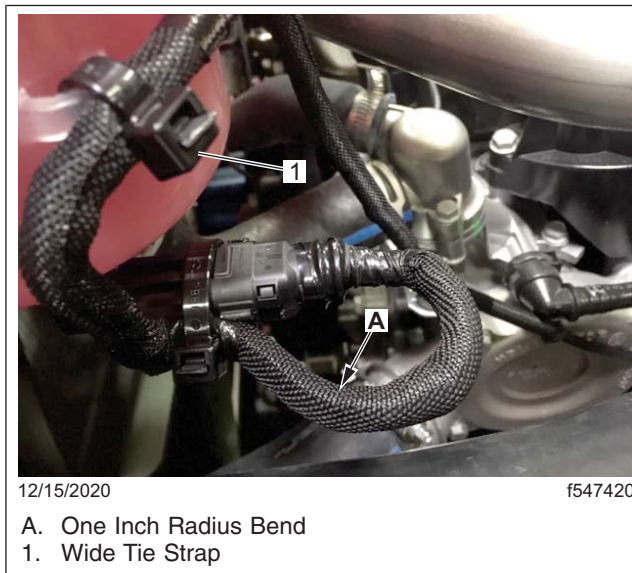
Fig. 7, Maintaining the Bend Radius

9. Route the harness as shown in [Fig. 7](#) using one of the mounting locations on the surge tank and secure it at the clipping points using wide tie straps. Maintain a minimum of one inch radius bend at the point where the harness enters the low coolant sensor connector.
