# SS 1034492 New Cascadia P4 Coolant Level Wiring Damage

Applicable Vehicles:

All New Cascadia P4 Vehicles manufactured before September 2019

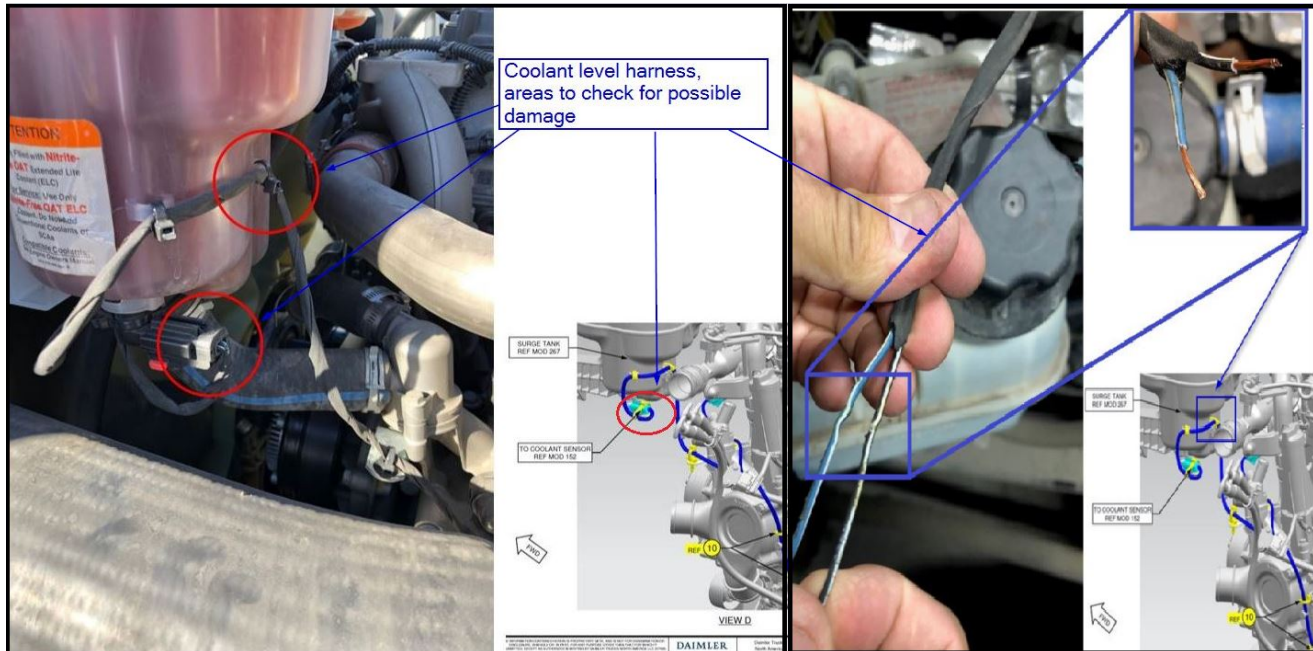
Depending on the tension applied to the wiring located at the coolant level sensor and its mounting locations, wiring damage can occur, resulting in one or more of the above listed codes becoming active. See figure 1 for areas of concern pertaining to the coolant level harness routing.

Picture of areas to check for damaged wires Figure 1

If the coolant level sensor harness is damaged, reference Freightliner Service Bulletin 54-290 for proper repairing of the harness. Once repairs are made to the harness, make sure that harness is properly wrapped with 8MM Twist Tube P/N BEN 2421000803SCM protecting the wiring. Route the wiring for HDEP engines referencing the new routing in figure 3 below and for Cummins engines reference figure 2.

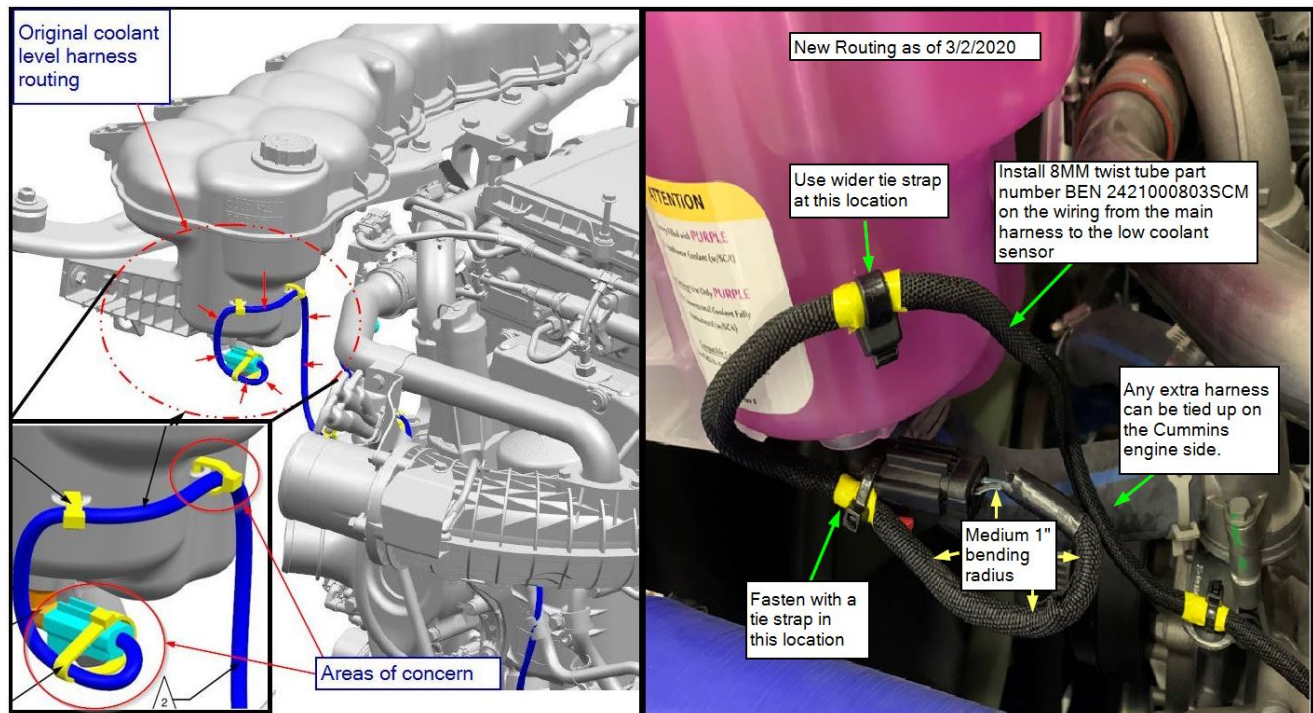
Cummins routing original vs new Figure 2

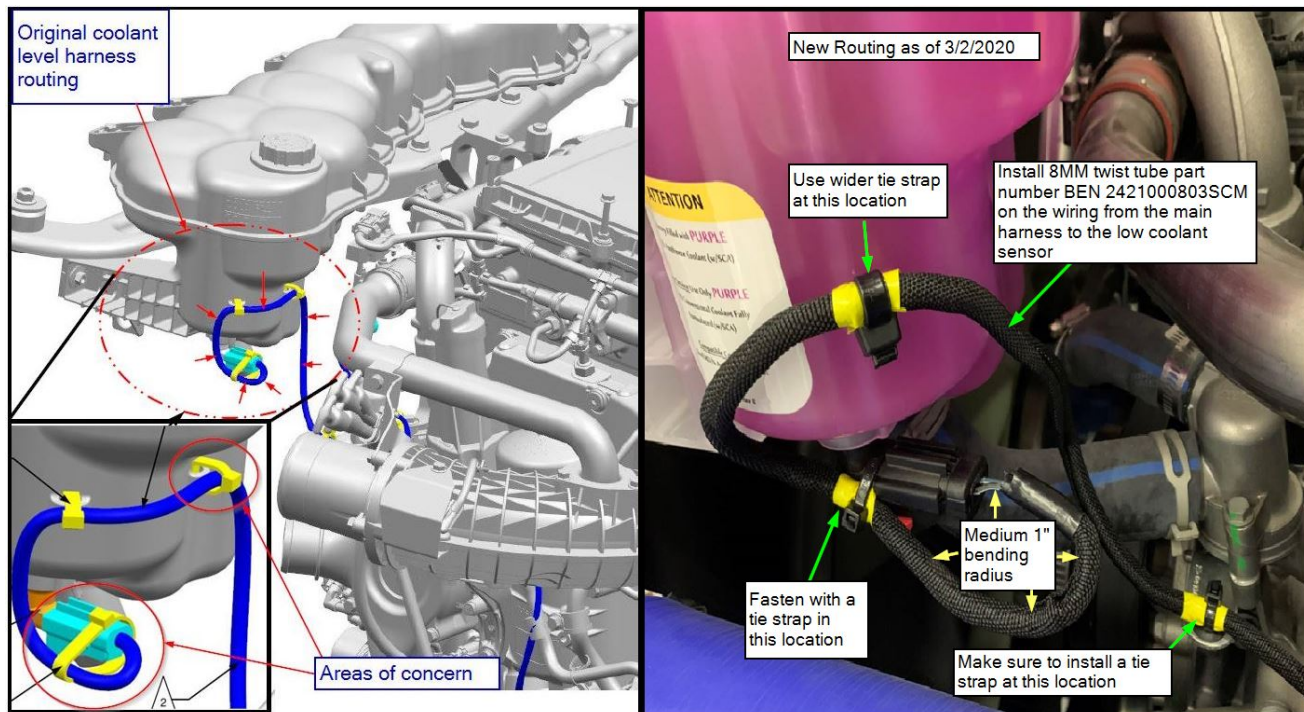
HDEP routing original vs new Figure 3
