GROUP
ELE
NUMBER
213 (Rev 2, 01/06/2021)

MODEL
2020-2021MY
Telluride (ON)
DATE
October 2020

TECHNICAL SERVICE BULLETIN

SUBJECT: SVM/AVM CAMERA DISPLAY IMAGE QUALITY
AND TPMS LIGHT ON

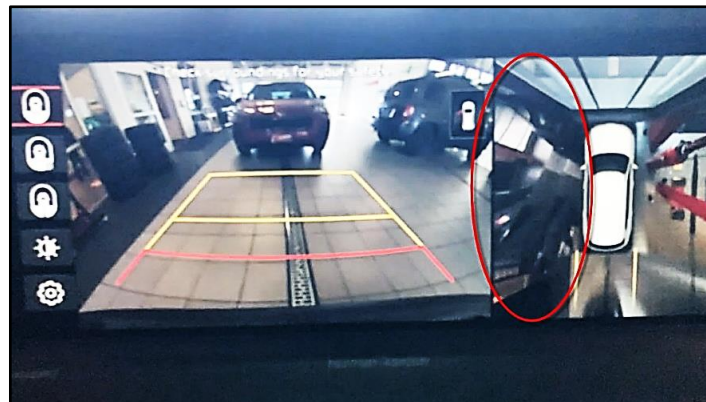
This bulletin provides the procedure to repair, the female coaxial cable terminals located in the respective locations as shown below on some 2020-2021MY Telluride (ON) vehicles produced June 1, 2020 to September 2, 2020, equipped with Side View Monitor or (SVM) or Around View Monitor (AVM) systems, which may exhibit intermittent issues with camera images flickering, displaying lines on the display, or intermittent TPMS communication failures resulting in error messages on the cluster.

Based on the complaint location, repairs should be made to one (1) or more of the four (4) locations listed below:

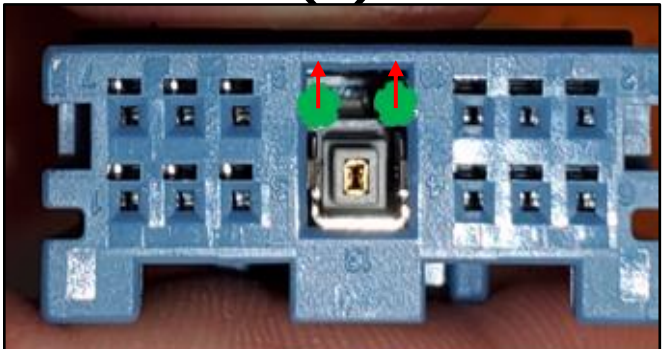
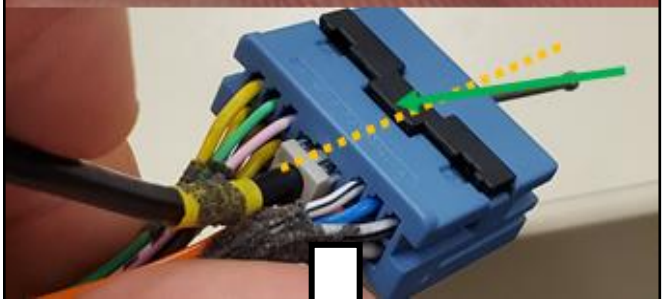
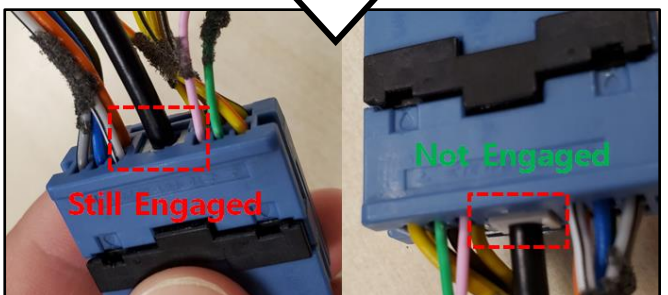
- 7a. Inspect the coaxial connector.

Note: The walls need to align parallel and evenly spaced.

Adjustment of 0.10~0.15 mm is recommended. To gauge proper adjustment, there will be a noticeable improvement in connection tension when mating male and female coaxial connections after adjustment is made.

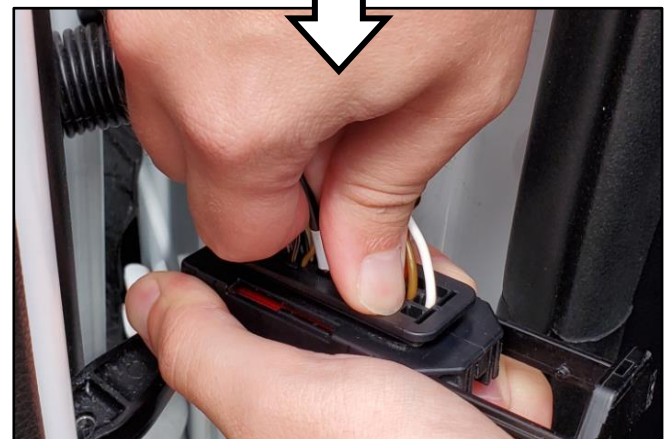
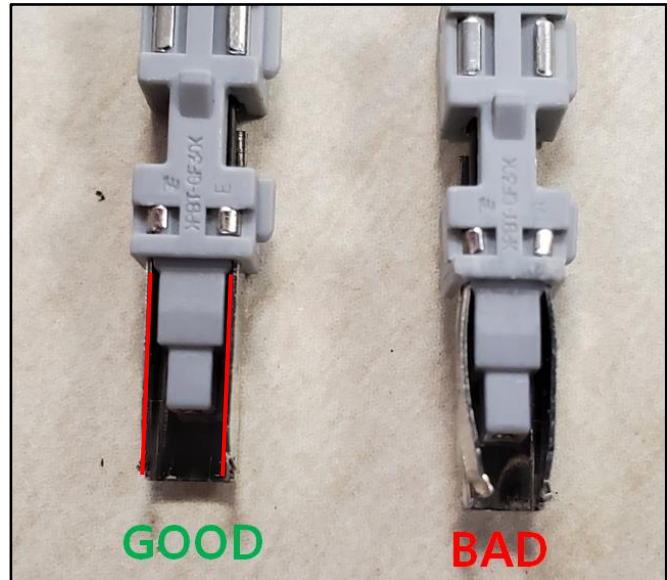
13. Inspect the coaxial connector.

Note: The walls need to align parallel and evenly spaced.

Adjustment of 0.10~0.15 mm is recommended. To gauge proper adjustment, there will be a noticeable improvement in connection tension when mating male and female coaxial connections after adjustment is made.
