MODEL
2021MY
Sorento (MQ4 HEV)

NUMBER
225

TECHNICAL SERVICE BULLETIN

SUBJECT: **SERVICE ACTION: CENTER AND REAR MUFFLER
INSPECTION AND REPAIR (SA461)**

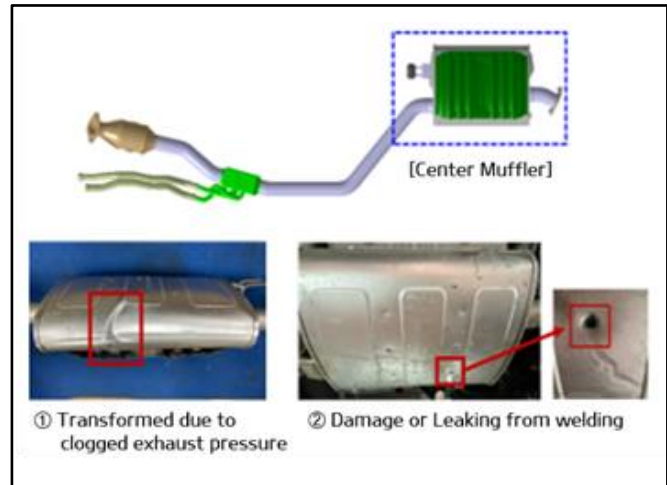
1. Inspect the center muffler for the following conditions:
 1. Deformation due to clog or physical deformation due to ice expansion.
 2. Leakage from corrosion/perforation damage from the welded area(s).

If conditions 1 or 2 apply, replace the center muffler assembly under normal warranty and perform the 'Repair Procedure' outlined below after replacement.

If conditions 1 or 2 **do not** apply, follow the '**Repair Procedure**' outlined below.

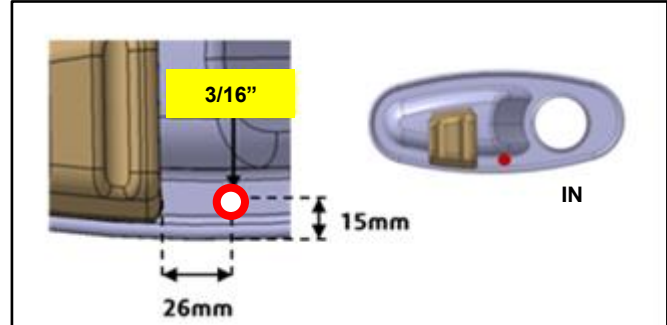
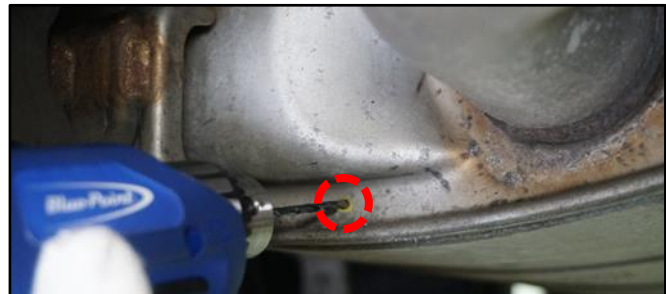
This bulletin provides the procedure to inspect the center muffler on some 2021MY Sorento (MQ4a HEV) vehicles equipped with 1.6L T-GDI engine, produced from September 02, 2020 through December 30, 2020, which may exhibit a poor engine start up due to freezing of condensation in the muffler(s) after parking the vehicle for an extended period of time in cold/freezing temperature. The issue does not affect drivability once the vehicle is started. Follow the procedure outlined in this bulletin to inspect the center muffler and drill a 3/16" hole on both the center and rear mufflers to improve condensation drainage. Before conducting the procedure, verify that the vehicle is included in the list of affected VINs.

1. On the front of the center muffler (inlet side, IN), measure from the edge of the muffler retaining bracket 26mm to the right and draw a line. Then measure 15mm from the bottom of the muffler and mark the spot to be drilled.
2. Using a power hand drill and 3/16" drill bit, drill a hole in the marked spot in the front of the center muffler as shown.
