**SERVICE PROGRAM BULLETIN**

**APPLICABILITY:** 2019MY Forester **NUMBER:** WRJ-20R  
**SUBJECT:** Power Rear Gate (PRG) Control Module Replacement **DATE:** 01/06/21

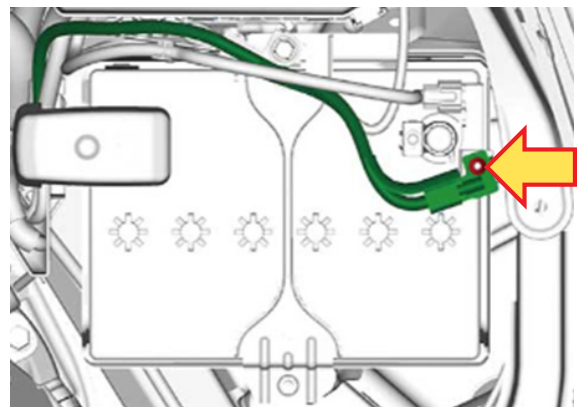
- Before proceeding with repair, refer to "Repair Contents" in the "General Description" section of the applicable Service Manual: [REPAIR CONTENTS > Repair Contents](#).
- Before disconnecting the battery, open the PRG fully.
- Before disconnecting connectors of any sensors or control units, ALWAYS remove the ground cable from the battery sensor as shown in the illustration. When removing the ground cable, always hold the sensor with one hand to prevent it from turning. DO NOT remove the sensor from the battery post.
