Subarunet Announcement

DATE: January 5, 2021

SUBJECT: Recall WRH-20 / WRI-20 Denso Gen 4 CP1 software update. Critical points to avoiding unnecessary hardware replacement

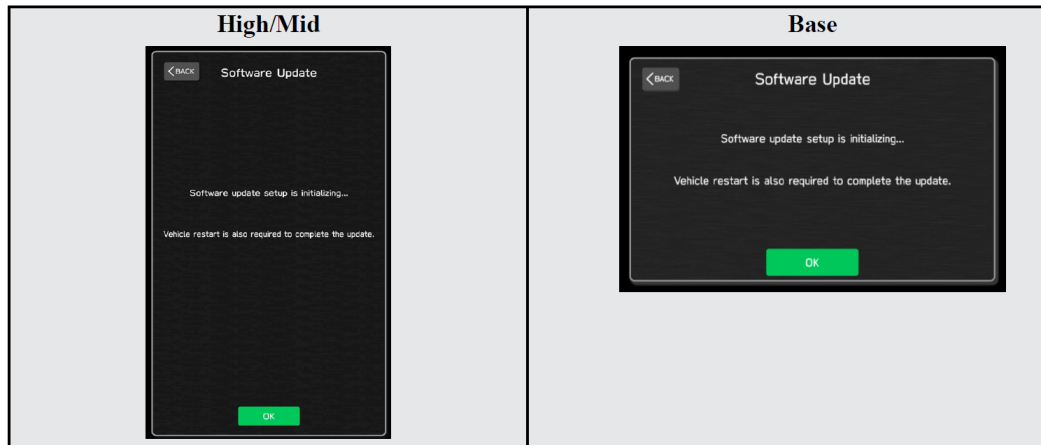
1. “Software update setup is initializing...” message

We have seen exchange claims for reported failures where the message “Software update setup is initializing...” appears when performing the software update.

Note: “Software update setup is initializing...” message could be displayed for any one of the reasons listed below:

- *When the software update is performed (FOTA or USB) following the installation of new Cockpit Control Unit (CCU) prior to keeping I/G ON for 30 minutes or longer.*
- *When re-attempting the software update, after the initial update failure following CCU rebooting.*
- *When the software update is performed, after the CCU rebooted following “Memory Initialization”.*

This is characteristic as outlined in the Service Bulletin. This does not mean the software update failed. If the screen shown above appears, **WAIT** for approximately **15-30** minutes to allow the

Software update setup initialization process to complete. This information is also provided in WRI-20, WRH-20, TSB 15-261-20R. Questions may be directed to SOA's Technical Helpline, if necessary.

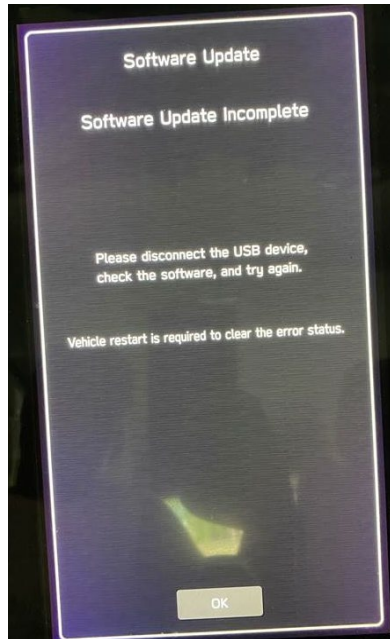
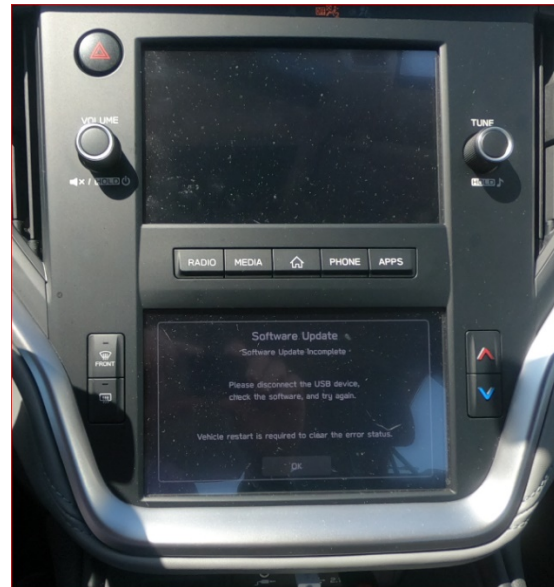
2. "Software Update Incomplete" message

We have seen exchange claims for the message "Software update Incomplete" appearing when performing the software update.

Please check the software version next, if you see this message. As long as the software version was updated to match the version found in the related WRH-20, WRI-20, TSB 15-261-20R you can continue following the software update procedure restarting the vehicle. In most cases this does not indicate an actual concern and will clear after the restart. If in some rare case, the software version didn't update, proceed with troubleshooting to identify the root cause. Questions may be directed to SOA's Technical Helpline, if necessary.

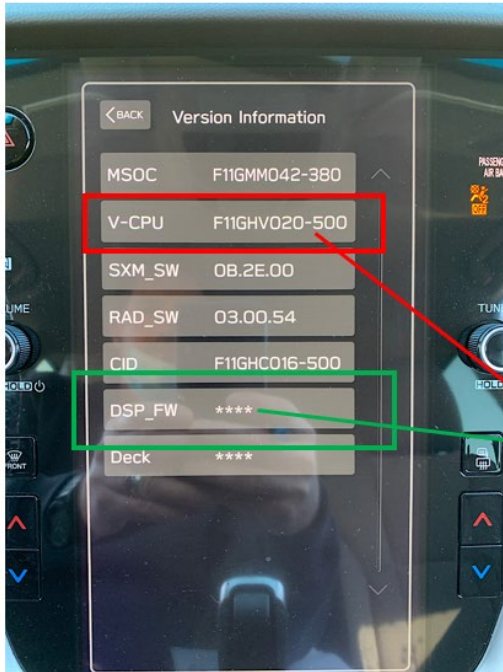
3. Software corrupted following the update

In some rare cases, there may be a loss of the audio output or CID malfunction following the software update. This condition may or may not be accompanied with an error message(s) other than the "Software update setup is initializing..." or "Software update Incomplete". Should this occur, go to the "Version Information" screen following **WRH-20, WRI-20** and **TSB 15-261-20R** and confirm "MSOC" version, "V-CPU" version, "RAD_SW" version and "DSP_FW" version. See below for an example of failed software update showing incorrect data for "V-CPU" version and "DSP_FW" version.

If the version displayed for MSoC is incorrect or there is no "RAD_SW" version and "DSP_FW" version displayed or asterisk symbols (****) are shown, the software was corrupted during the software update. Should this occur, **NEVER use the same USB drive for another update without reformatting it and loading a new set of the update files as outlined in the related service bulletin.**

Please note it is still possible to recover CCU state by performing another software update, if "V-CPU" version is wrong and "DSP_FW" version doesn't show as "****". CCU recovery is successful, as long as you get "Software update setup is initializing..." message during next attempt to update the software. Otherwise the condition is not recoverable and will require Cockpit Control Unit (CCU) replacement.
