SERVICE BULLETIN

APPLICABILITY: 2012-2013MY Impreza with FB Engine **NUMBER:** 02-130-12R
SUBJECT: Oil Seepage Diagnosis and Repair Procedures **DATE:** 07/18/12
REVISED: 01/22/21

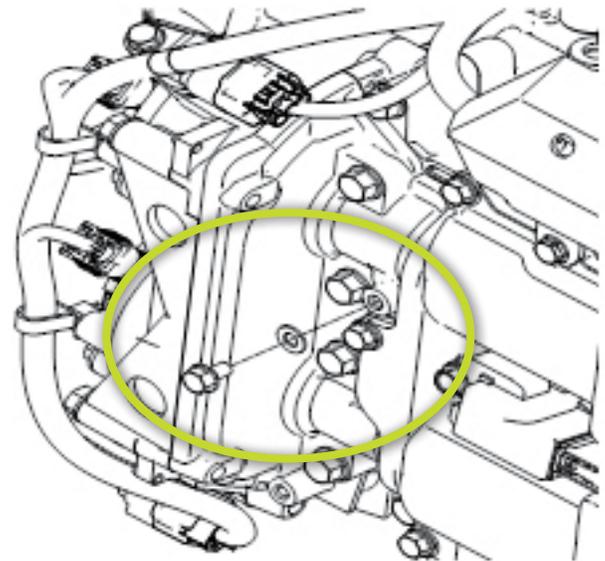
If oil seepage is verified coming from the 6mm threaded hole in the left-hand camshaft cap, install the specified bolt and flat washer.

Bolt: Part# 800206180

Washer: Part# 031106000

Tightening Torque: 6.4 +/- 0.5 Nm
(57 +/- 4 inch-pounds)

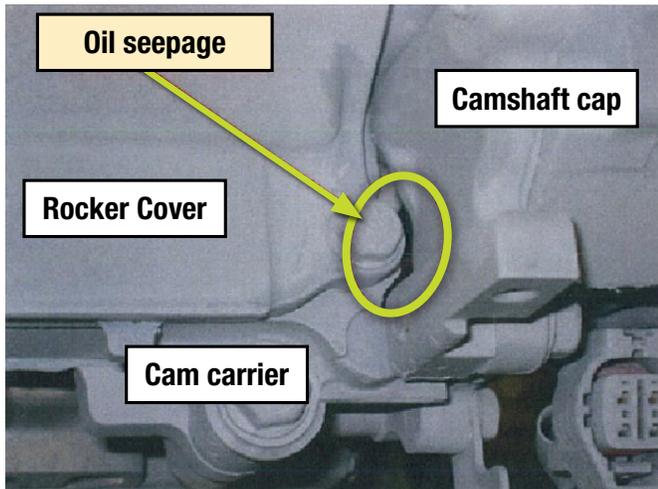
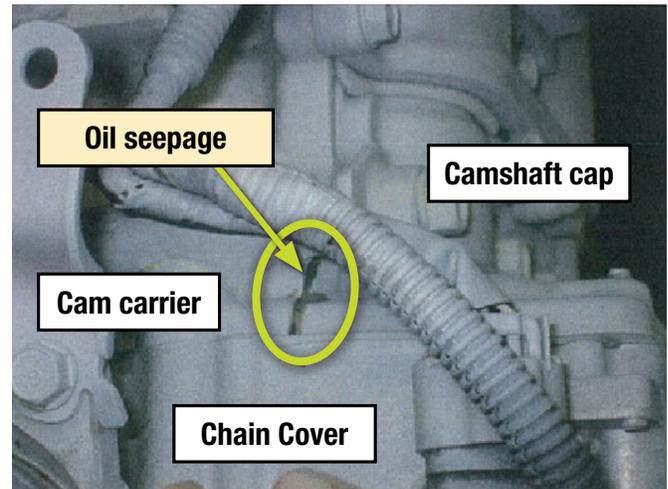
If oil seepage is verified coming from the front camshaft cap or cam carrier as shown in the photos below, remove the cam cap and clean both surfaces thoroughly before applying sealer. **Note:** The 2 o-rings between the camshaft cap and the cam carrier will need to be replaced as they are not re-usable.

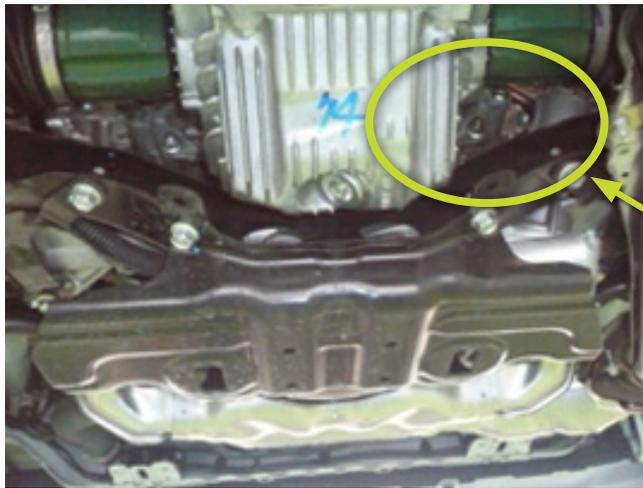
If you find engine oil seepage between the cylinder block and upper oil pan, remove the upper oil pan, clean the machined sealing surfaces thoroughly and then re-seal using Liquid Gasket ThreeBond 1217H (SOA868V9610) or equivalent*. **Note:** The o-rings between the upper oil pan and the cylinder block along with those between the upper and lower oil pan will need to be replaced as they are not re-usable.

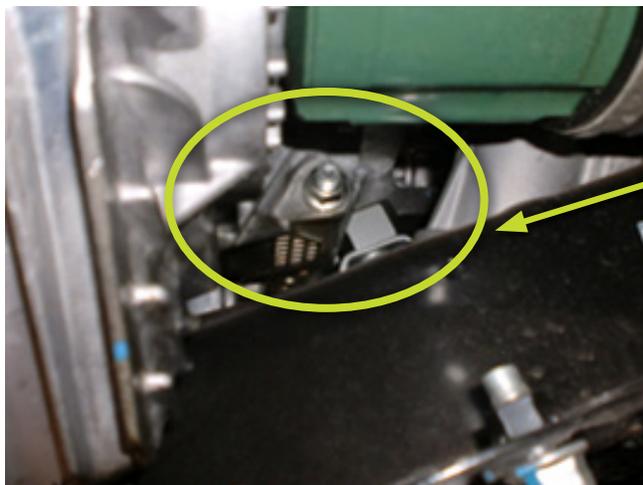
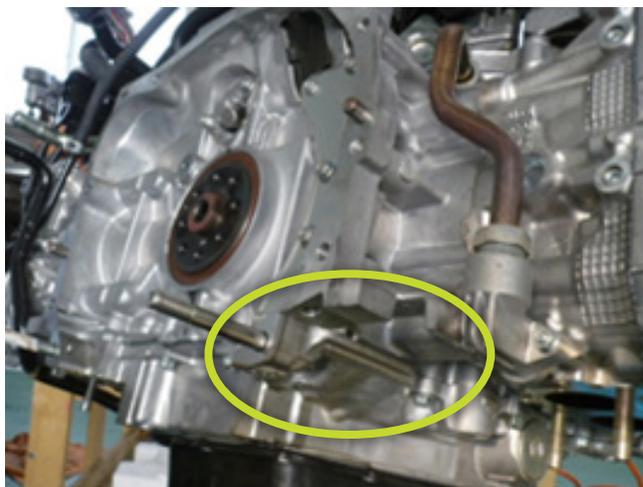
As viewed from the rear, oil seepage from the upper pan to engine block sealing area may be present in these areas.

Photo shows seepage from upper oil pan to engine block sealing surfaces.

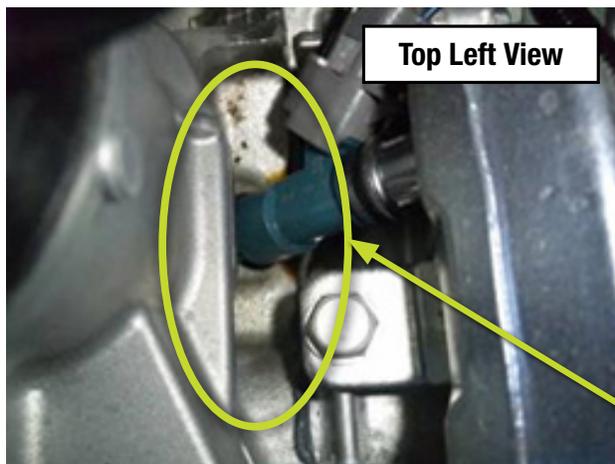
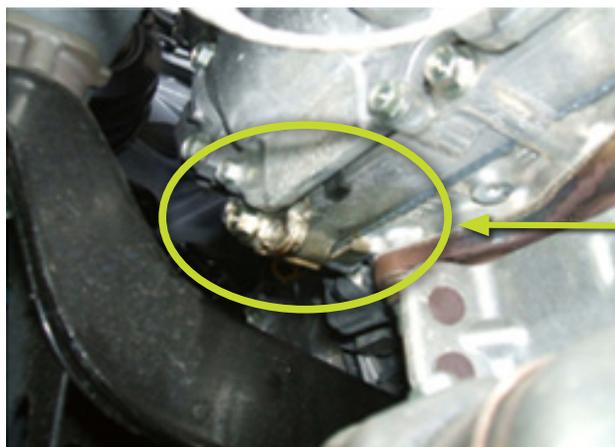
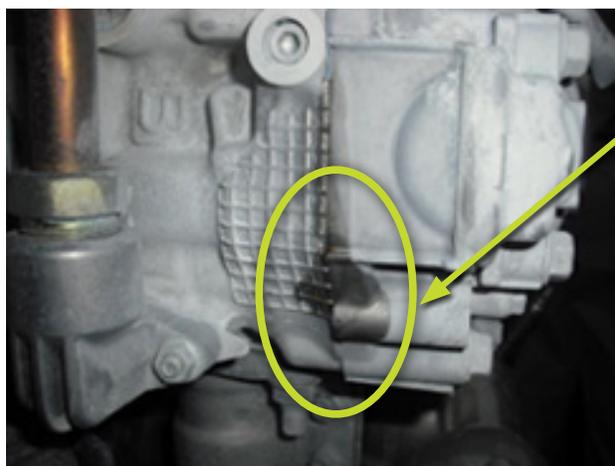
Cam carrier seepage seen from top left and lower right side of engine

If oil seepage is verified coming from between the cam carrier and the cylinder head as shown in the photos below, remove the cam carrier. Clean the machined sealing surfaces thoroughly and then re-seal using Liquid Gasket ThreeBond 1217H (SOA868V9610) or equivalent*. As shown in the photos below, the o-rings between the cam carrier and the cylinder head will need to be replaced as they are not re-usable. This would also be a good time to clean the Active Valve Control System (AVCS) filter screens which are contained in the cam carriers. **NOTE:** The filter screens are one-time use and must be replaced if they need to be removed. The replacement filter part# is 14451AA050.

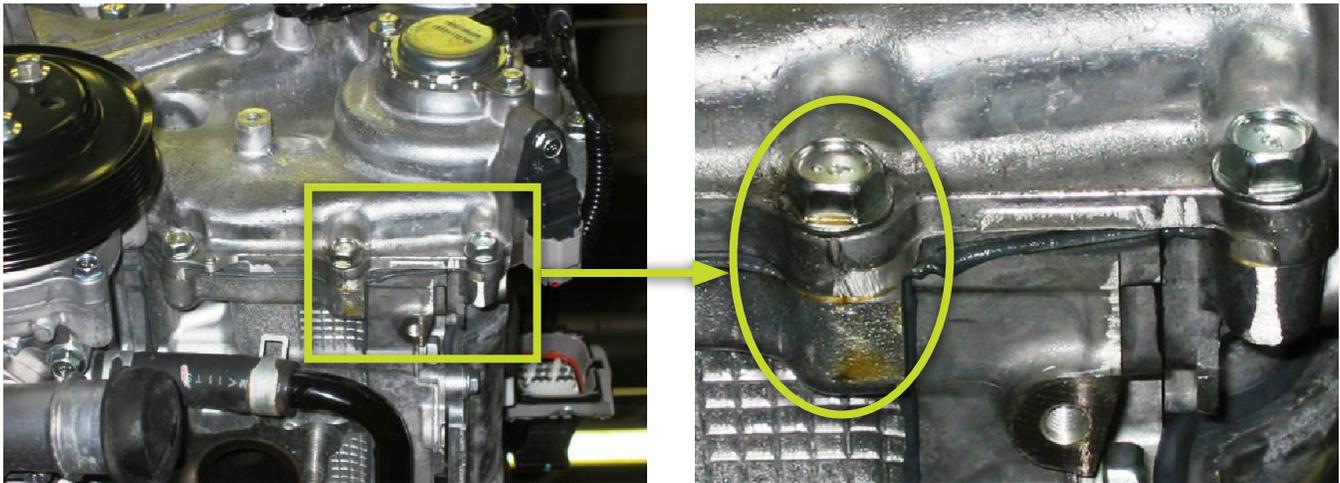
Note: Only reseal the front chain cover AFTER confirming there is no oil seepage coming from the cam retainer cap (area 1) as previously described.

1. If there are no oil droplets found on the engine under-cover or the lower radiator hose, thoroughly clean the chain cover sealing area along with the surrounding cylinder head and crankcase areas. Re-check for oil seepage again at the next service interval.
2. If the front chain cover is leaking and needs to be resealed, follow the repair procedure in the applicable Service Manual. Thoroughly clean and inspect the sealing surfaces then re-seal using Liquid Gasket ThreeBond **1217H (SOA868V9610)** or equivalent*.
