SERVICE BULLETIN

APPLICABILITY: 2013-19MY BRZ

NUMBER: 02-136-12R

SUBJECT: Oil Seepage Diagnosis and Repair Procedures

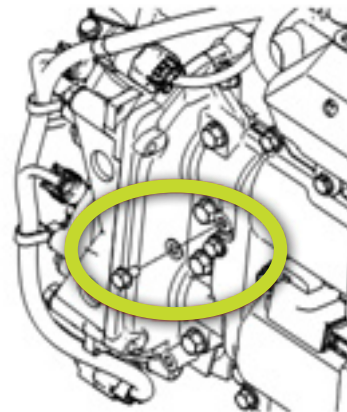
If oil seepage is verified coming from the 6mm threaded hole in the left-hand camshaft cap, install the specified bolt and flat washer.

Bolt: Part# 800206180

Washer: Part# 031106000

Tightening Torque: 6.4 +/- 0.5 Nm
 (57 +/- 4 inch-pounds)

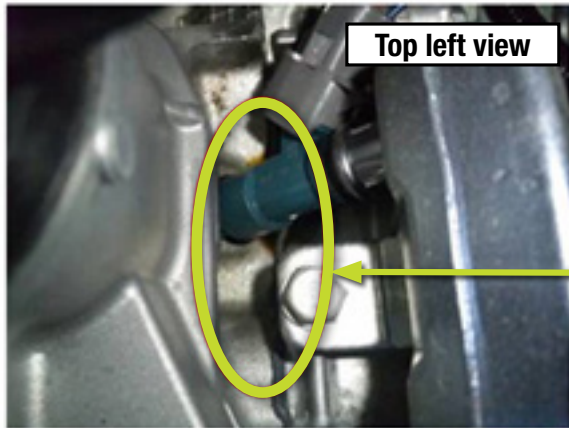
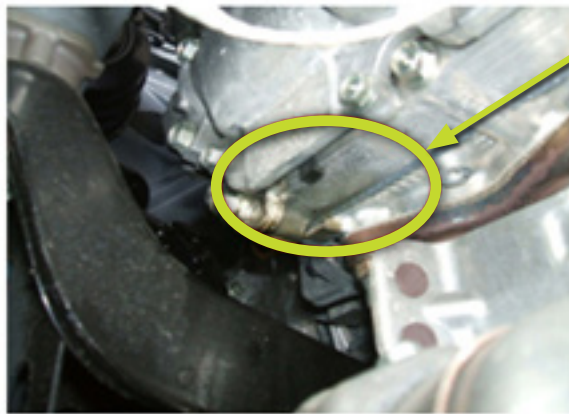
Cam carrier seepage seen from top left and lower right side of engine

If oil seepage is verified coming from between the cam carrier and the cylinder head as shown in the photos below, remove the cam carrier. Clean the machined sealing surfaces thoroughly and then re-seal using Liquid Gasket ThreeBond 1217H (SOA868V9610) or equivalent*. As shown in the photos below, the o-rings between the cam carrier and the cylinder head will need to be replaced as they are not re-usable. This would also be a good time to clean the Active Valve Control System (AVCS) filter screens which are contained in the cam carriers and shown in the photos below. **NOTE:** The filter screens are one-time use and must be replaced if they need to be removed. The replacement filter part # is 14451 AA 050.

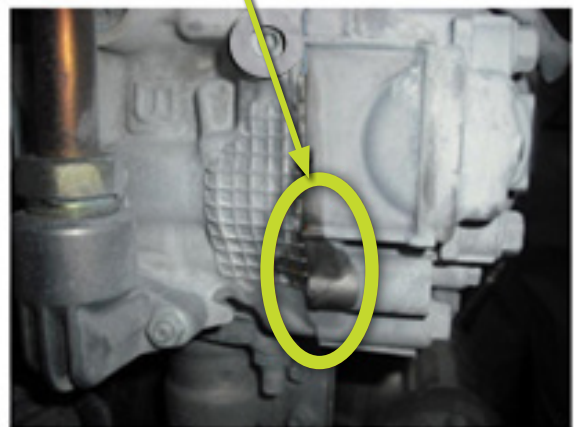
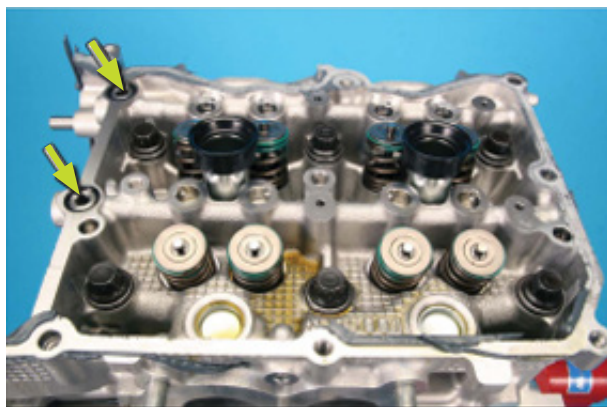
One-time use cam carrier o-rings which must be replaced.

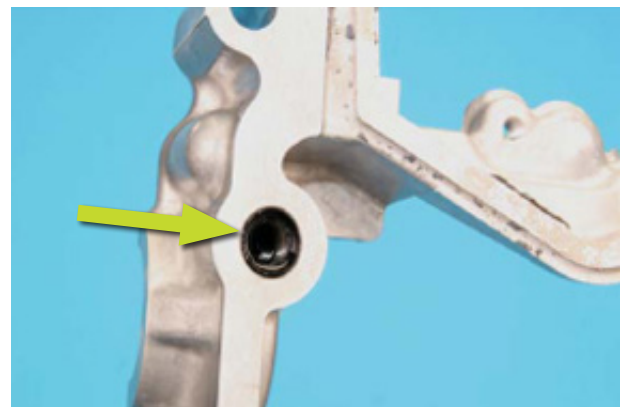
AVCS filter screens must be replaced if removed.

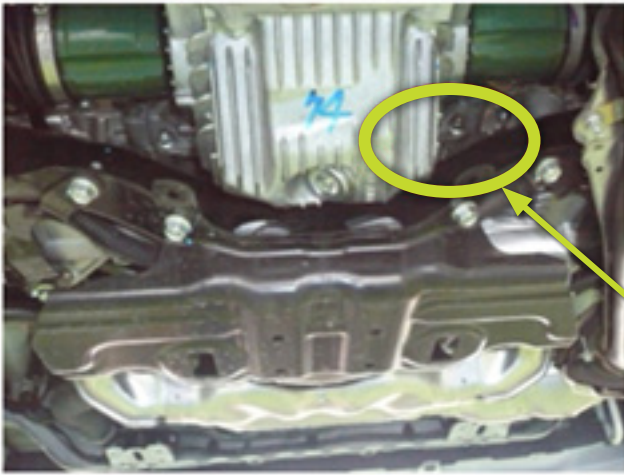
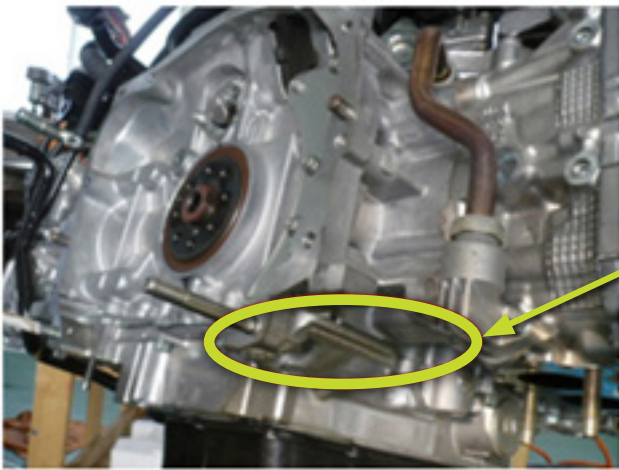
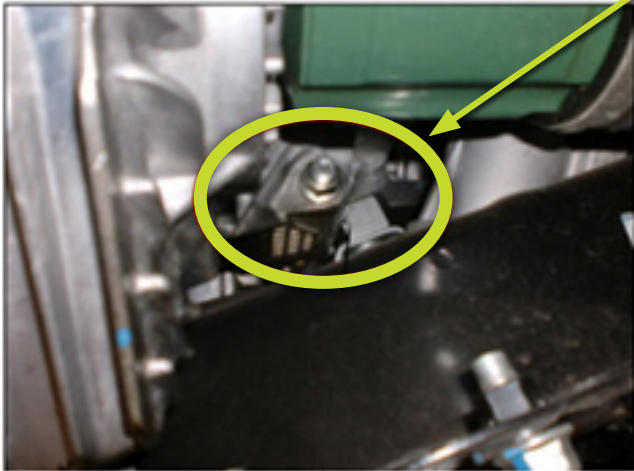
These photos show areas of seepage coming from the upper oil pan to engine block sealing surfaces.

If you find oil seepage between the cylinder block and upper oil pan, remove the upper oil pan, clean the machined sealing surfaces thoroughly and then re-seal using Liquid Gasket ThreeBond 1217H (SOA868V9610) or equivalent*. In addition, the o-rings between the upper oil pan and the cylinder block along with those between the upper and lower oil pan will need to be replaced as they are also one-time use items.

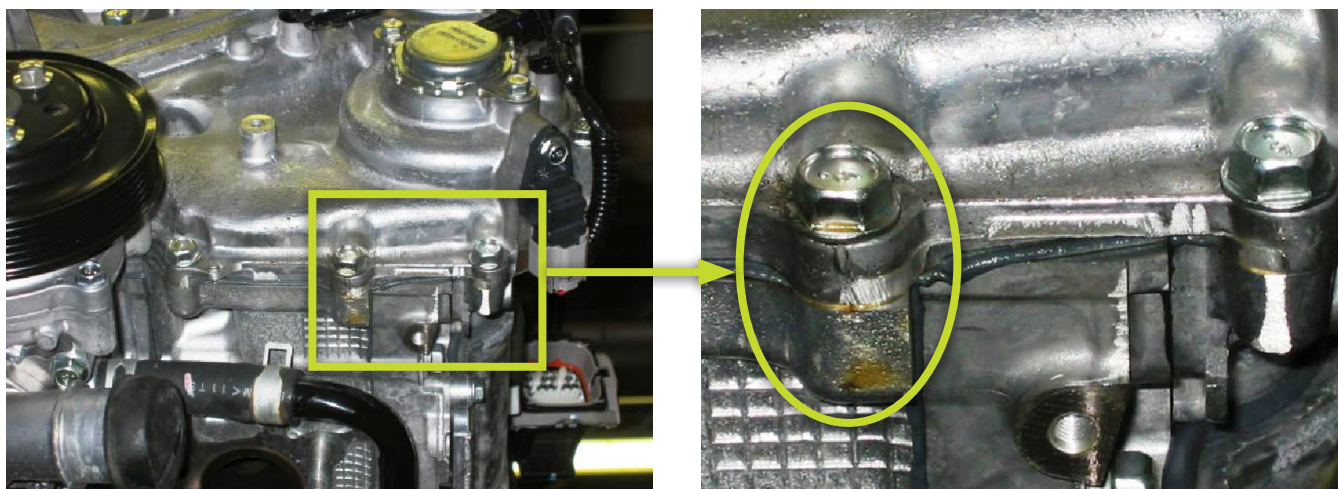
NOTE: Only reseal the front chain cover **AFTER** confirming there is no oil seepage coming from the either cam retainer cap (area 1) and / or the cam carrier (area 2) as previously described.

1. If there are no oil droplets found on the engine under-cover or the lower radiator hose, thoroughly clean the chain cover sealing area along with the surrounding cylinder head and crankcase areas. Re-check for oil seepage again at the next service interval.
2. If the front chain cover is leaking and needs to be resealed, follow the repair procedure in the applicable Service Manual. Thoroughly clean and inspect the sealing surfaces then re-seal using Liquid Gasket ThreeBond **1217H (SOA868V9610)** or equivalent*.

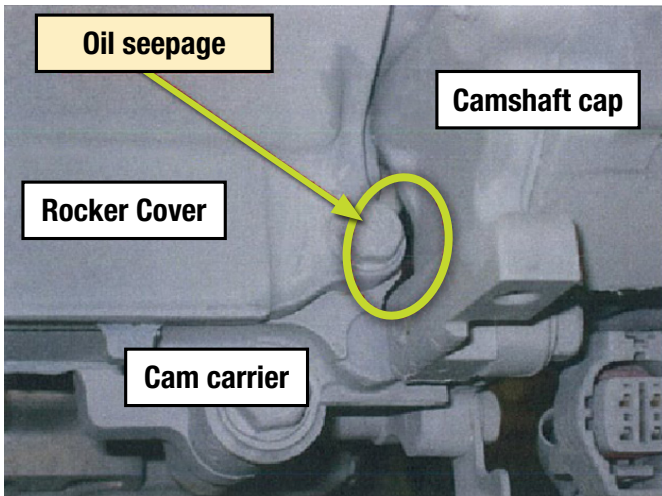
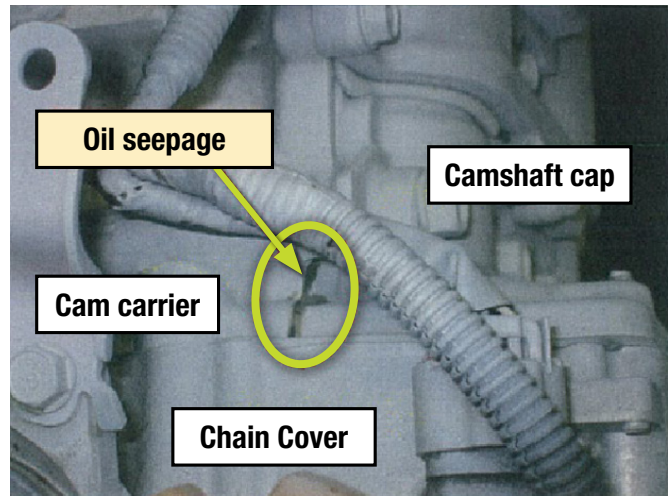
If oil seepage is verified coming from the front camshaft cap and/or camshaft carrier as shown in the photos below, remove the cam cap and clean both surfaces thoroughly before applying sealer. **Note:** The 2 o-rings between the camshaft cap and the cam carrier will need to be replaced as they are not re-usable.

Apply Liquid Gasket, ThreeBond 1217H (SOA868V9610) or equivalent* as shown below:

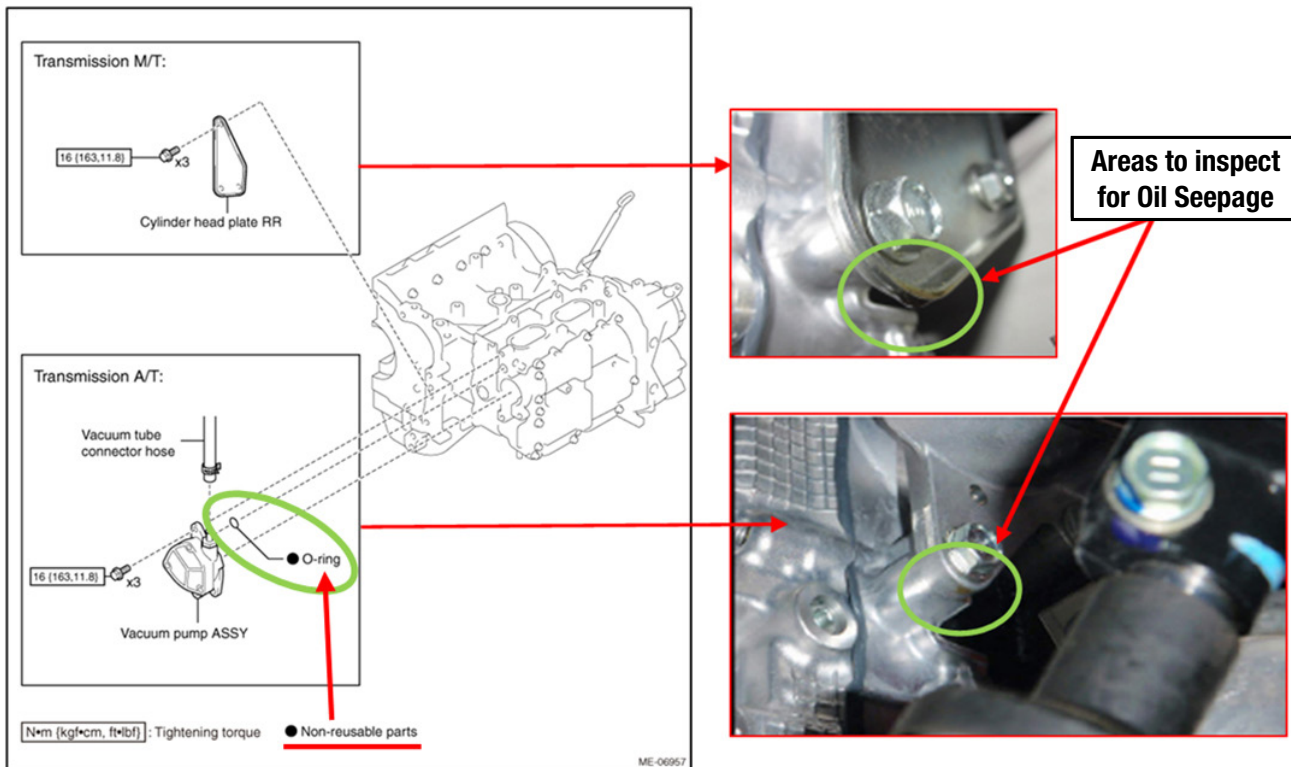
If oil seepage is verified at the bottom of the cylinder head block-off plate (on M/T models) or bottom of the vacuum pump assembly (on A/T models), the source may be the area between the cam carrier and the intake cam cap. The seeped oil then collects at the bottom of the block-off plate or vacuum pump as shown in the photo and illustration below.

IMPORTANT: ALWAYS replace the small vacuum pump o-ring as it is a **one-time use item**.
