## SERVICE BULLETIN

**APPLICABILITY:** 2012-19MY Forester  
 2012-19MY Impreza  
 2015-19MY WRX

**NUMBER:** 02-131-12R  
**DATE:** 07/18/12  
**REVISED:** 01/22/21

**SUBJECT:** Oil Seepage Diagnosis and Repair Procedures

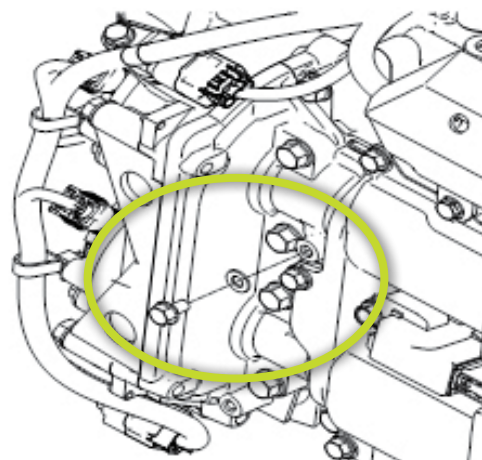
If oil seepage is verified coming from the 6mm threaded hole in the left-hand camshaft cap, install the specified bolt and flat washer.

**Bolt:** Part# 800206180

**Washer:** Part# 031106000

**Tightening Torque:** 6.4 +/- 0.5 Nm  
 (57 +/- 4 inch-pounds)

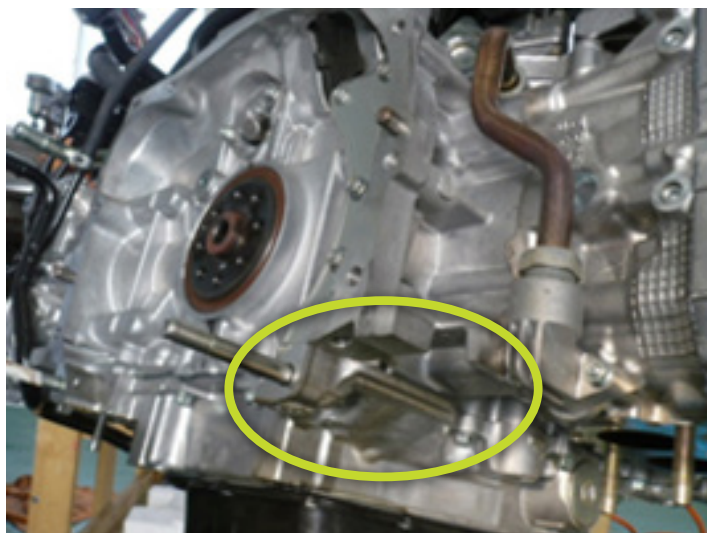
Photo shows seepage from upper oil pan to engine block sealing surfaces.

If you find engine oil seepage between the cylinder block and upper oil pan, remove the upper oil pan, clean the machined sealing surfaces thoroughly and then re-seal using Liquid Gasket ThreeBond **1217H (SOA868V9610)** or equivalent\*. **Note:** The o-rings between the upper oil pan and the cylinder block along with those between the upper and lower oil pan will need to be replaced as they are not re-usable.

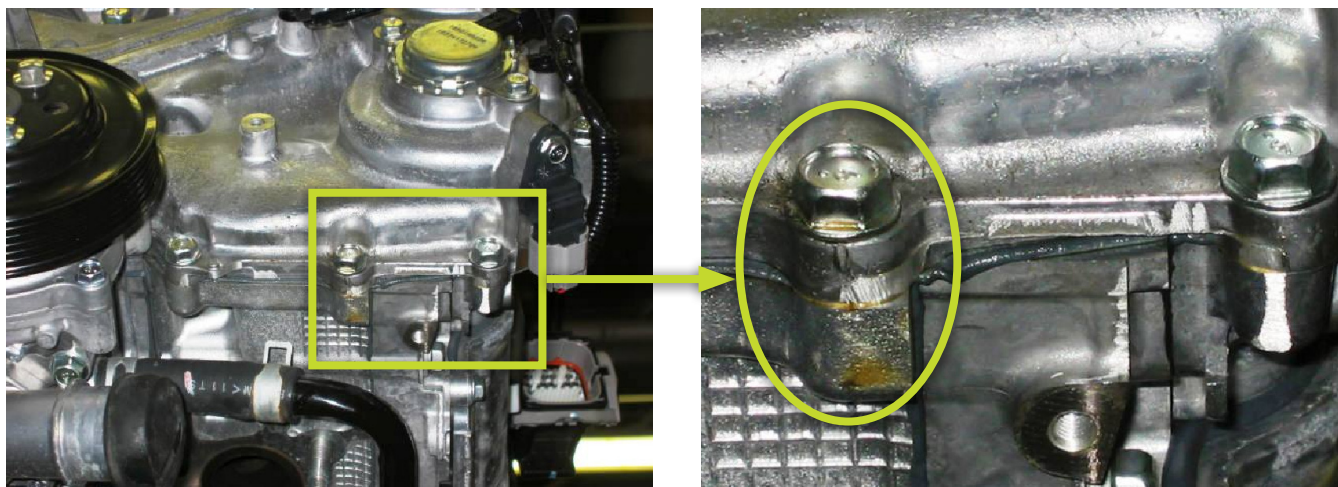
**Note:** Only reseal the front chain cover AFTER confirming there is no oil seepage coming from the cam retainer cap (area 1) as previously described.

1. If there are no oil droplets found on the engine under-cover or the lower radiator hose, thoroughly clean the chain cover sealing area along with the surrounding cylinder head and crankcase areas. Re-check for oil seepage again at the next service interval.
2. If the front chain cover is leaking and needs to be resealed, follow the repair procedure in the applicable Service Manual. Thoroughly clean and inspect the sealing surfaces then re-seal using Liquid Gasket ThreeBond **1217H (SOA868V9610)** or equivalent\*.
